Effective Floor Cavity and Knee Wall Construction Techniques in Two-Story Homes in Hot Climates

Buildings XIII Conference, Clearwater, FL
Session 6 Practices - 3:30 PM-5:00 PM
December 6, 2016

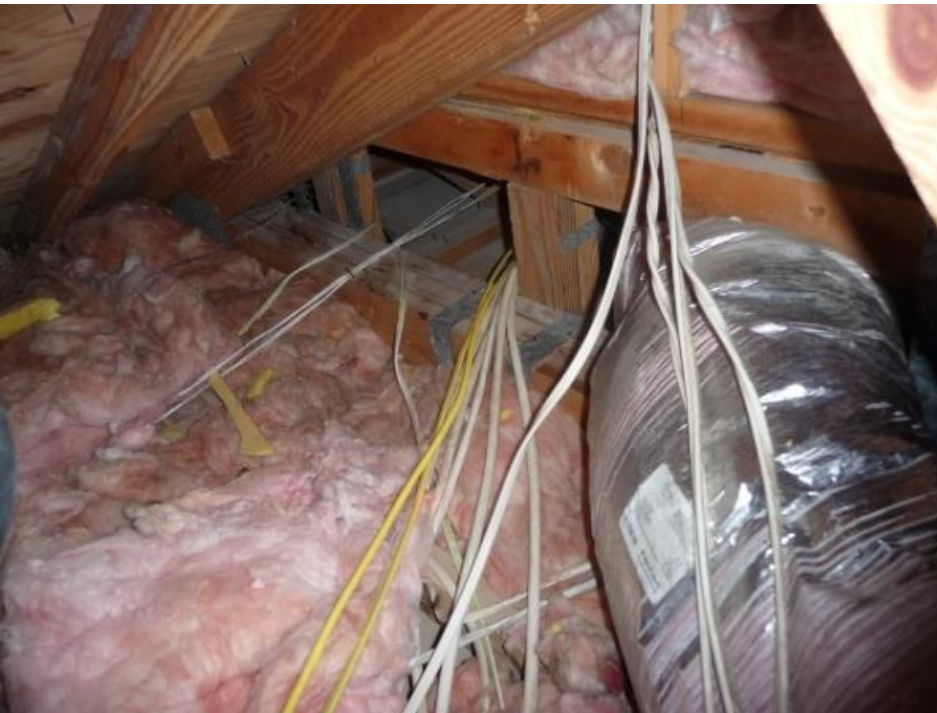
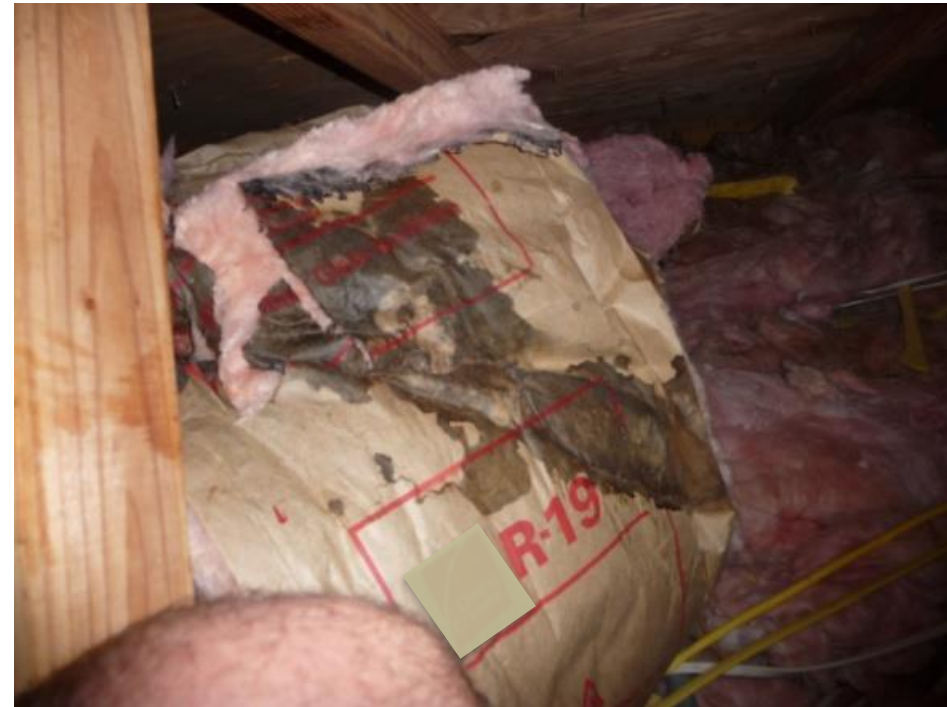
Wind Wash Floor Cavity Inspection

- Inside east attic view of open floor space

Insulation in direct contact with cold supply duct resulted in condensation on duct and insulation. Sealing floor space around ducts must be done right.

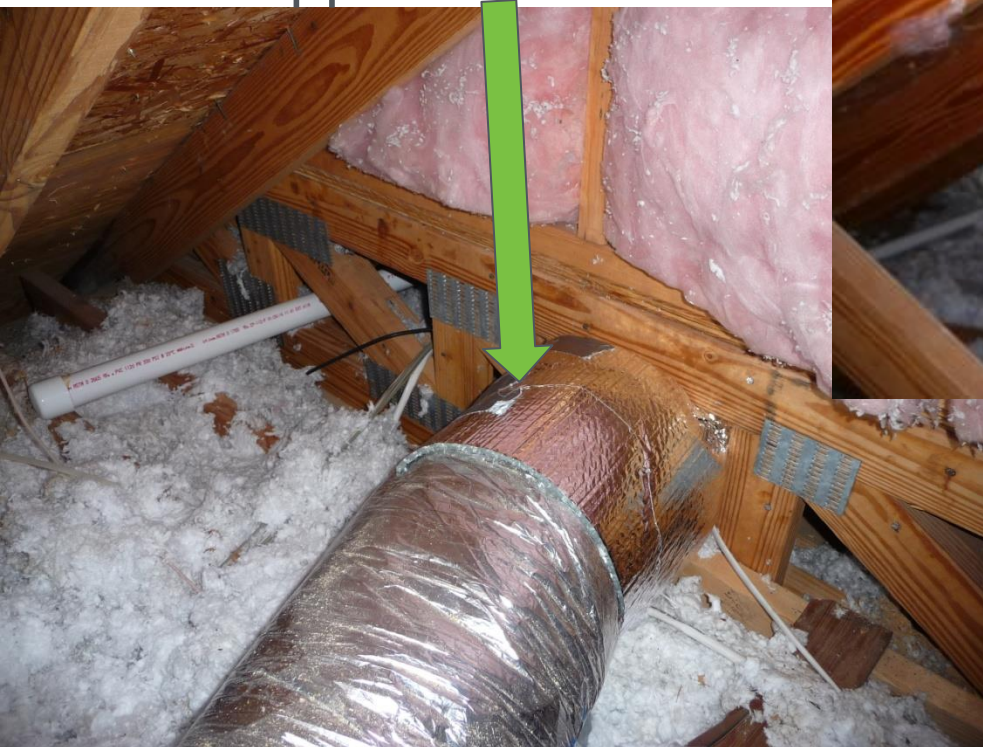
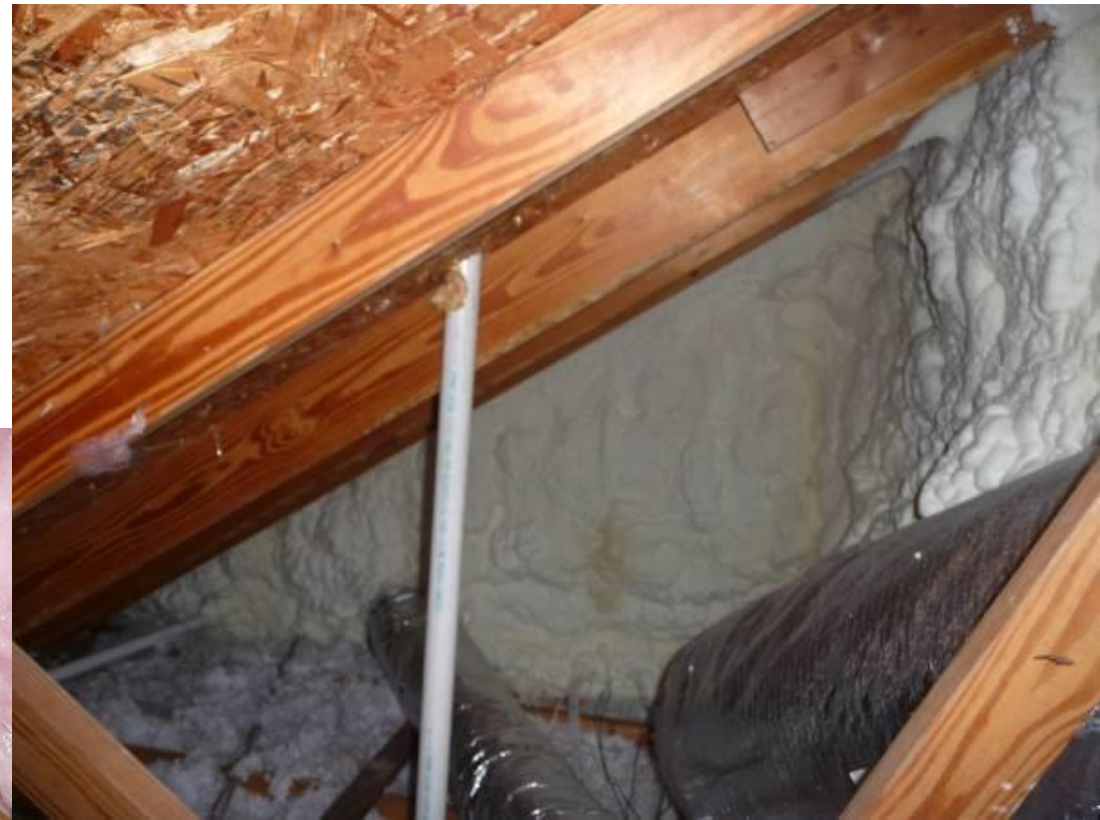
Floor Cavity Repair Around Cold Supply Ducts

Insulation exterior with class I vapor retarder placed around ducts before spray foam application.

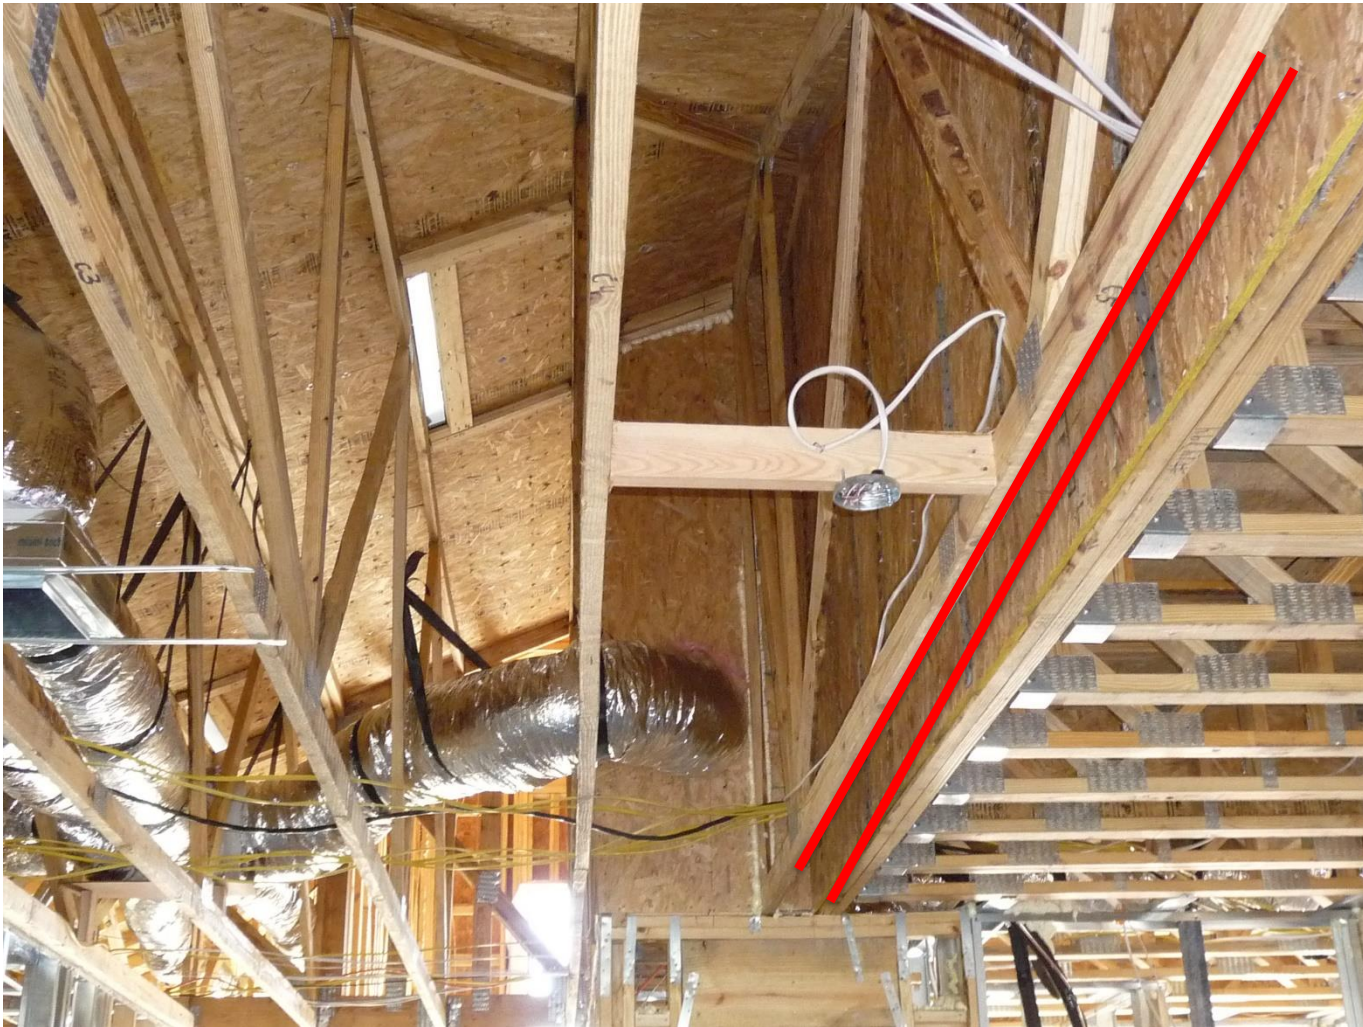
Floor Cavity is Sealed by Plywood, But Little Clearance Between Roof Truss and Knee Wall.

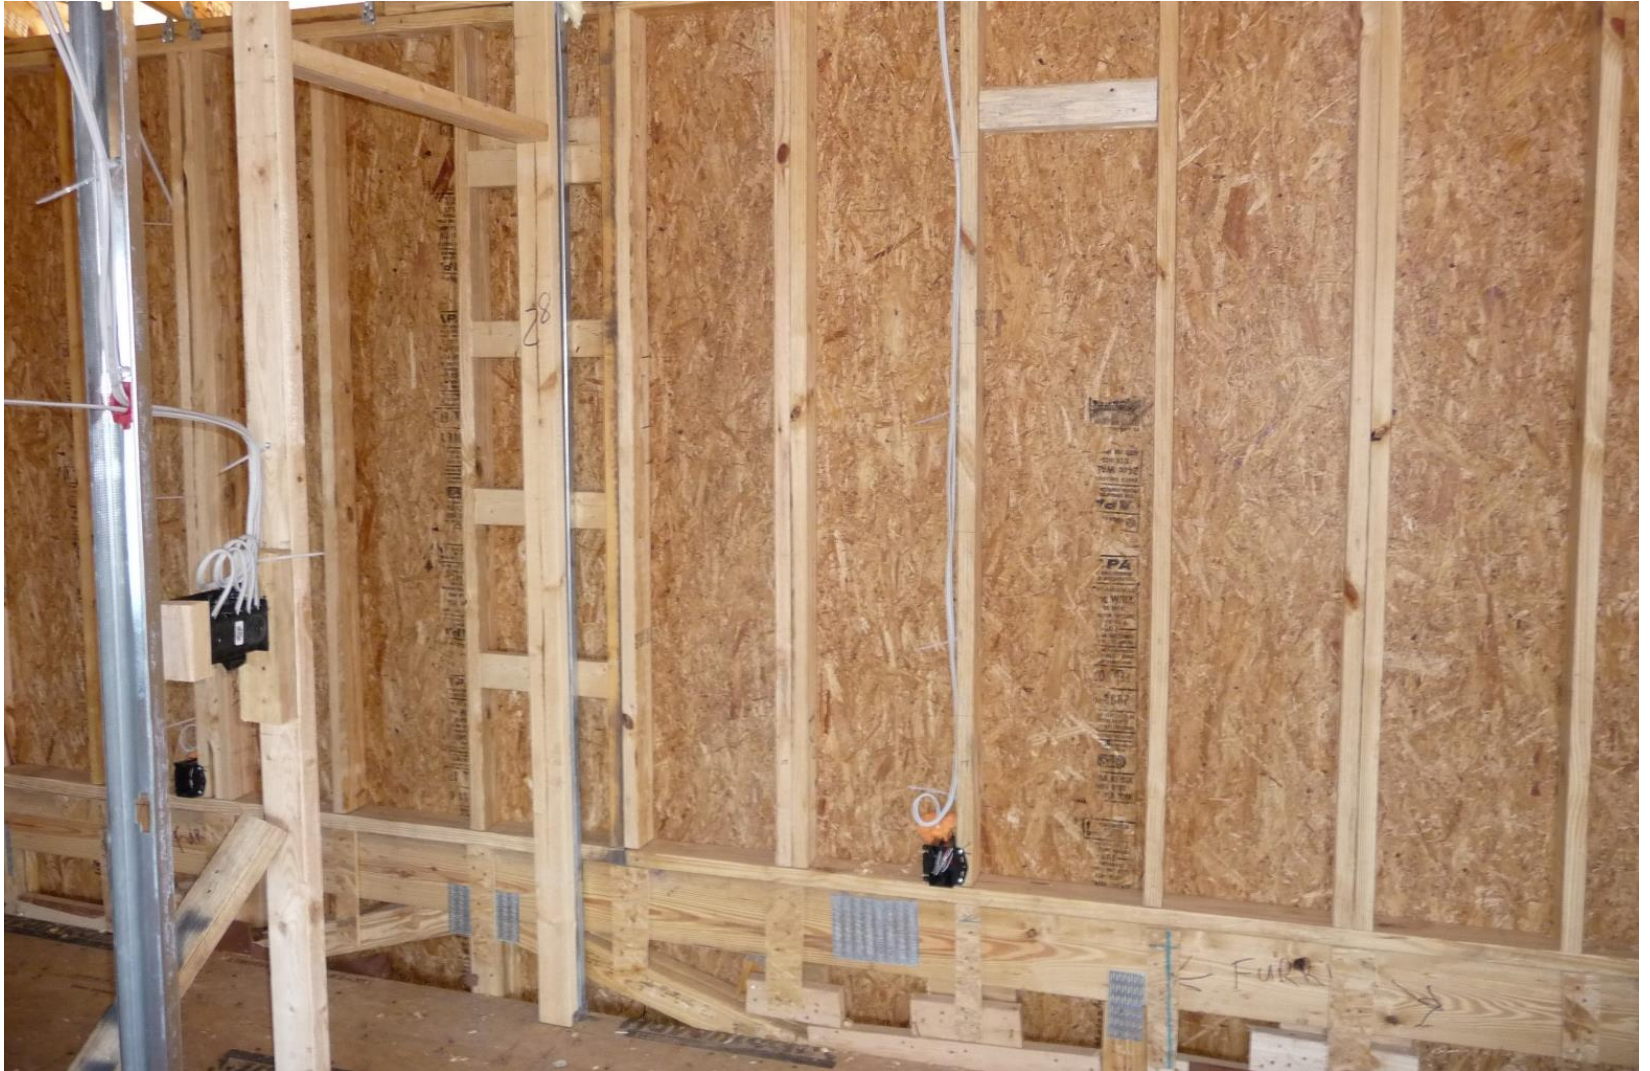
Interior of This Wall Is Not Good Location for Batts !

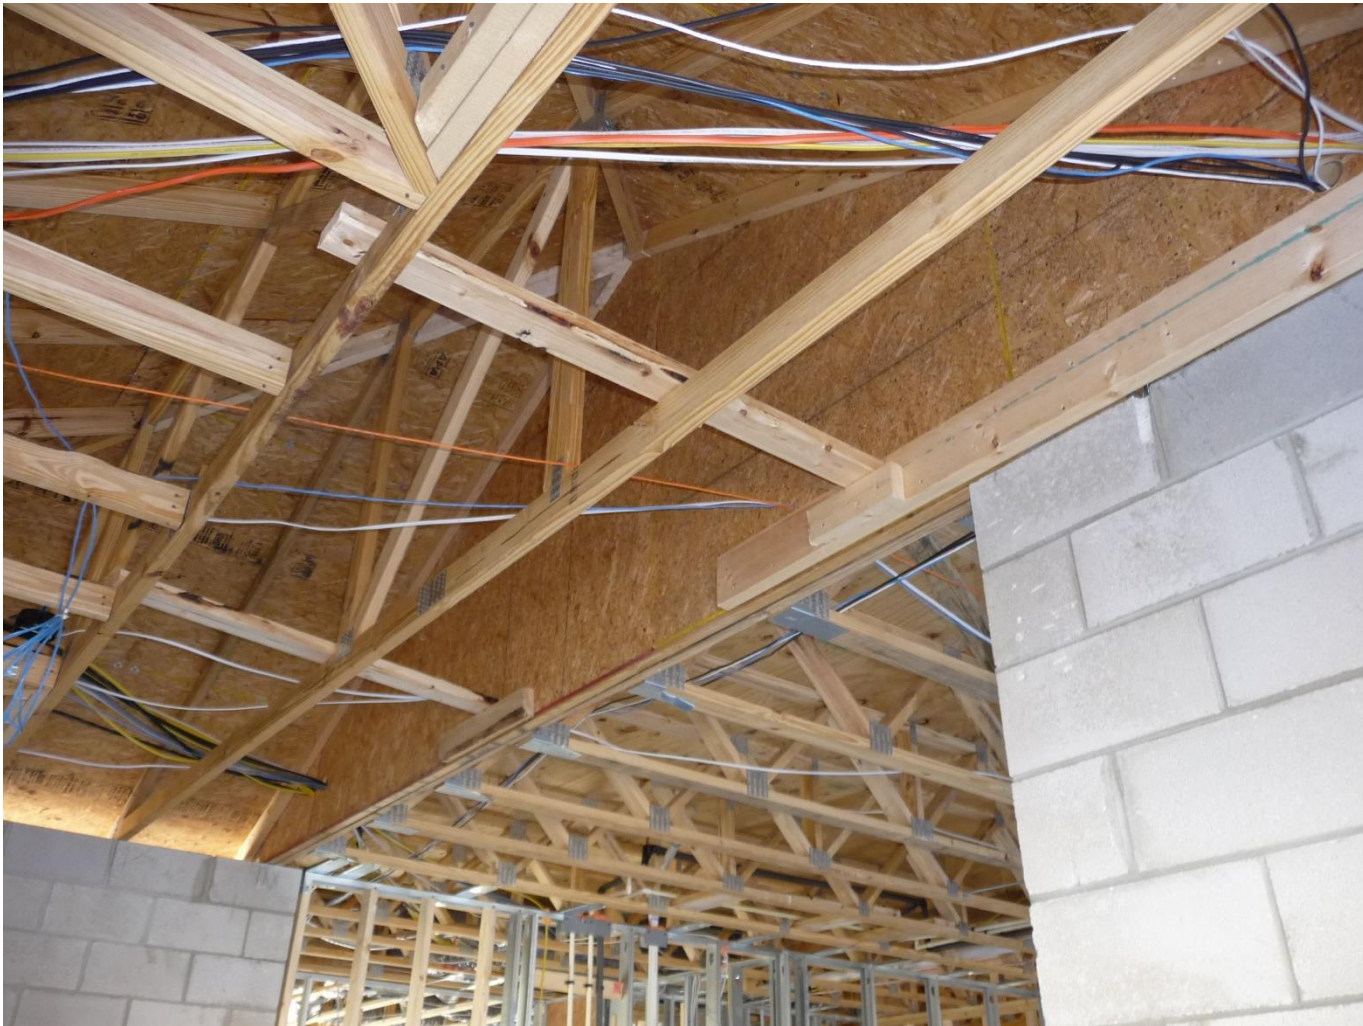
Floor Cavity Covered by Plywood With Adequate Clearance Between Roof Truss and Knee Wall For Insulation

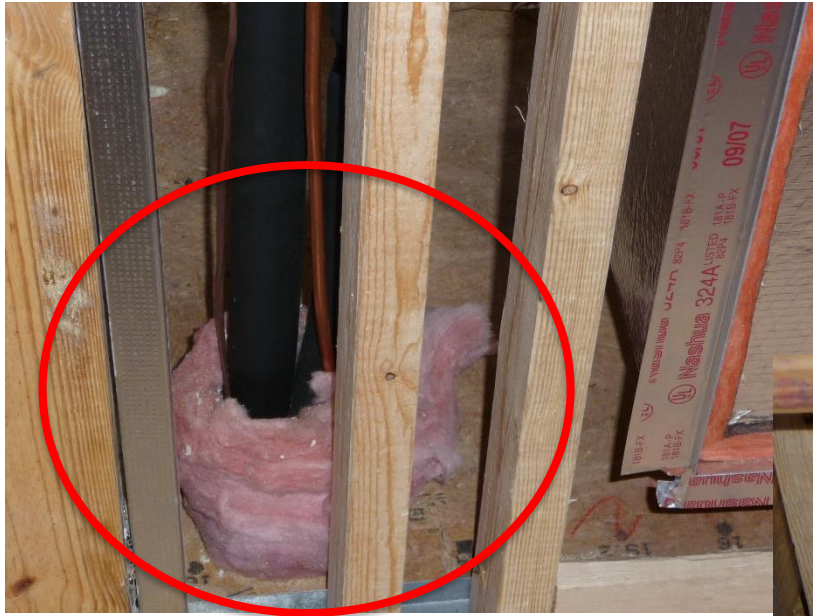
2nd Floor System Refrigerant Penetrations Into Floor Cavity Must Be Sealed.

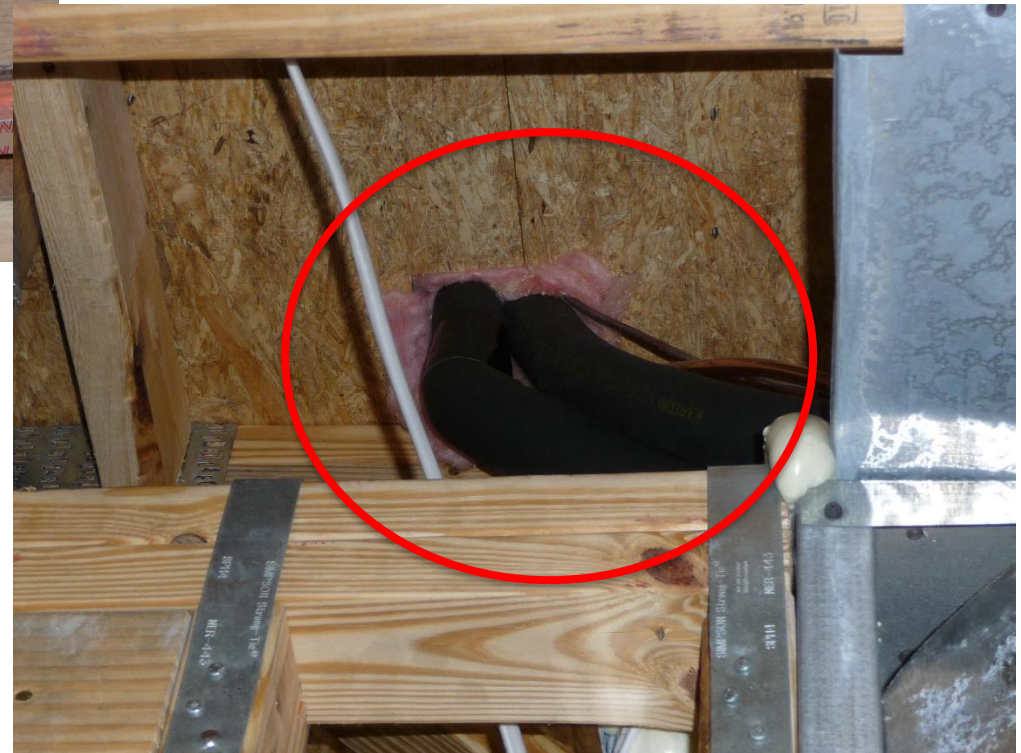
Penetrations from return plenum into leaky floor cavity = return duct leaks
