# Field Evaluation of Thermal and Moisture Response of Highly Insulated Wood-frame Walls

*Presented by:* **Michael A. Lacasse, Ph.D., P. Eng.**  
Building Envelope & Materials, Construction, Ottawa, Canada

**Session 9: Walls – Hygrothermal Performance & Durability,  
Wednesday, 6 December, 2016**

***BUILDINGS XIII International Conference: Thermal Performance of the Exterior  
Envelopes of Whole Buildings; Clearwater, FL, USA***

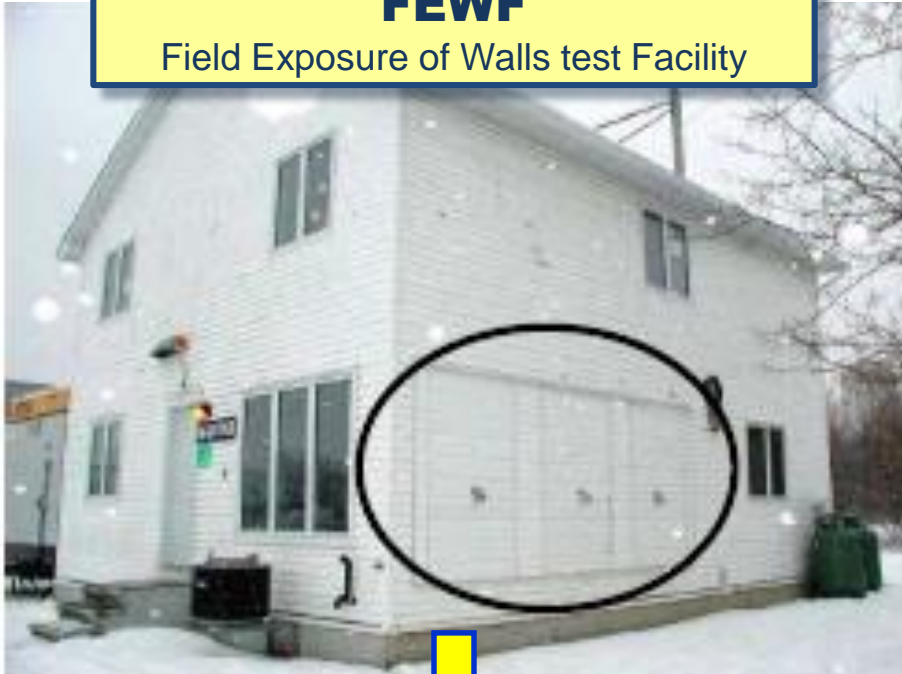
## FEWF

Field Exposure of Walls test Facility

- **Wall exposed to local climate effects**
  - Each year monitor 3 wall assemblies over exposure period
  - Exposure period: January to September (cold, mild & warm months)
- **Results from field study**
  - **Phase 1 / Yr 1 – 1<sup>st</sup> set 3 walls having exterior insulation (R4 – R5)**
  - **Phase 2 / Yr 2 – 2<sup>nd</sup> set of 3 walls – various insulation types**

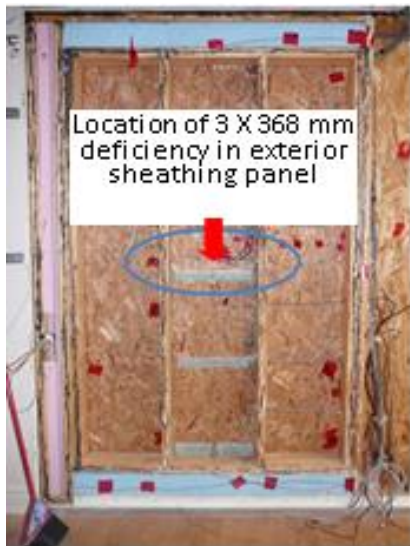
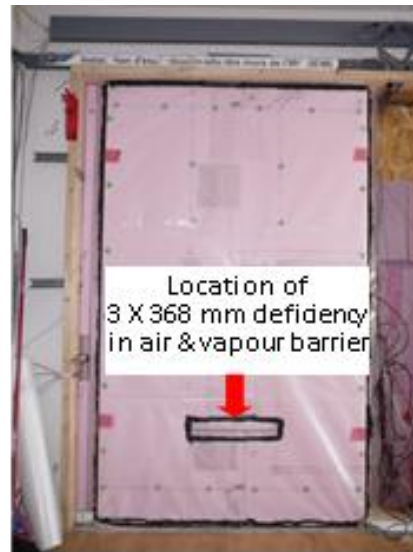
# Air leakage measurements / 0.1 L/s–m<sup>2</sup> @ 75 Pa

Project Phase	Wall	$\xi$ (L/min) = $a \Delta P^n$	
		a	n
Phase 1	W1	73.5	0.320
	W2	75.9	0.316
	W3	53.4	0.300
Phase 2	W4	0.685	0.989
	W5	0.654	0.766
	W6	0.593	0.953

$$\xi = a (\Delta P_{tot})^n$$

$$n (avg) = 0.69 \approx 0.7$$

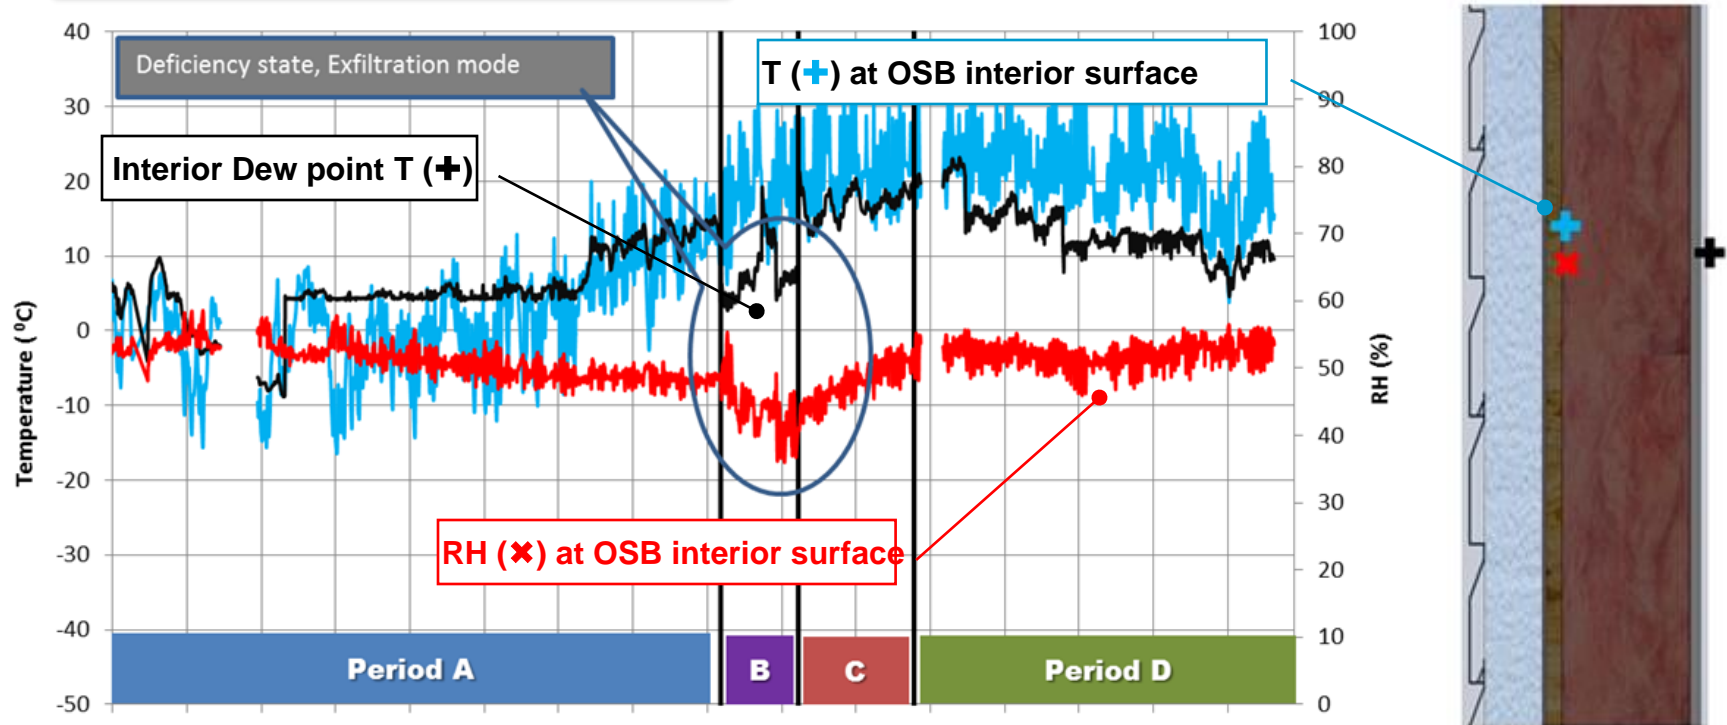
# H – Response of wall assembly W1 (EPS)

## Monitoring period 2013/14

Temperature [T+]; Relative humidity [RH+] @ interior OSB surface; Dew point [T +]

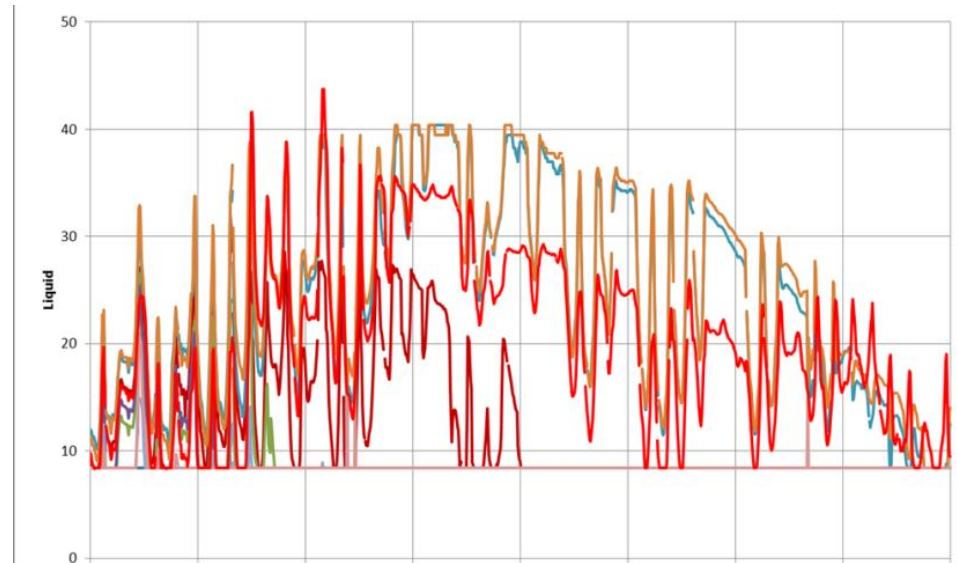
# H – Response of W4

Response of moisture detection strip to presence of moisture in wall

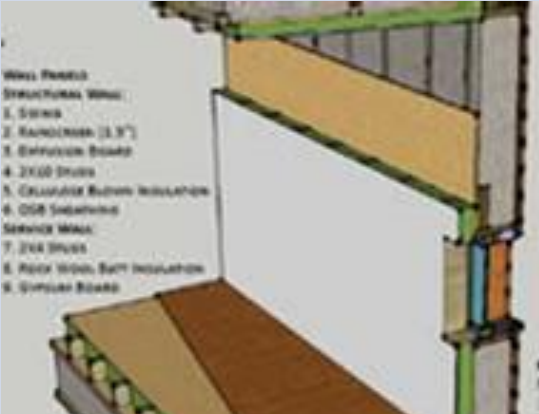
# Proposed Walls for Phase III (FY 2015/2016)

2015- 2016 walls	Wall-2015-1 <u>R24 + R5</u> 1 inch XPS	Wall 2015-2 <u>Passivhaus R43</u>	Wall 2015-3 OSB as vapour barrier
	<p>Wall components</p> <ul style="list-style-type: none"> <li>• Vinyl siding</li> <li>• 1.5 in wide x 7/16" thick furring strip installed vertically</li> <li>• 1 inch XPS rigid foam insulation (exterior insulation)</li> <li>• Sheathing membrane</li> <li>• 11 mm OSB wood-sheathing</li> <li>• 2x6 nominal stud cavity with R24 glass fiber insulation batts</li> <li>• 6 mil poly air/vapour barrier</li> <li>• ½ inch painted drywall</li> </ul> <p>Notes: XPS a low permeance product compared to (&gt;60ng) EPS</p> <p>Does not meet inboard-outboard ratio; change requirement in NBC (§ 9.27) &amp; see what happens</p>	<p>Wall components</p> <p>Exterior wythe</p> <ul style="list-style-type: none"> <li>• Vinyl siding</li> <li>• 1.5 in wide x 7/16" thick furring strip installed vertically</li> <li>• Wood-based diffusion board</li> <li>• 2 x 10 studs</li> <li>• Wood fibre insulation</li> <li>• 11 mm OSB wood-sheathing (interior air and vapour barrier)</li> </ul> <p>Service wall interior</p> <ul style="list-style-type: none"> <li>• 2x4 studs</li> <li>• mineral wool or wood fibre insulation</li> <li>• gypsum board</li> </ul>

<ul style="list-style-type: none"> <li>• Replace poly vapour barrier with interior OSB taped for one of the walls to demonstrate the effectiveness of a smart vapour barrier.</li> </ul> <p>Wall-2015-1 with poly vapour barrier replaced with OSB plywood. BC solution - wood sheathing from between studs and XPS to interior; cost the same.</p>
