## Alistair Kuegler Senior Consultant Instrumentation & Field Engineering

# Monitoring technologies are available to track products and materials through:

### DigiSCAN

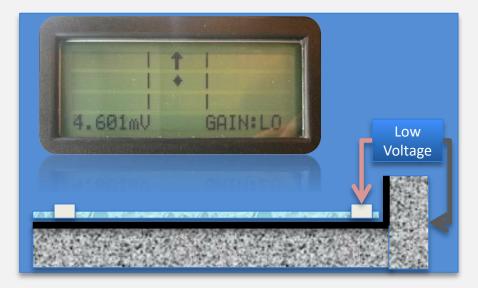
A manual procedure in which we evaluate typical inverted roof decks to pin-point leaks.

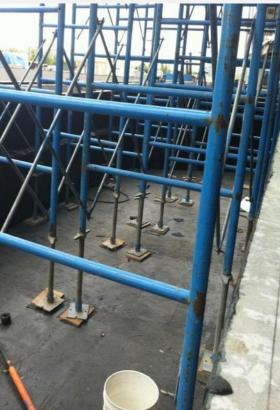
Prior to covering with overburden.

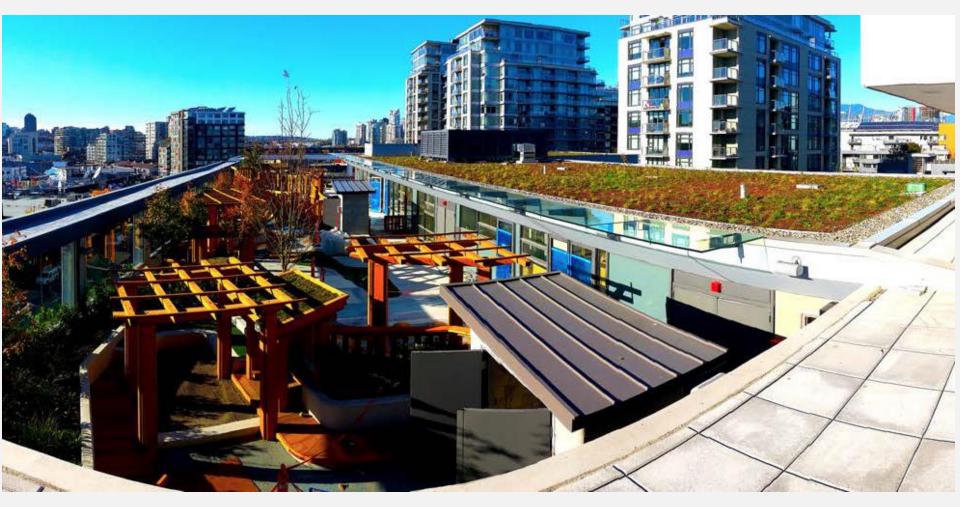
Concrete / Paving Topping or Green roof over 8" To inspect the membrane you need a jackhammer to get into it.

Green Roof Overburden under 8" of soil To Inspect the membrane you would need a shovel and knife.

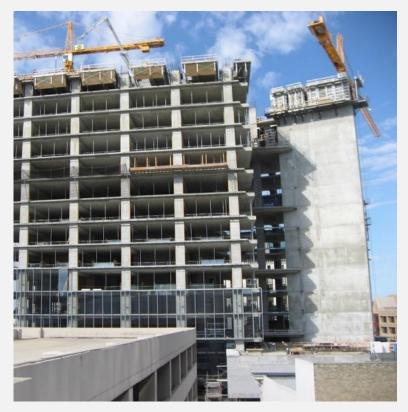
6ftx6ftGrid

10ft×10ftGrid

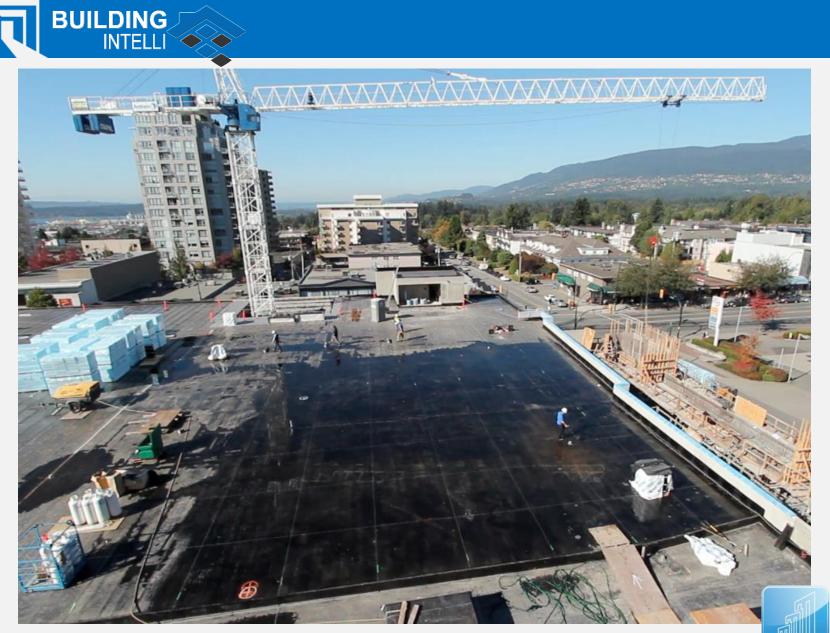
Project: MB Hydro head quarters. Winnipeg, Manitoba 36,000 sq ft Green Roof completed 2009 LEED Platinum, Most Energy Efficient Building in North America

Moisture Detection Tape installed AFTER membrane Installed Installation coordinated with roofing and green roof contractors.

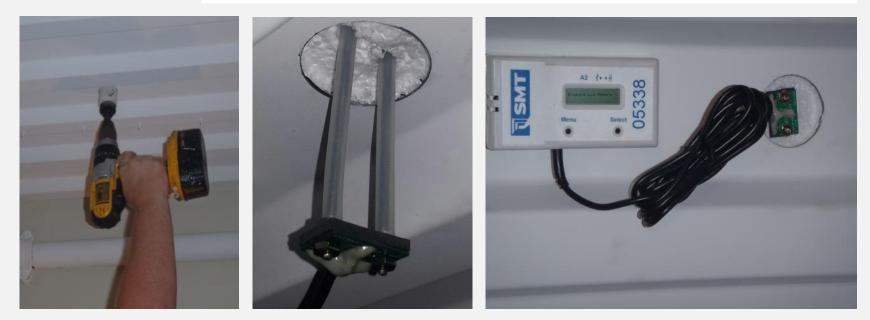
SMT A3 Wireless data-logger sends data in real-time with a permanent installed Building Intelligence <u>Gateway(BiG)</u> and View Data remotely over the internet OR Collect Data on your next site visit, using your laptop.

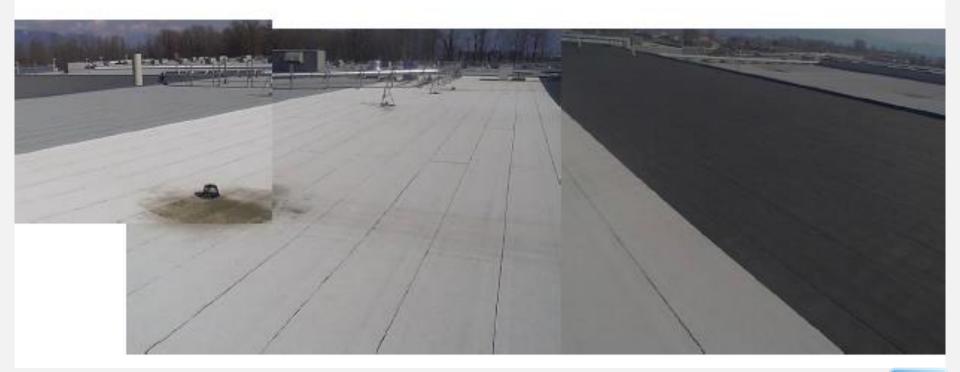
# ---> Visual indication to observe roof getting dirtier over time

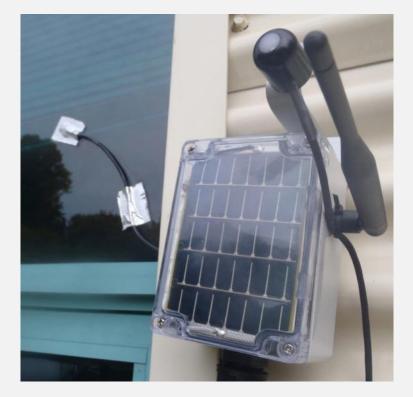
**Exterior Conditions:**

- Solar radiation
- Glass temperature
- Weather station data

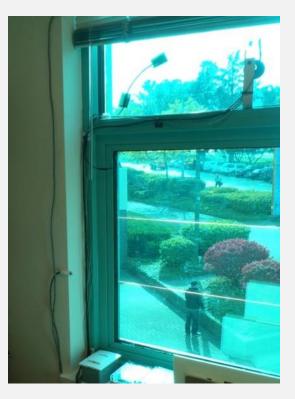
Interior Conditions: Rh/T, Radiation, Duct Pressure, Supply Temp, Lights On/Off, Curtain Status,Interior Glass T

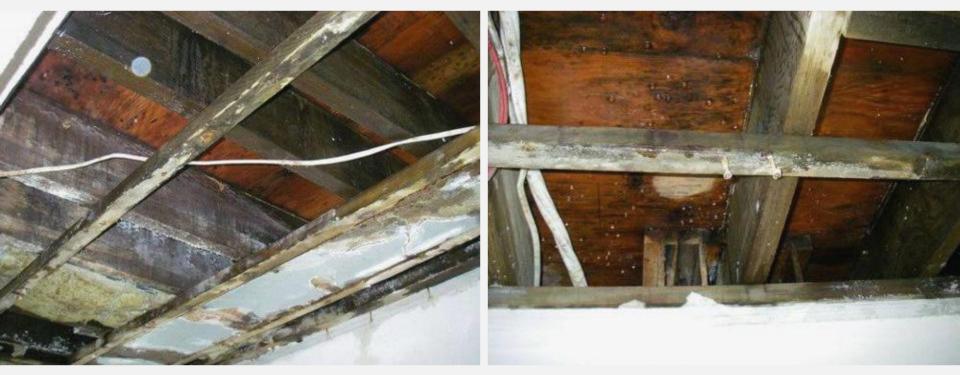
- Air leakage from suites leaking into exterior walkways of a wood frame building caused widespread damage.
- Rehabilitation to repair wood framing and air-seal joist spaces from interior.
- North facing walkway low drying potential if leaks do occur.

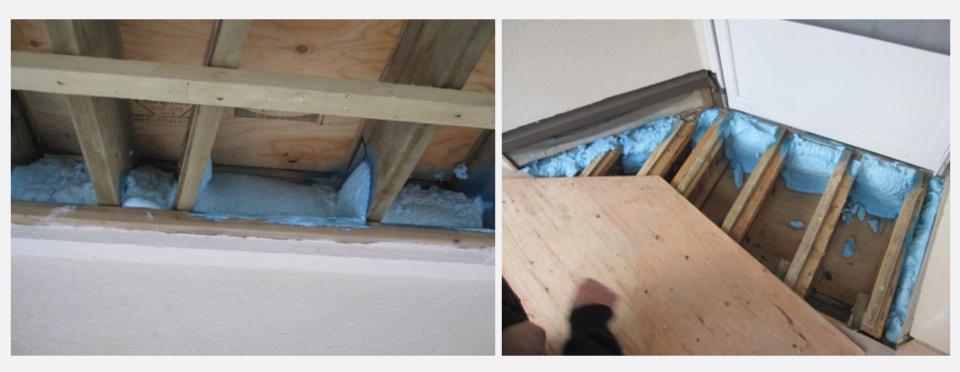
- Walkway Repair & Verification using moisture content monitoring.
- Sensors installed at locations of severe damage and at control locations.

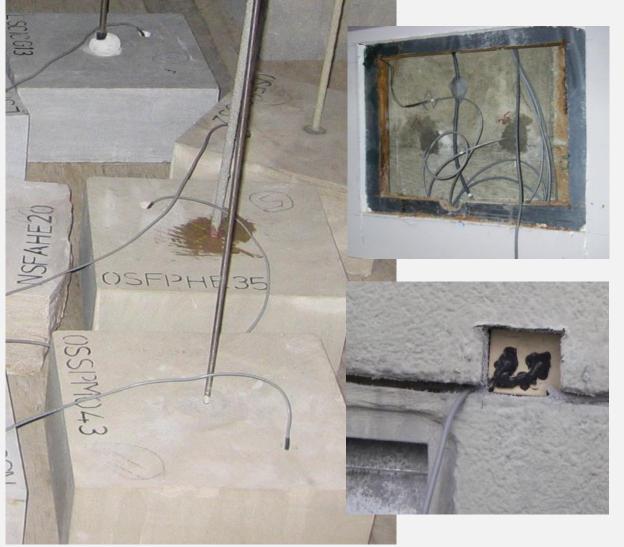
### EMBEDDED MOISTURE SENSOR

- Research Grade
- Integrated Temprature
- Moisture Content & Level
- Wood, Gypsum, Insulation, Concrete, Masonry

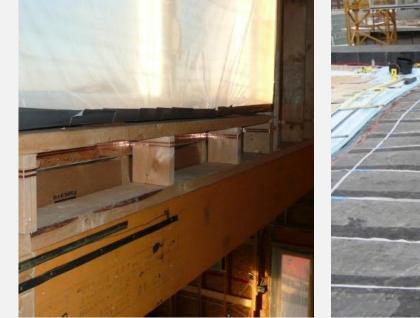
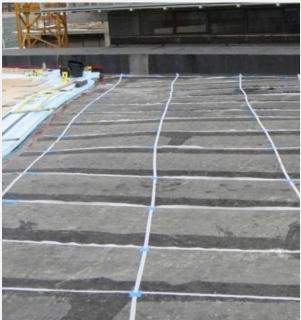
### LINEAR MOISTURE SENSORS

- Presence of moisture
- Wide coverage area
- Limited accurancy

WALL

ROOF

FLOOD

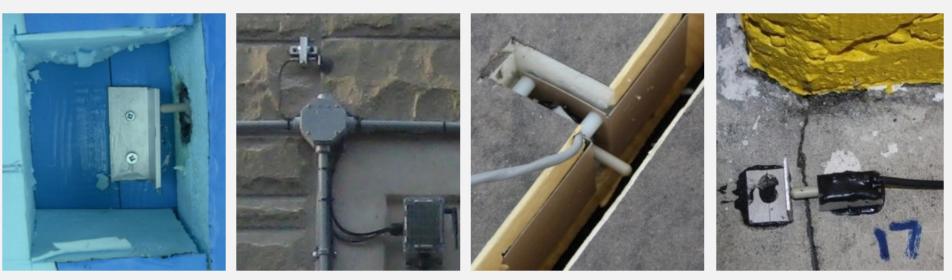
### DISPLACEMENT SENSORS

- Custom mounting options
- Various ranges and resolutions

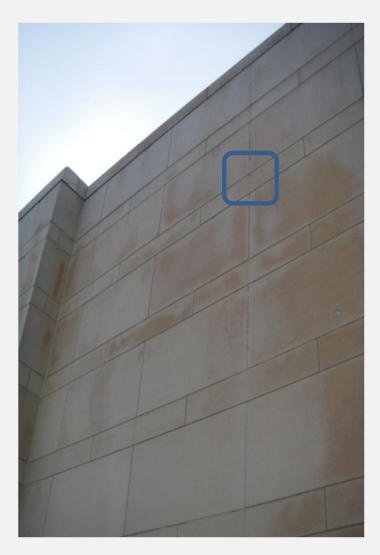
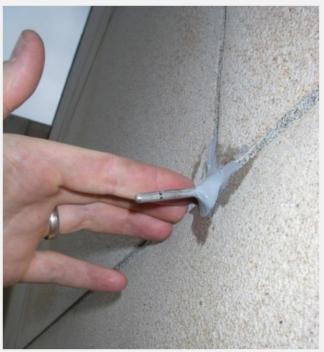
### DIFFERENTIAL PRESSURE SENSORS

- Differential wall pressure
- Pitot tube to interior space
- Range +/- 250 pascal
- Auto zero feature

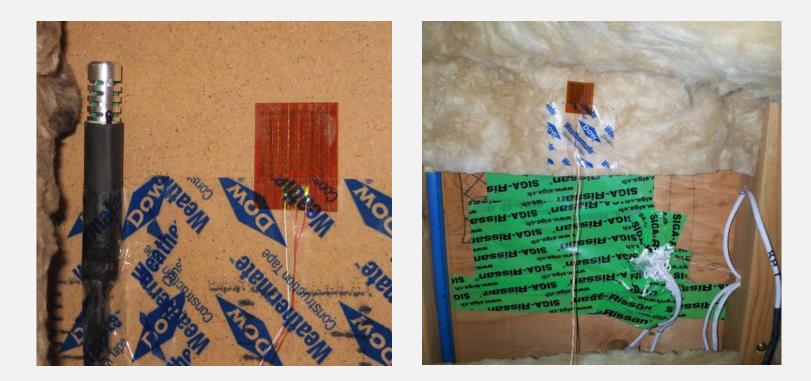
### HEAT FLUX SENSORS

Guidelines for field deployment:

- Heat Flux sensors should be embedded in the material under test. Installation on the surface could be influenced by external factors.
- R value is a static value so the building must be at steady state in order to calculate it. To do this use two HF sensors once the outer sensor equals the inner sensor then take delta T over Q and calculate R value.

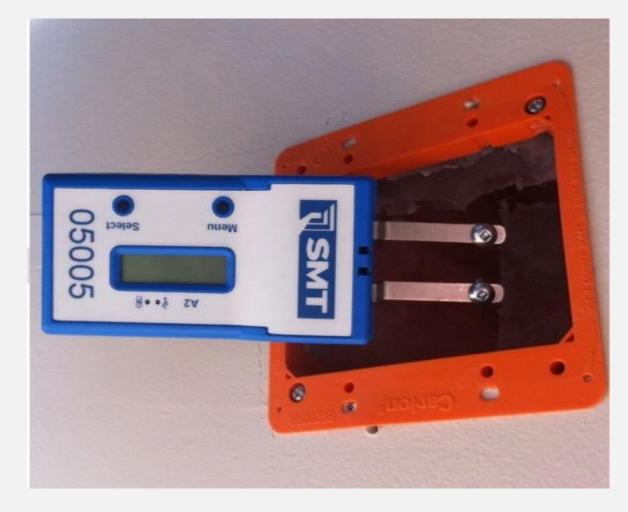
### NODES -A2

Internal RH/T 1- Moisture 1- Ext RH or pressure

- Wireless live
- Datalogging
- Hybrid wireless
- Battery long life
- 16x memory as WIDAQ
- USB rechargeable
- Standalone PC device

Other models:

- Pressure A2
- Water resistant A2

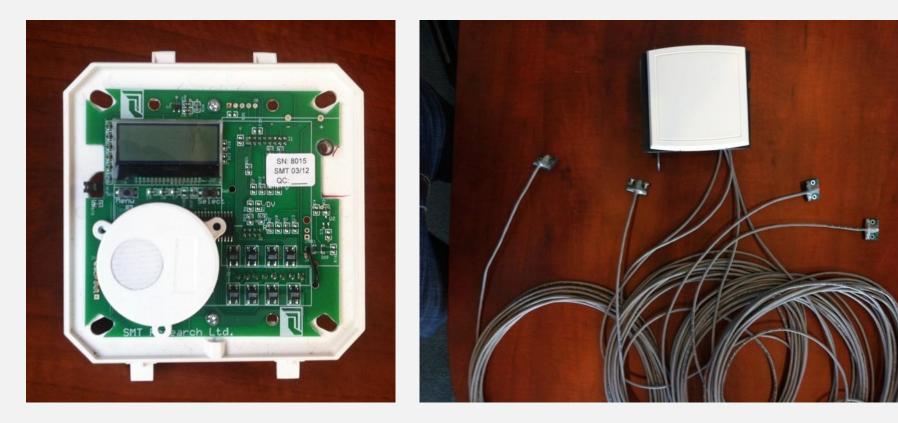
Internal RH/T options:

- 4 moisture/4 temp
- CO2, delta pressure
- Custom Dev

- Wireless live
- Datalogging
- Hybrid wireless
- Battery long life
- 16x memory as WIDAQ
- USB rechargeable
- Standalone PC device

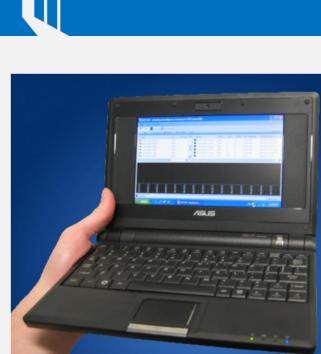
### GATEWAY DATA COLLECTION

- Real time data
- Wireless datalogging
