Reliability of Energy Efficient Building Retrofitting- Probability Assessment of Performance and Cost Annex 55 (RAP-RETRO)

Carl-Eric Hagentoft
Operating agent (OA)

Chalmers University of Technology, Sweden

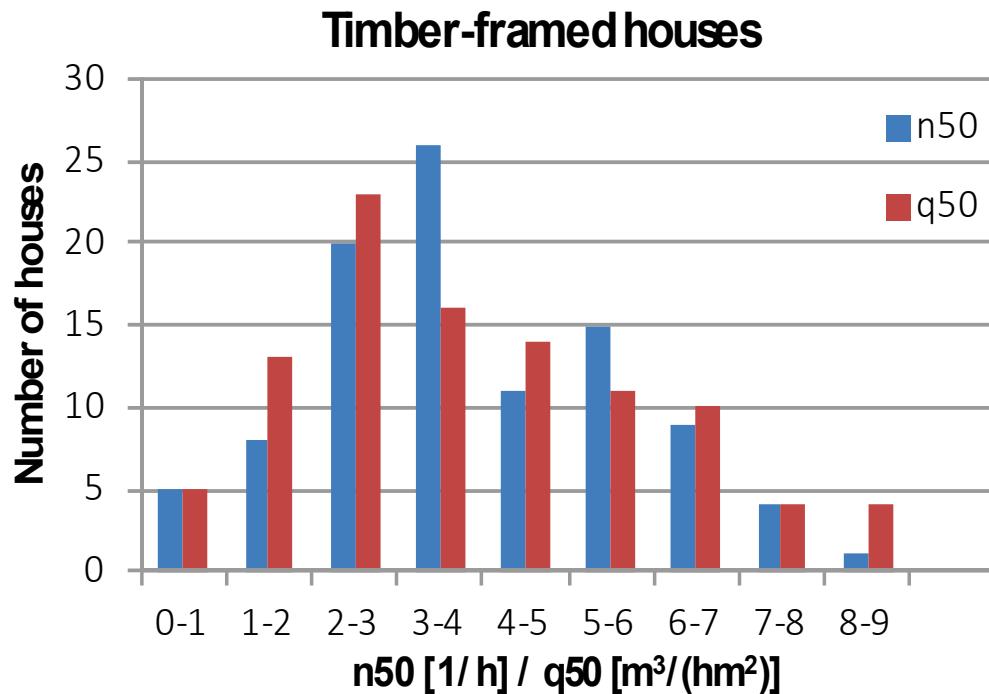
Performance -Air tightness at 50 Pa of 100 timber-framed Finnish buildings built after year 2000

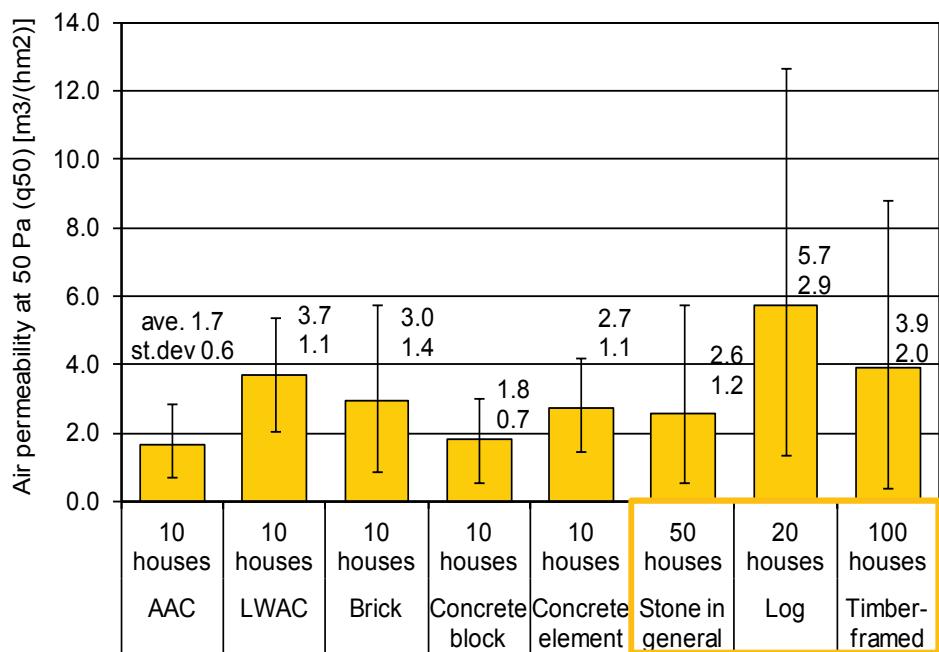
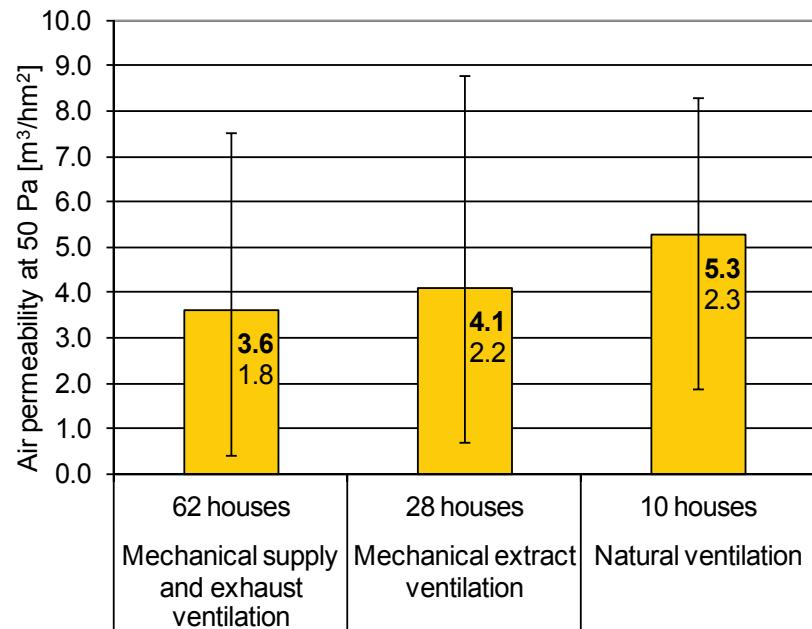
Airtightness – The spread!

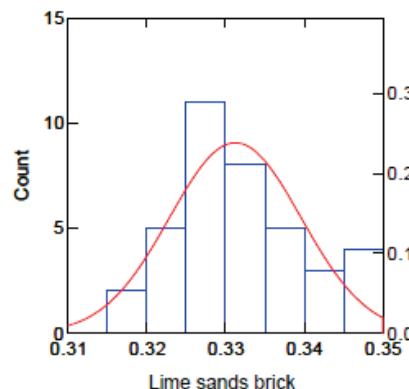
Lime sands brick

Estimated: mean = 0.33, SD = 0.008
 Kolmogorov-Smirnov test statistic = 0.11
 Shapiro-Wilk test statistic for normality = 0.969
 P-value = 0.36

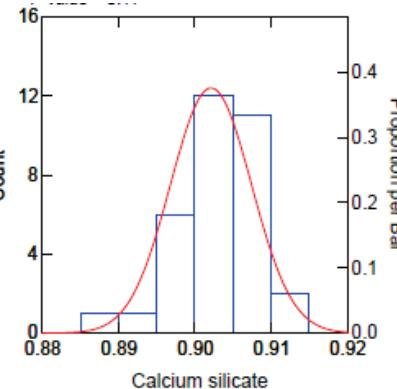
Calcium silicate

Estimated: mean = 0.903, SD = 0.007
 Kolmogorov-Smirnov test statistic = 0.129
 Shapiro-Wilk test statistic for normality = 0.95
 P-value = 0.12

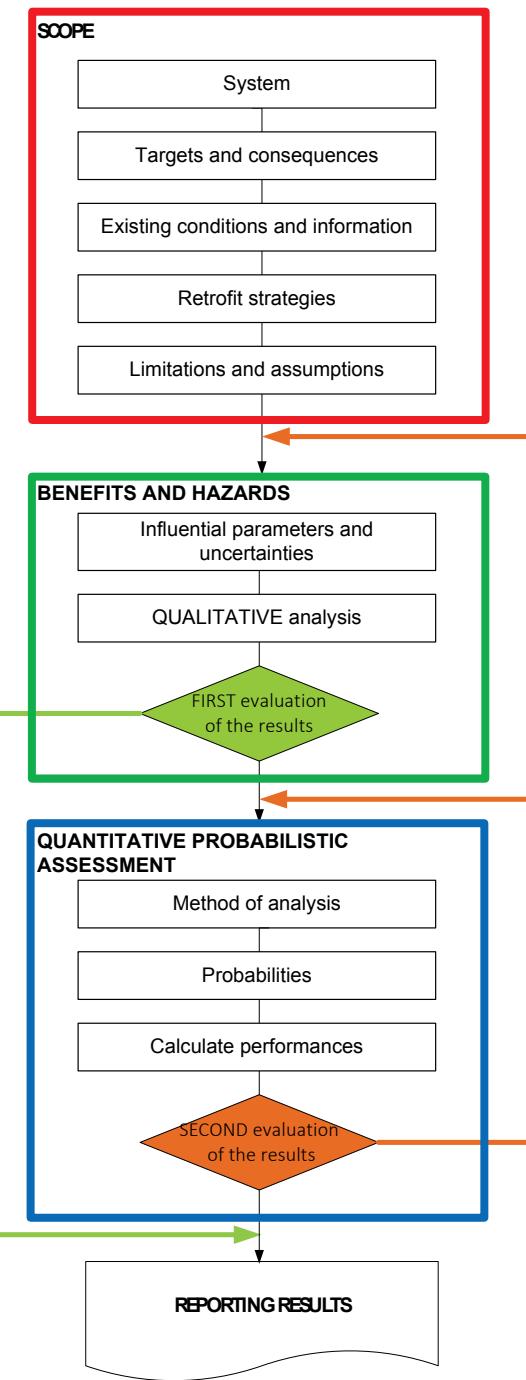
The Framework as a flow chart

Different sections and loops.

Outgoing loops mean quick 'exit' , i.e. when the assessment shows too high or very low risk.

Backward loops – that's usually a trouble, i.e. mistake made in the assessment process

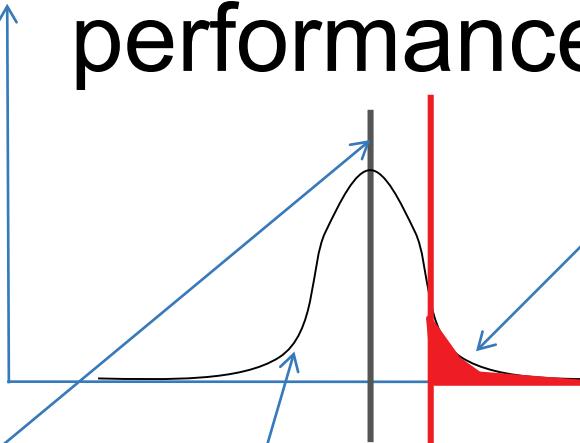
Probability of outcome

If the performance exceeds the acceptable value costly measures are required.

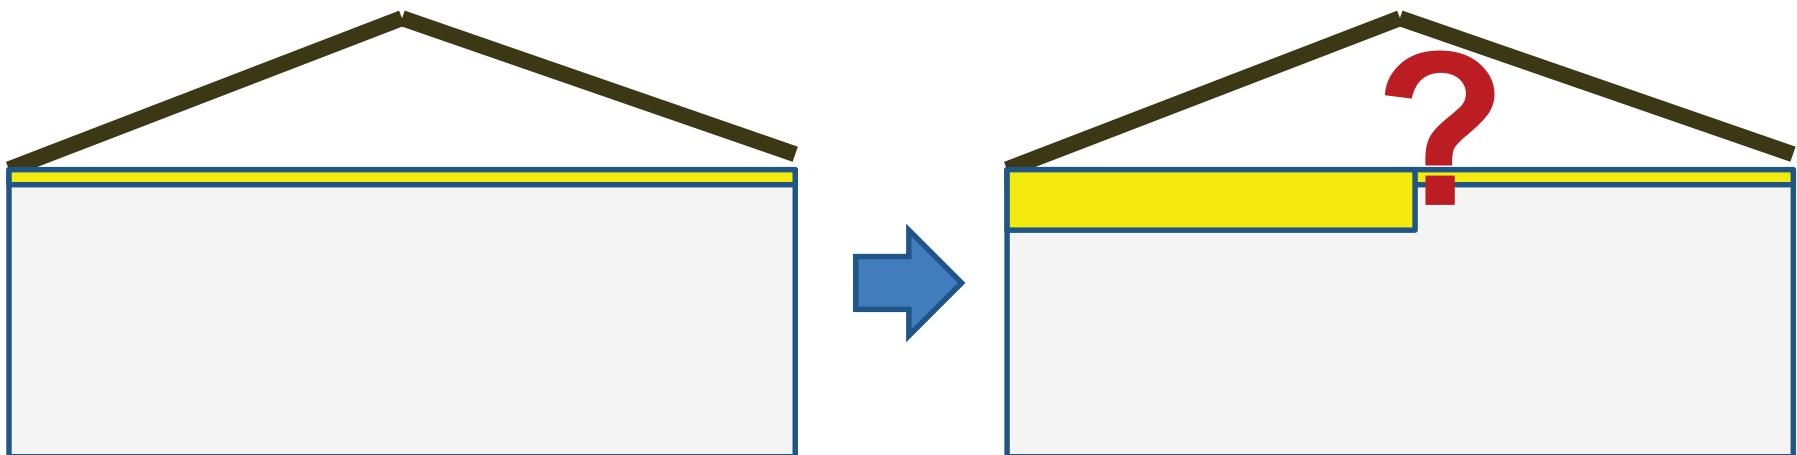
Example: Retrofitting of attic insulation

Different possible scenarios for retrofitting, but of course each renovation measure corresponds to a certain cost, will result in certain benefits (energy savings) and may result in hygrothermal risks (mould growth)

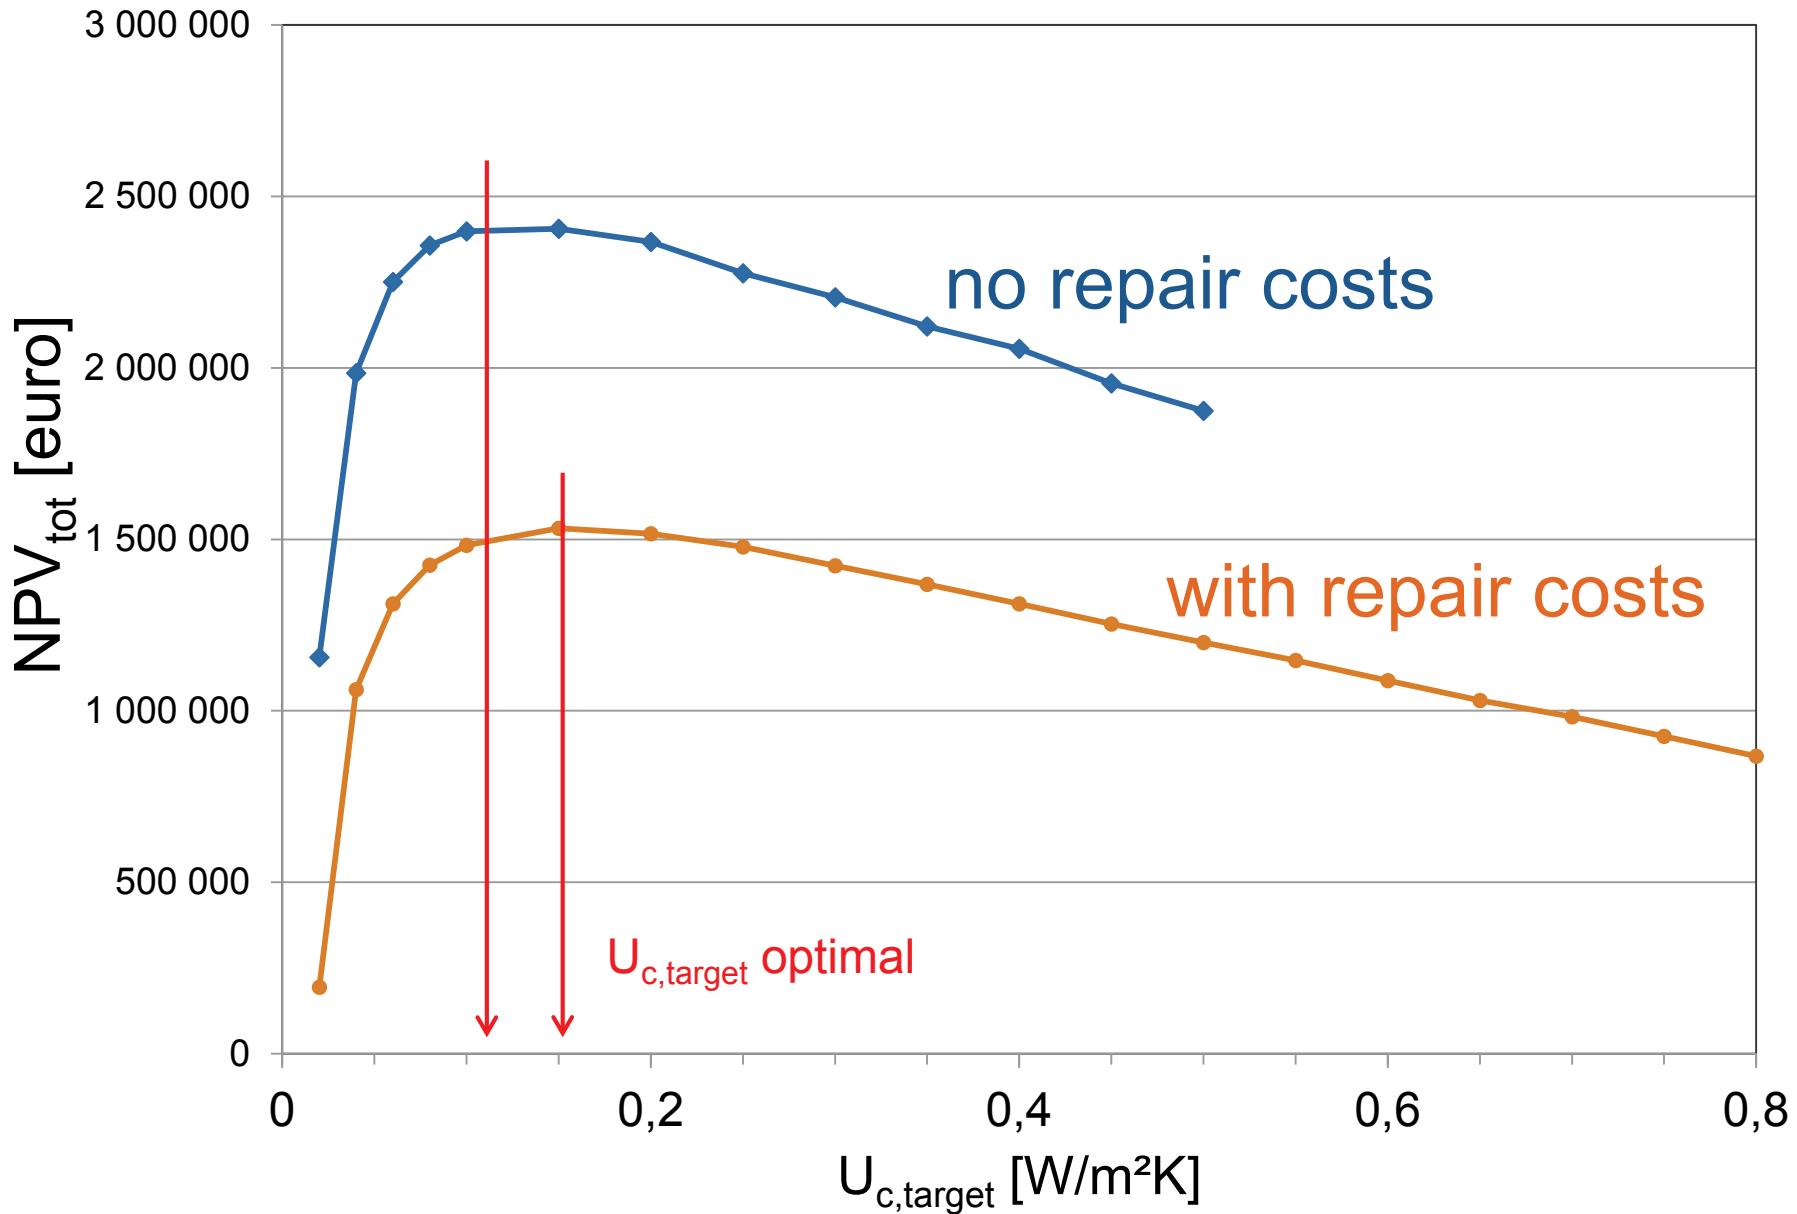
Outcome of analysis: Total Net Present Value for all 237 dwellings

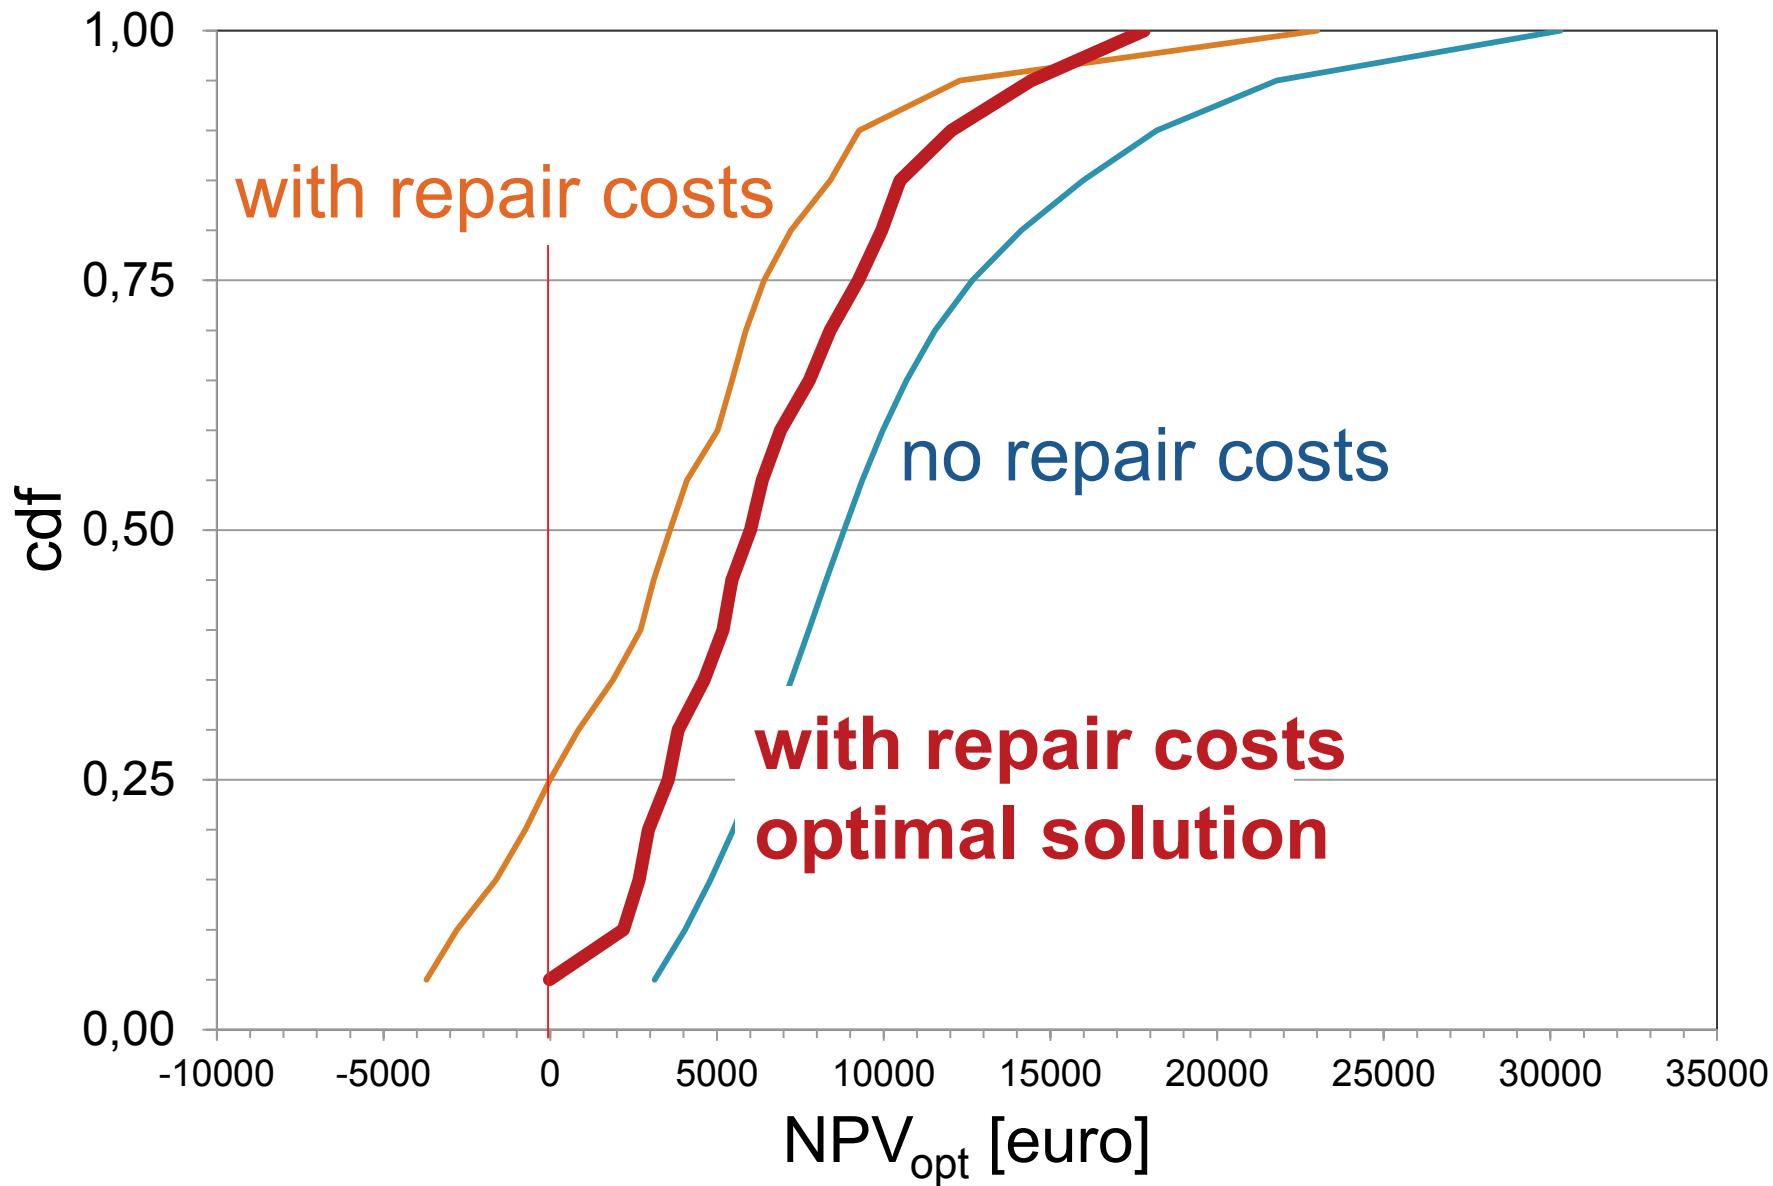
CDF of Net Present Value for optimal solution

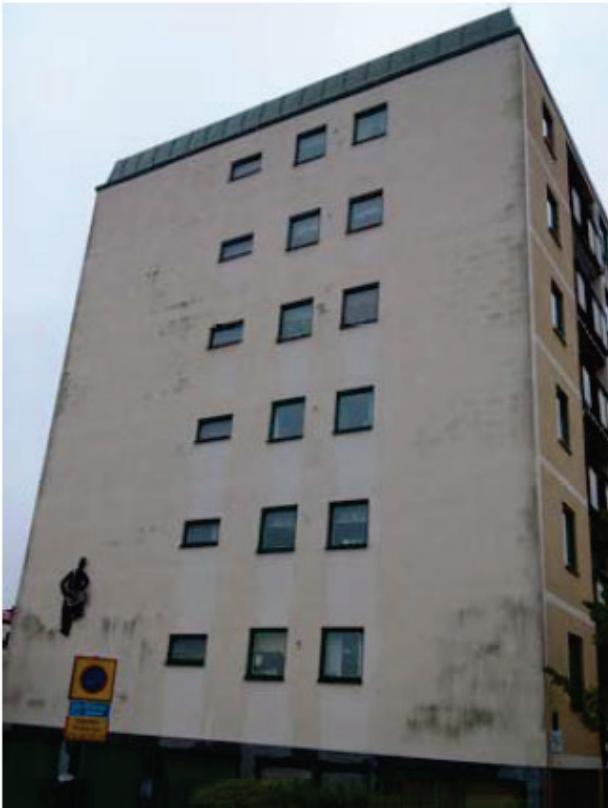
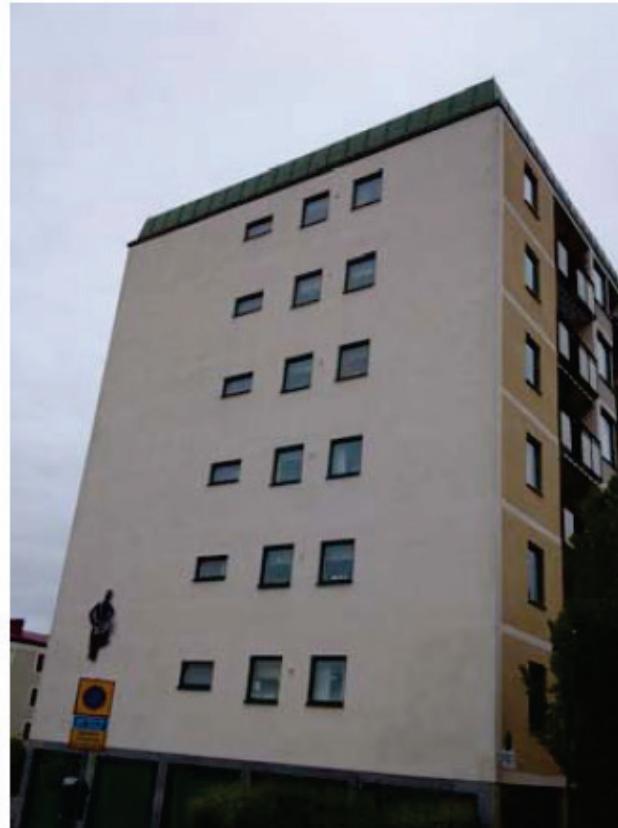
Figure 8 Left: appearance of MBG on retrofitted façade. Right: MBG removed from the façade by water.
