Central Europe towards Sustainable Building 2016  
Innovations for Sustainable Future

## LABORATORY STUDY OF DRIVING RAIN RESISTANCE OF FOUR FAÇADE SYSTEMS WITH WINDOW FITTINGS – EXPERIMENTAL RESULTS OF LEAKAGE FLOWS

Lars Olsson

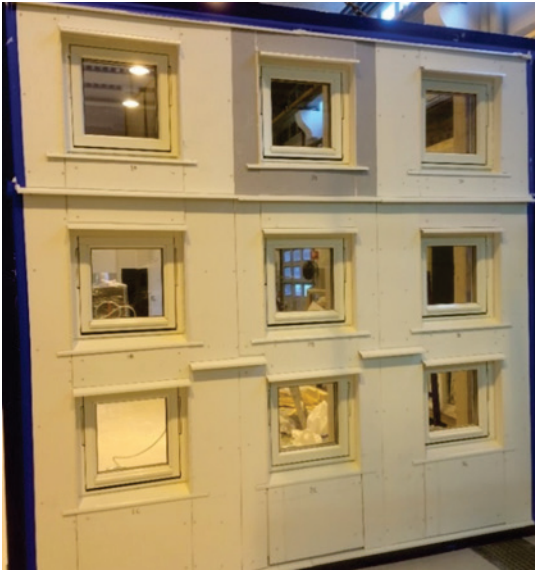
1

- Façade board (polymer composite board)
- 25 mm outdoor air gap + metal lath
- 300 mm mineral wool insulation
- 12 mm plywood board
- Plastic foil

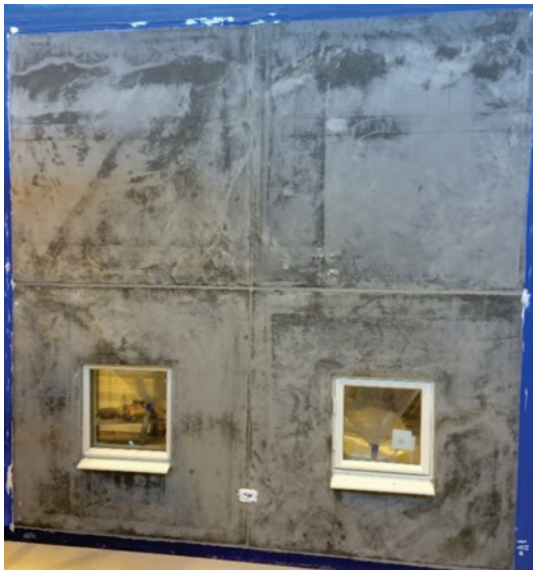
2

- 15 mm prefabricated high-performance concrete element
- 15 mm mineral wool insulation
- 100 mm XPS-insulation

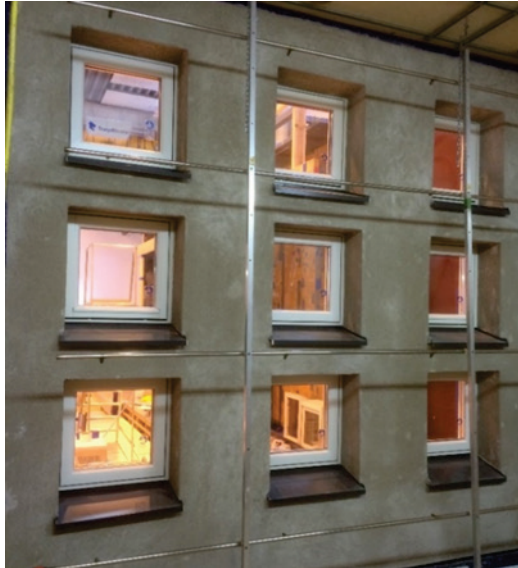
- 20 mm render (plaster)
- 200 mm mineral wool insulation (drainage possibility)
- Water-resistant gypsum board (second line of defence)

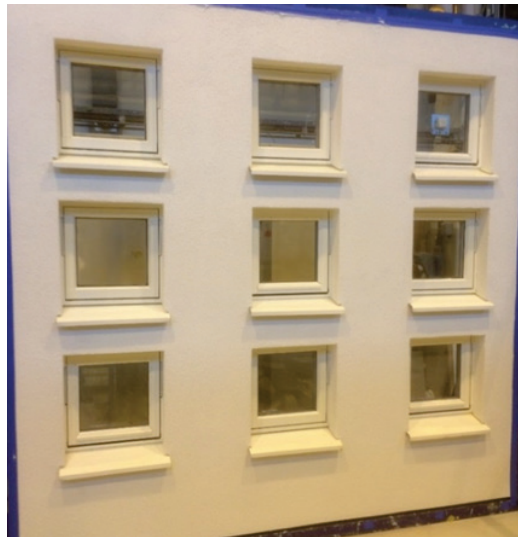
- 8-10 mm render (plaster)
- 100 mm EPS-insulation with drainage possibility
- Paintable waterproofing layer and fiber cement board (second line of defence)

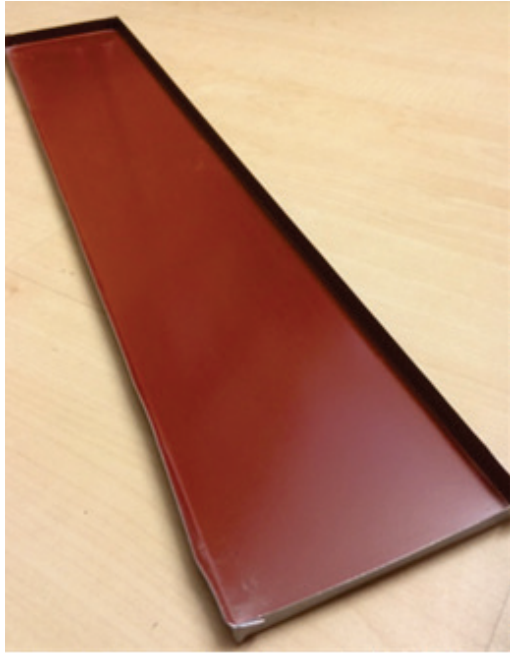
Collection tray

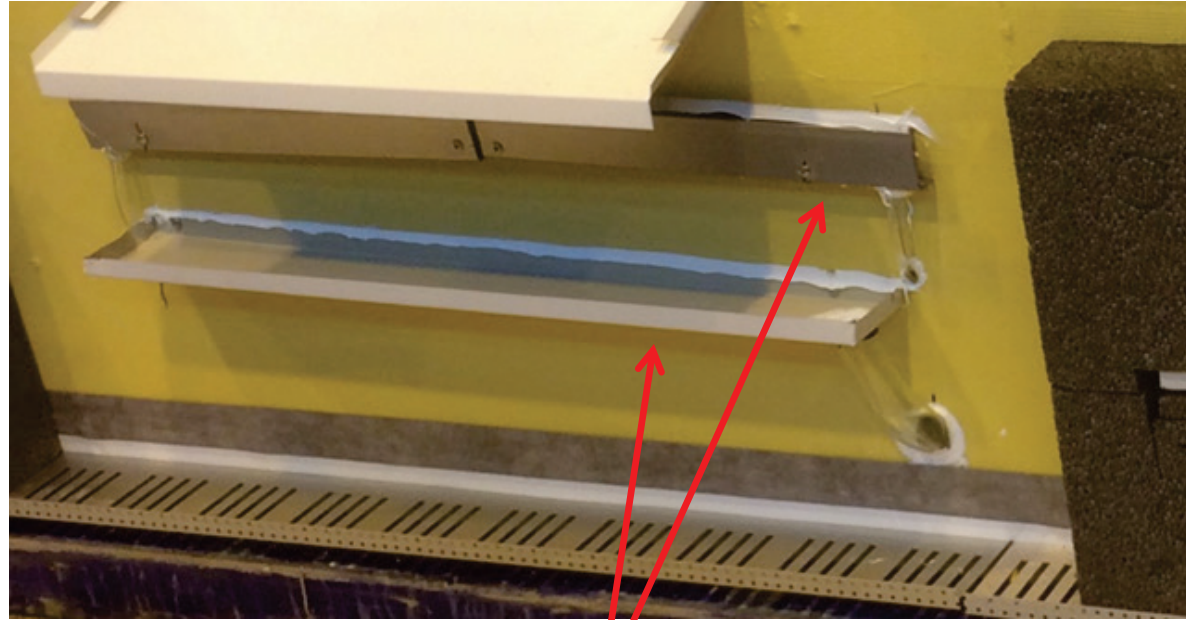
Catchment chutes

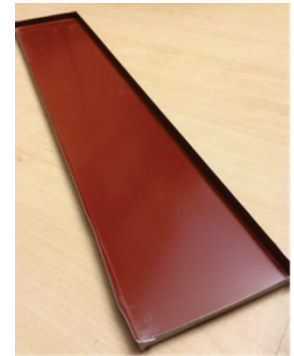
Number of trays	Mass of water leakage [g]
1	182
1	89
1	79
1	70
1	35
1	24
1	15
1	11
2	8
1	5
5	< 5, >0
11	0 No leaks!

Leakage in 16 of 27

Collection tray

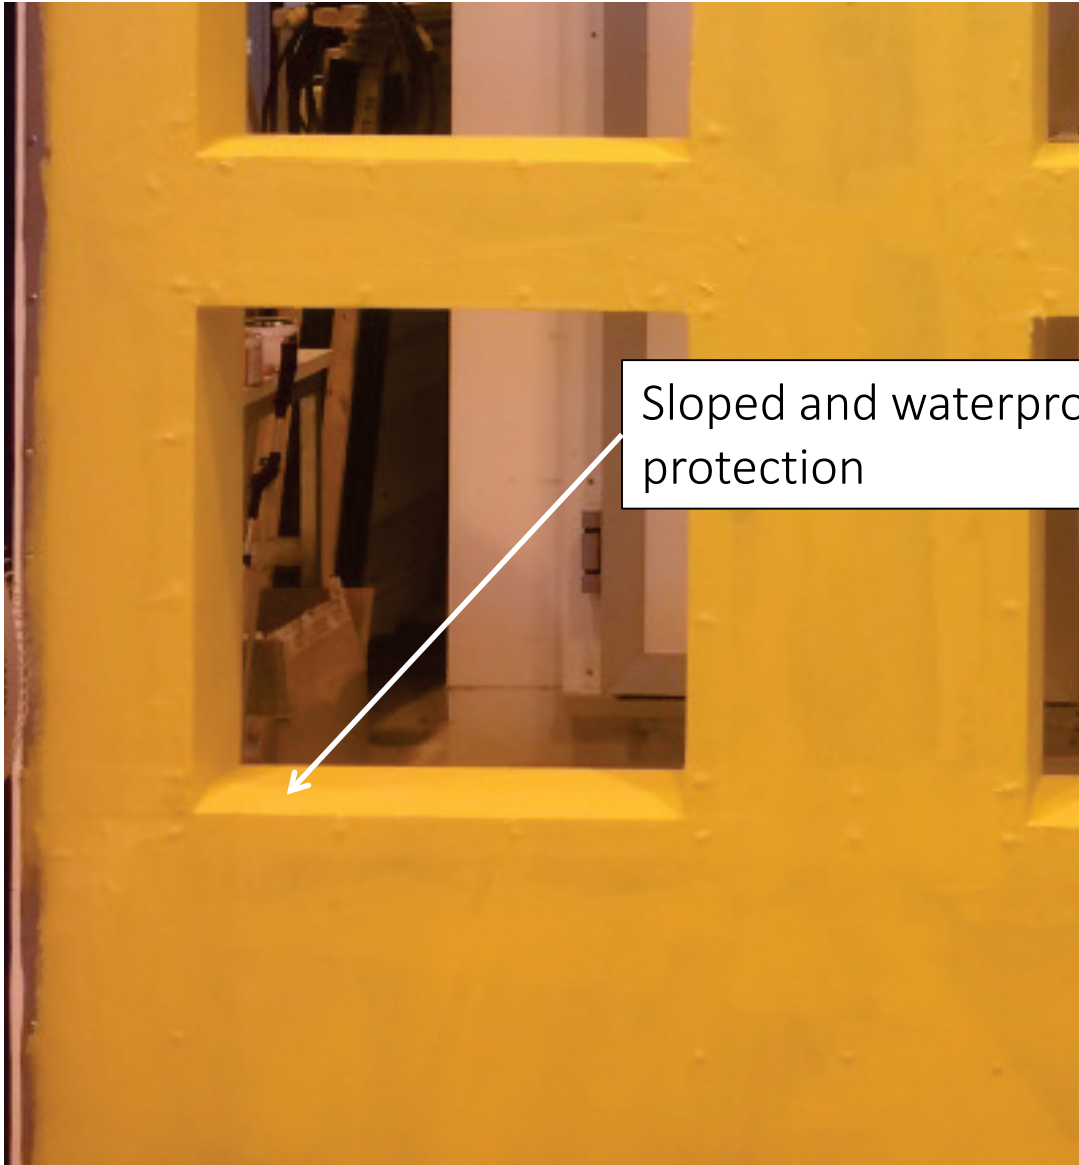
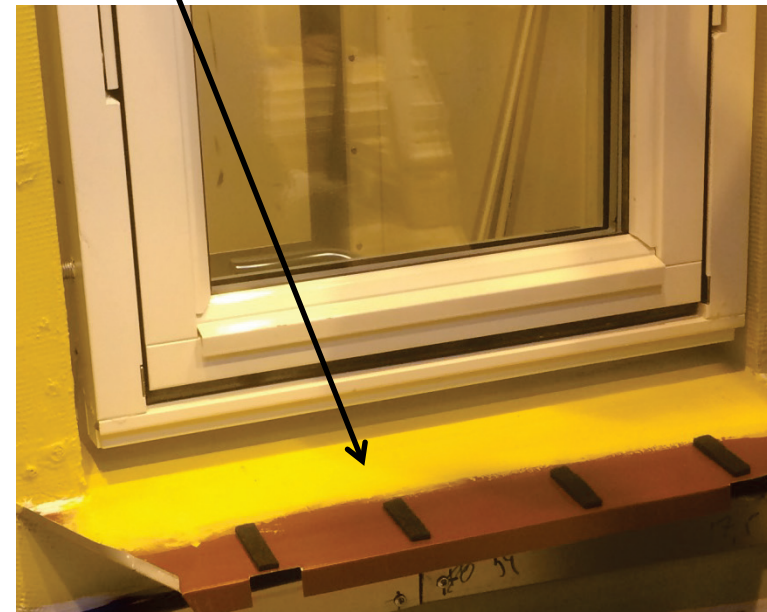
# Wall 3-4 Managing water to drain out

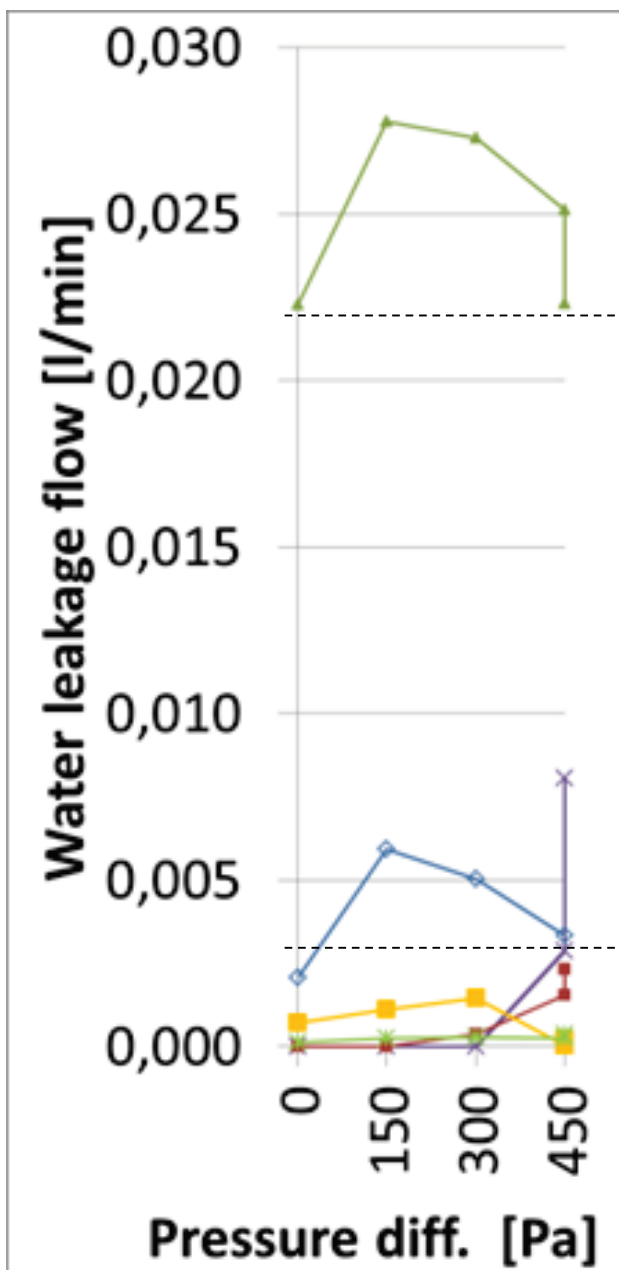
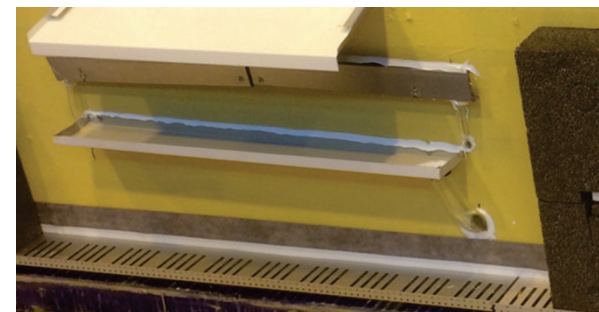
Catchment chutes

Same flow at 0 Pa and 450 Pa

6 out of 12 leakages are presented in the diagram

- It is more of a rule than an exception that leakage occurs.
- Out of 27 window-wall interfaces 16 had water leakage (60%).
- Significant leakage flows (0.01 to 0.03 l/min).
- Many of the leakages started already at 0 Pa.
- No clear distinction between section 1 (trained installers) and sections 2-3 (some seals were excluded) – one reason; *small defects are not visible during installation.*
- The results could be used as point sources in 2D or 3D calculations.

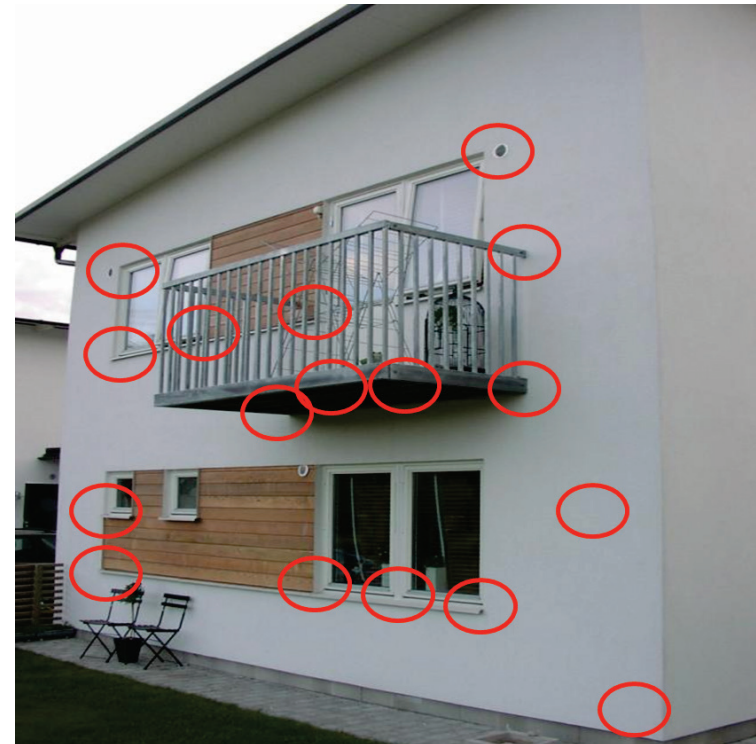
The damage is never visible on the surface of the wall, but hidden within the wall

- During the last few decades rendered, unventilated and undrained (ETICS or EIFS) stud walls have been very popular in Sweden.
- Experiences from survey of (>1000) buildings in Sweden show that the problem is moisture entering the structure, at joints and window (door)-wall interfaces etc.
