THERMAL PERFORMANCE OF THE NORRIS COTTON FEDERAL  
BUILDING IN MANCHESTER, NEW HAMPSHIRE

T.E. Richtmyer, W.B. May,  
C.M. Hunt and J.E. Hill

ABSTRACT

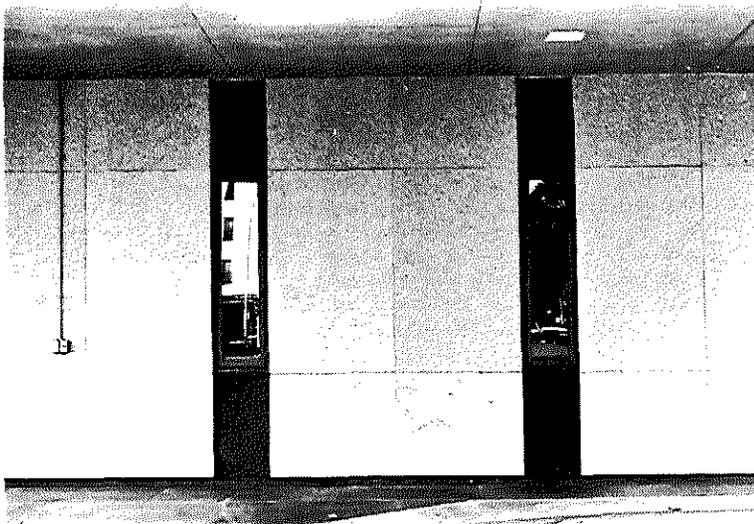
6a. First Floor East, Exterior

6b. Results of Thermogram:  
1 = coldest isotherm 10 = warmest isotherm

Based on these findings, a general survey was made of the entire building. This consisted of spot temperature measurements of wall sections, additional thermograms, and qualitative examination by simply feeling walls and ceiling plenums for cold temperatures and leaking air. It was found that cold surfaces were more numerous on the first three floors and that they generally occurred on the east and west walls. However, all exterior walls had sections that exhibited, to some extent, the same problems found on the second floor. Even the north wall on the third floor was found to be substantially cooler than expected. This was surprising since there are no windows on the north wall and the construction is different than on the other three. Air must have been infiltrating the cavity space here along some path different than that on the other three walls.
