ENERGY-EFFICIENT DESIGN OF BUILDING ENVELOPES FOR HIGH-RISE RESIDENTIAL BUILDINGS

E.O. Kainlauri, Ph.D.

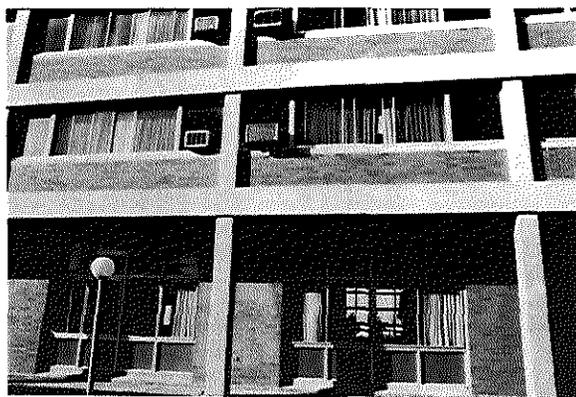
Figure 1. Exterior wall of Building 1 showing exposed concrete frame

Three buildings in another city were built in succession, about 1973, 1975, and 1977. They are six to nine stories high, with about 160 units in each. Experience from earlier construction was used to improve designs. In the first of the three, both vertical and horizontal concrete frames are exposed (Figure 1). The initial single-pane windows were eventually replaced with double-glazed windows for the living units only. This building is listed as No. 1 in Table 1. A slight improvement was made in the design of the 1975 building, as the floor edge was covered. This made about a 2% improvement in the total energy profile. Better quality windows were also initially installed. The orientation was same, with the long axis running east to west.

The two older buildings of the group of three can be improved by adding inside insulation, but it is somewhat of a costly improvement. By using one-inch phenylic insulation boards, u-values can be significantly lowered. The thermal bridges at the structural frame will continue to cost energy, and corrective measures are expensive. The newest of the three buildings continues to lead the way to energy conservation.

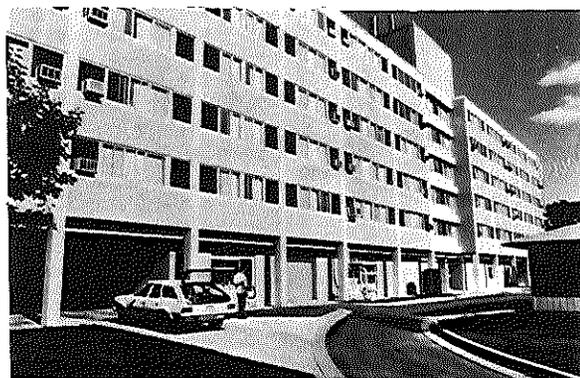
Figure 2. Slightly improved design of exterior wall with floor edges covered

The apartments facing north appeared to have slightly fewer windows open than the south-side apartments. The overall energy figures were still similar to the 1973 building, because part of the first floor area was open, and the second floor above that portion was poorly insulated (Figure 2).

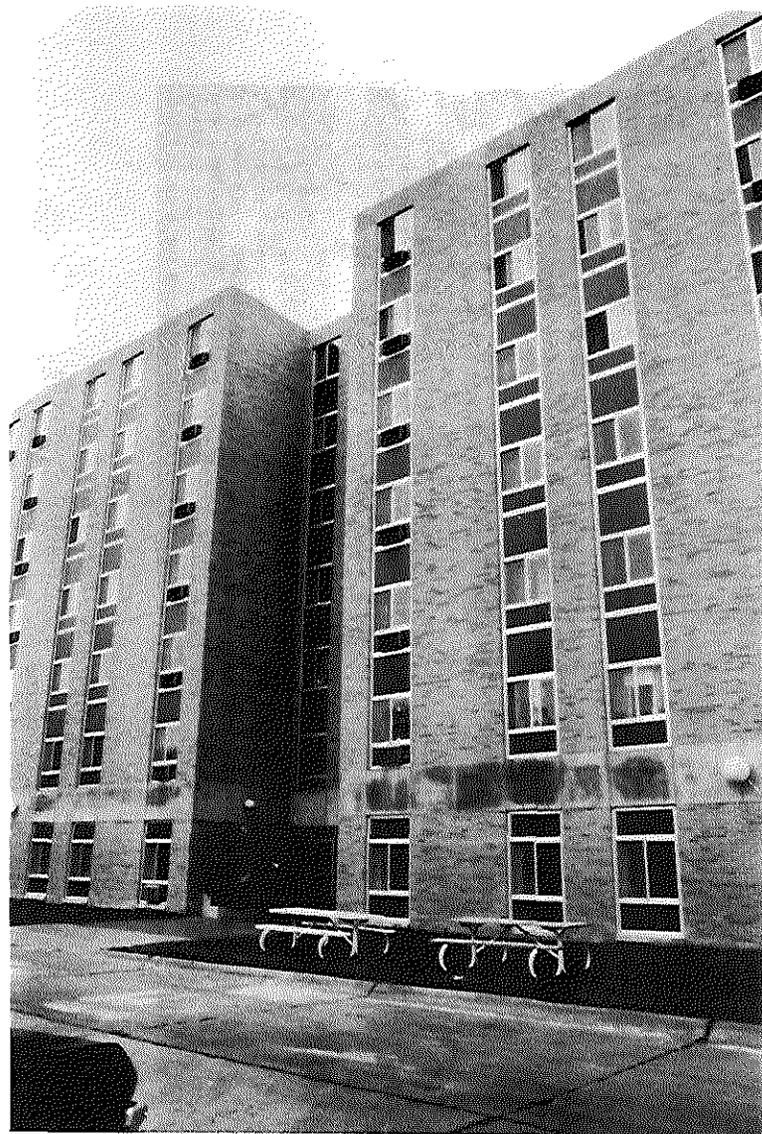
Figure 3. North wall of Building 3 with structure covered and with less window area

In the newest of these three buildings, the structural frame is covered and the exterior walls and roof are better insulated than the previous models. Also, there are fewer windows and insulated wall panels. The orientation is still the same, east to west, but the occupants are perhaps a little more energy conscious, as the percentage of open windows seems to be less (although some are still wide open, regardless of the season, see Figure 3). This building is listed as No. 3 in Table 1.

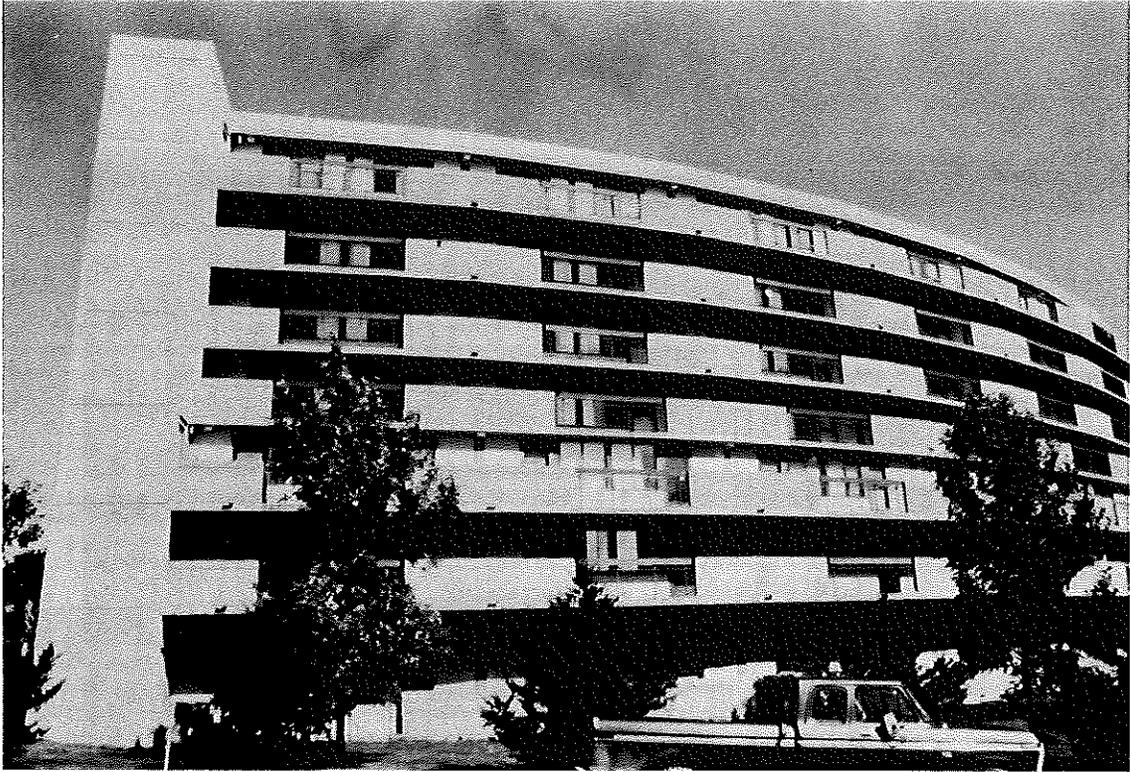
Figure 4. South side of Building 2 with balconies and exposed concrete structure

The sixth sample building is located in the southern-most city of Iowa. It is curvi-linear, following the sun from east to west and also the river on which it fronts. The design of its plan is drastically different, as it discards the central corridor idea and provides instead open concrete balconies on the south side for circulation. As a result, the apartments have two exposures and enjoy cross ventilation (Figures 4 and 5). For this building, solar contribution was estimated as about 14% of the energy demand during the heating season. The natural ventilation is much utilized during the cooling season, particularly during the fall and spring when practically no space conditioning is otherwise needed. As a result, the owners of the building have been pleased with the relatively low energy cost per apartment but have been unaware of the higher energy losses and costs on an area unit basis. As Table 1 shows, this building (No. 2) has an identical energy budget as the No. 1 building, which was the poorest of the three in the other city based on energy use per area unit. Not only is the structural frame without a thermal break, but the HVAC-system was designed to the lowest initial cost. On the north side of this seven-story building, the hot water baseboard heating runs continuously to each end from the center of the building with two risers at center and one at each end. The south side is similar, except the piping has to underpass the doors to the balconies. A total of four thermostats controlled the entire 160 units, located at two top-floor apartments for south and north side piping. The loss of energy through the thermal bridges is compensated by the ample solar contribution during heating season and by shading provided by balconies during cooling season.

For the curvi-linear building with exposure to both south and north in its apartments, improvements to the control system include separate thermostats for each apartment on the south side and zone thermostats at the center of each floor section on the north side. Additional insulation by phenylic wall panels is a possibility. The thermal bridges will be difficult to eliminate. Windows can be improved by demountable plastic panes, mounted with magnetic strips.

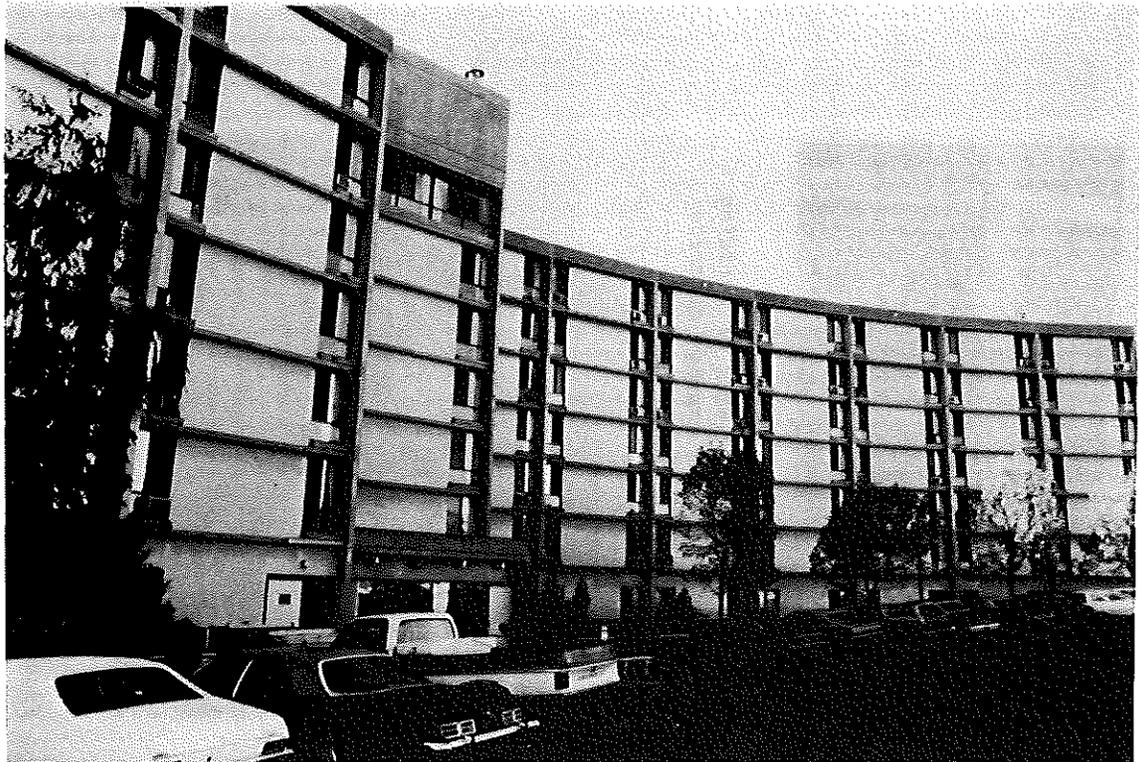
Figure 5. North side of Building 2
