# A DESIGN GUIDE FOR ENERGY-EFFICIENT MILITARY FAMILY HOUSING

## ABSTRACT

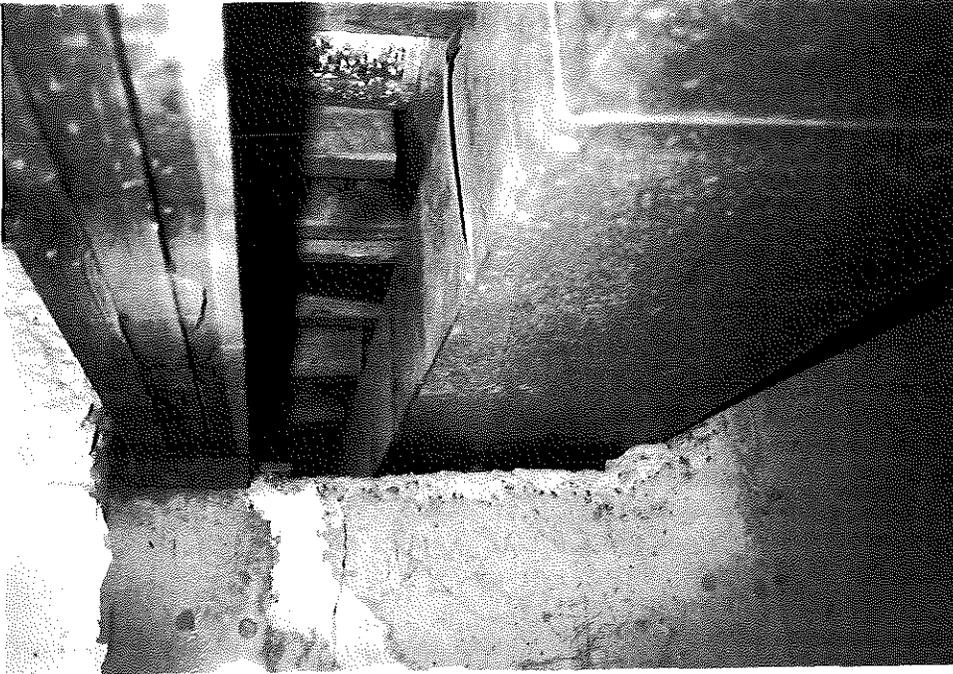
**Figure 2** A main distribution supply trunk runs from the basement (which contains a supply register) into a ventilated (nonconditioned) crawlspace. An adequate thermal boundary for this housing unit has not been defined considering the free air movement allowed by the hole in the wall separating the conditioned basement from the ventilated crawlspace, and the lack of floor and duct insulation in the ventilated crawlspace.

- Air leakage between the conditioned and nonconditioned spaces (primarily to the attic) around unsealed openings (Figure 1).
- Poorly defined building thermal boundary, resulting in incomplete insulation coverage (Figure 2).
