Radiation Control Coatings on Rough-Surfaced Roofs at a Federal Facility: Two Summers of Monitoring Plus Roof and Whole Building Modeling

ABSTRACT

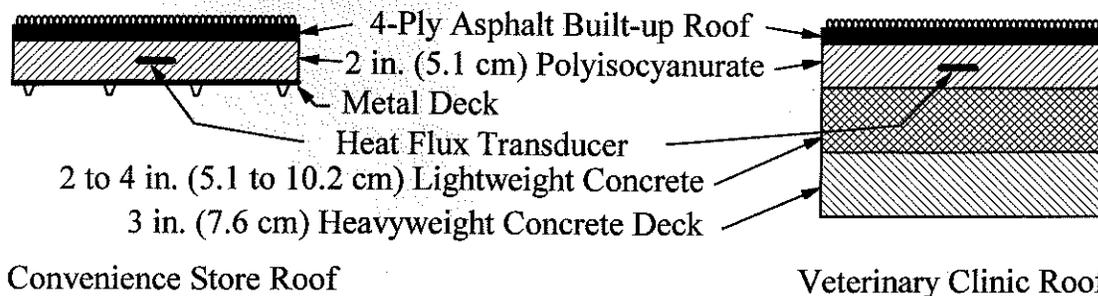
Figure 1 shows cross sections of the two roofs and placement of heat flux transducers in the middle of the polyisocyanurate insulation in them. Three thermocouples were vertically aligned with each heat flux transducer, comprising a set of instruments for monitoring thermal performance. One thermocouple was attached to the underside of the deck, another was placed on the outside surface, and the third junction was about 3 in. (7.6 cm) above the surface in the outside air. There were two sets of instruments on each roof, one in an area coated in July 1996 and the other, about 2 ft by 2 ft (0.61 m by 0.61 m), left uncoated throughout the project. The uncoated areas were masked during coating by pieces of BUR like that on the roofs. These coated loose pieces were weathered along with the rest of the coated areas on each roof. Samples were cut from these pieces periodically to take to a laboratory for

Figure 1 Cross sections of built-up roofs on a convenience store and a veterinary clinic at the federal facility in Florida used for the project.

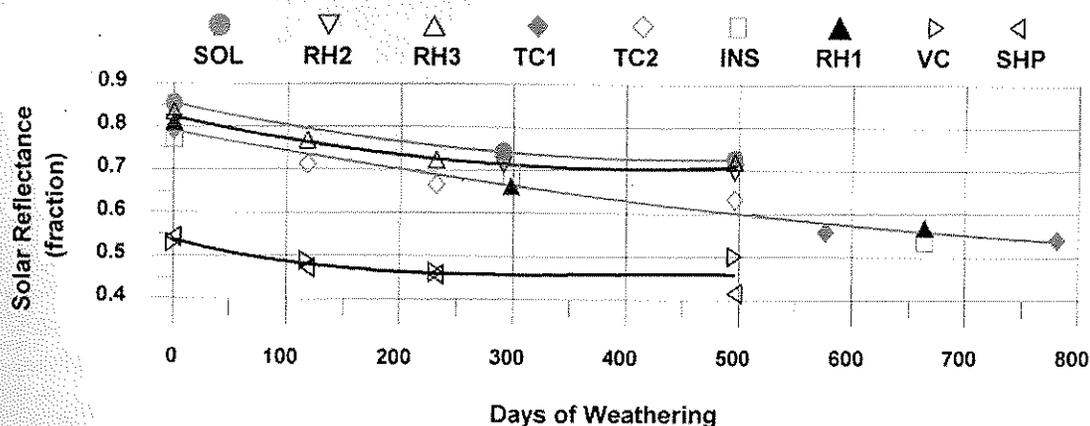
Figure 2 is a graph of some of the data in Table 1 for perspective on the solar reflectances of samples SHP and VC from the coated BURs. The solar reflectances of these fresh white coatings on smooth surfaces vary from 0.77 to 0.85. The fresh values on smooth surfaces are more than 0.20 higher than the fresh values on the rough BURs. However, Table 1 shows that the fresh values of 0.53 to 0.54 on the rough BURs are 0.45 higher than the reflectances of the uncoated

Figure 2 History of the solar reflectances of various white coatings on smooth and rough surfaces (see Table 1 for details about coatings).

The surface temperatures for the TC2 and RH3 coated surfaces are consistent with the behavior of the solar reflectances. Figure 2 showed that the solar reflectance of coating TC2 started out slightly lower than the reflectance of coating RH3 and decreased more in the 500 days of the project. Both coatings were brushed on the smooth fast food restaurant roof itself and a piece of smooth EPDM substrate laid down over

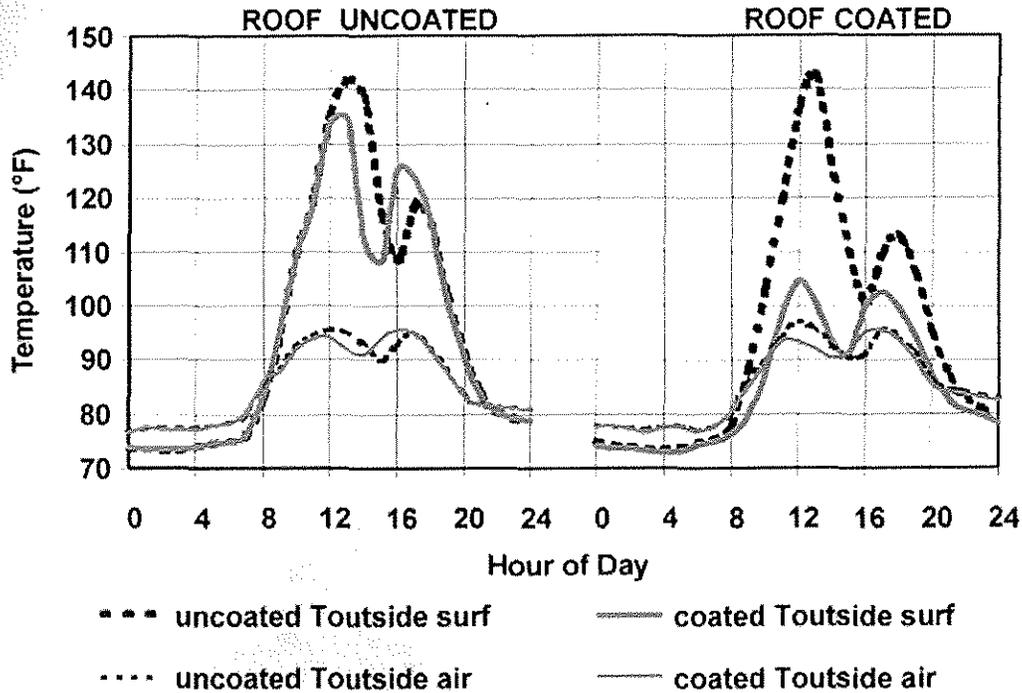
Convenience Store: June 21, 1996 vs. July 30, 1996

To illustrate this preferential shading, Figure 3 shows hourly temperatures for two similar days in 1996 just before and after the convenience store roof was coated. Outside-air

Figure 3 Hourly outside-air and outside-surface temperatures for the coated and uncoated locations on the convenience store roof for similar sunny days just before and after the roof was coated.

temperatures for the coated location (lower solid curve) and uncoated location (lower dashed curve) and the uncoated surface temperatures (upper dashed curves) are affected by the shading but have similar profiles before and after the roof was coated. As the upper solid curves show, there is clearly a beneficial decrease in the surface temperatures from the roof uncoated to the roof coated situation.

transient behavior in the measured heat fluxes, in addition to the expected diurnal behavior. One-hour averages captured these behaviors well. Figure 3 showed the same irregular behavior imposed on diurnal variations for the outside-surface temperatures just before and after the roof was coated.

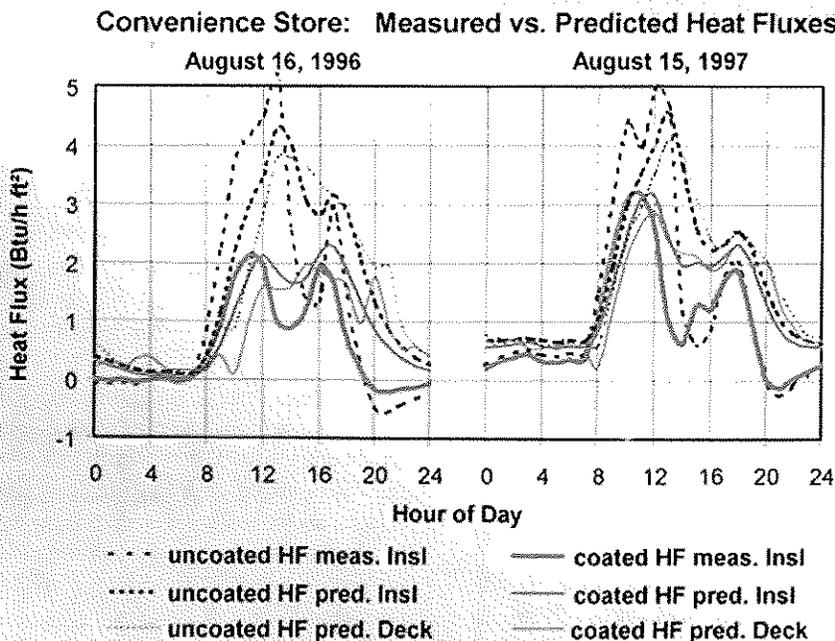
Figure 4 shows typical behavior of measured and predicted heat fluxes in the roof of the convenience store at the uncoated location (dashed curves) and coated location (solid curves) for two sunny days about a year apart. Measured and predicted heat fluxes are shown in the middle of the insulation. The predicted heat fluxes for the deck are also shown. The shading of the roof of the convenience store induced irregular

Figure 4 shows that STAR was not able to mirror the measured heat flux behavior given only the hourly surface temperatures as boundary conditions. The solid curves for the coated location show that the predictions for the middle of the insulation compare well, except for a delay, to the measured insulation heat fluxes up to the noontime peak. The predictions do not fall off fast enough to follow the dip at 2 p.m., overshoot the 4 p.m. peak, and are significantly above the measurements in late afternoon and evening. The predictions for the coated heat flux through the metal deck generally follow the predictions for the coated insulation heat flux, wiggling above and below them. This is reasonable for the lightweight roof on the convenience store. Note that the increase in measured heat flux for the coated area after a year of weathering is duplicated by the predictions. The dashed curves for the uncoated heat fluxes show the same inability of the predictions to mirror the measured heat fluxes. The situation is exacerbated by the more severe peaks and valleys of the uncoated heat fluxes. However, there are again small differences between the predicted insulation and deck heat fluxes, much smaller than between the measured and predicted insulation heat fluxes, with the deck fluxes wiggling above and below the predicted insulation fluxes.

Figure 4 Hourly measured and predicted heat fluxes for the coated and uncoated locations on the convenience store roof for similar sunny days one year apart.

To generalize the lessons from Figures 4 and 5, Table 4 presents average sunlit roof values for heat fluxes in the same manner as Table 2 did for outside-surface temperatures. Sunlit heat fluxes are included in the monthly averages in Table 4 for times when the coated heat flux was positive and the uncoated heat flux exceeded it by 0.5 Btu/h-ft^2 (1.6 W/m^2). This sunlit criterion is more complicated than for surface temperatures, but was necessary because heat fluxes routinely became negative at night and still occasionally satisfied the difference. Requiring positive heat fluxes excluded nighttime heat fluxes. The sunlit criteria generally yielded entries for pairs of heat

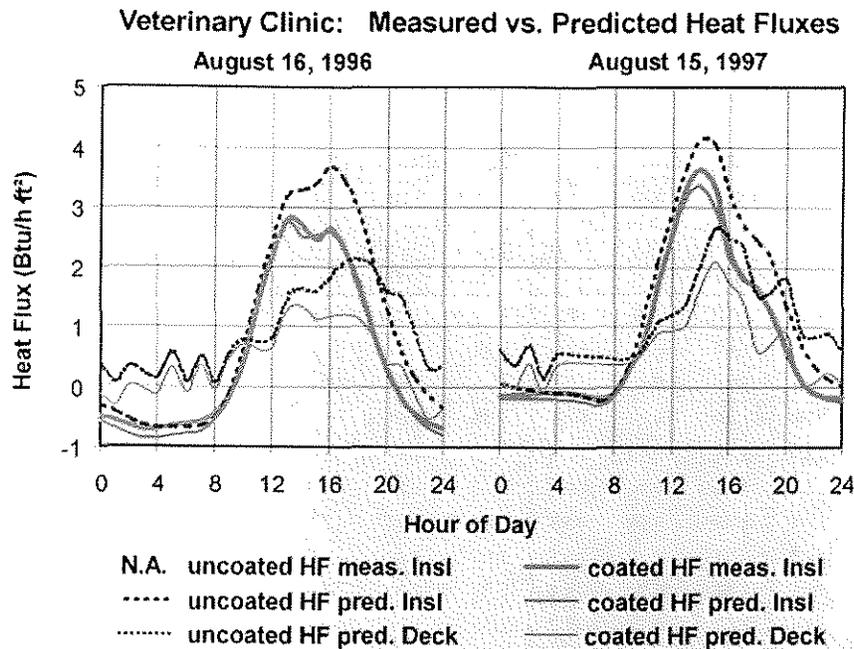
Figure 5 shows the same comparisons of heat fluxes for the veterinary clinic as Figure 4 did for the convenience store, except that measured heat fluxes were not available for the

Figure 5 Hourly measured and predicted heat fluxes for the coated and uncoated locations on the veterinary clinic roof for similar sunny days one year apart.

uncoated area due to the failure of the heat flux transducer there early in the project. The agreement between the measured and predicted heat fluxes in the middle of the polyisocyanurate insulation under the coated area is excellent on these hot sunny days, and both capture the effect of the weathering of the coating. Weathering effects do not seem as severe as on the roof of the convenience store, which the measurements of solar reflectance at 500 days for the samples VC and SHP in Figure 2 corroborate. The differences between the predicted coated and uncoated heat fluxes are not as large as on the convenience store either, which is due to the enhanced effect of the shading on the coated area on the convenience store, preferentially shading it near noon when solar irradiation peaks. The predicted heat fluxes through the heavyweight concrete deck of the veterinary clinic are delayed and diminished relative to those through the insulation. The deck heat flux through the uncoated area is positive (into the building) all 24 hours of these sunny hot days. The fresh coating allowed a few hours per day of negative heat fluxes (out of the building), but after a year, the weathered coating has lost this advantage or the climatic conditions are slightly more severe.

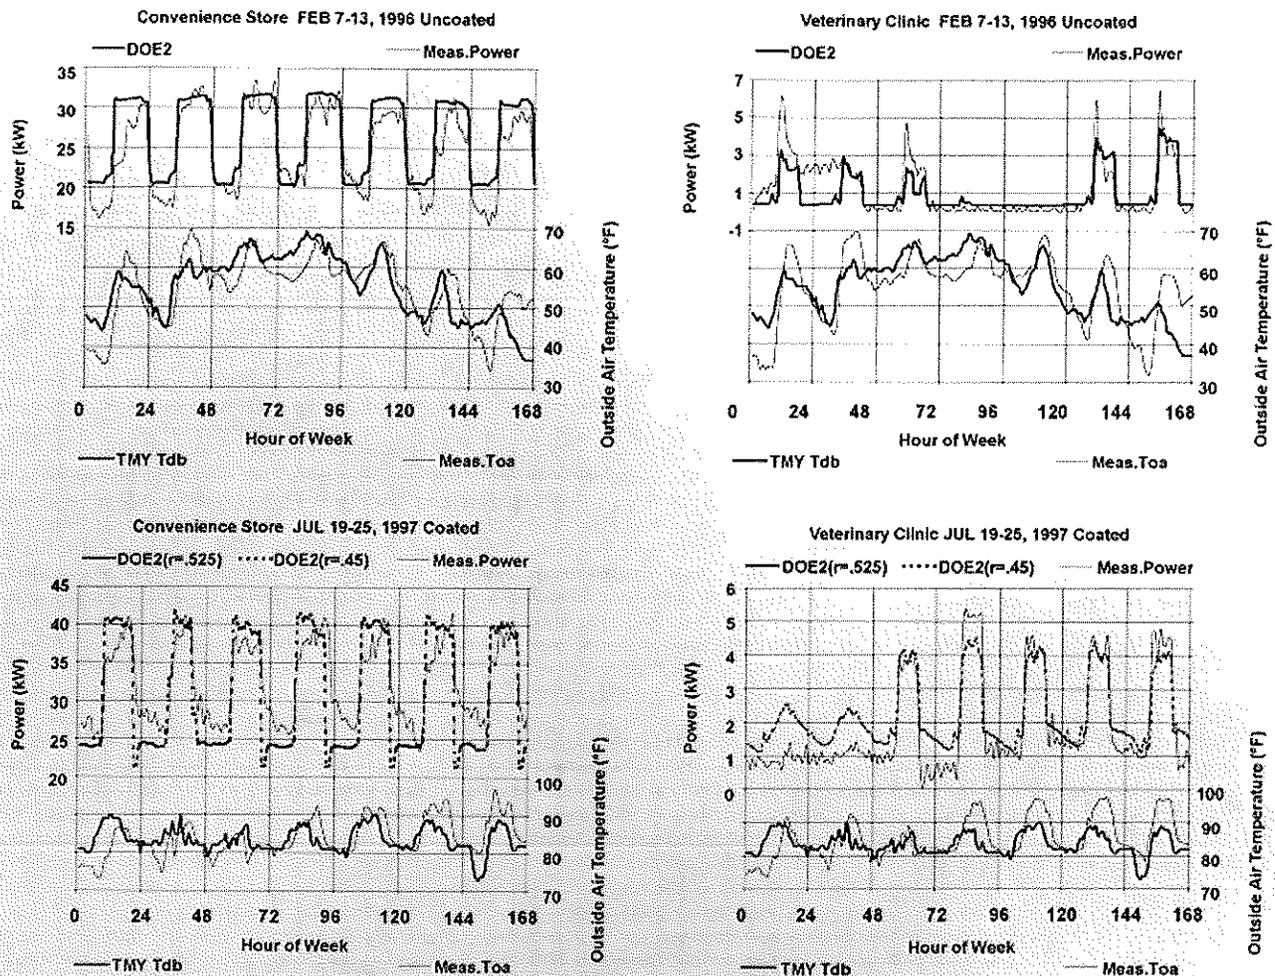
Figure 6 Comparison between measurements and DOE2 predictions of electrical power for the convenience store and veterinary clinic for a winter and summer week during the project.

general match the measured T_{oa} , but the measured power in both buildings does not exactly follow the outside-air temperature anyway. Moreover, measured power is more erratic than the predicted power despite considerable effort to match the observed power by adjustments in occupancy, lighting, and equipment as well as heating and cooling thermostat setting schedules. Note that the DOE-2 model successfully followed the change in schedule starting August 1, 1996, in the convenience store. The hours of nonsetback power demand in February 1996 are longer than in July 1997. The data loggers were kept on Eastern Standard Time year-round and scheduling was adjusted in the DOE-2 models.
