# Moisture in the Roofs of Cold Storage Buildings

## ABSTRACT

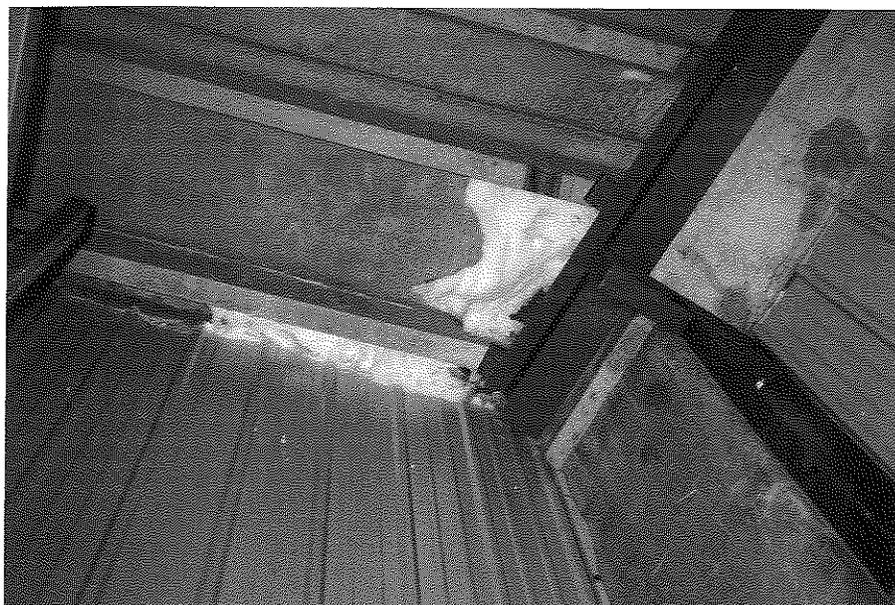
**Figure 1** *Photograph and thermogram taken within a freezer looking up at its roof in a corner. Frost and ice are present there due to infiltration of warm, moist outdoor air where the two walls and roof join. Airtight seals are needed at such roof-wall intersections.*

*Visually, all ten roofs appeared to be in good condition. However, areas of wet insulation were found in eight of them. Some moisture was associated with infiltration of warm, moist outdoor air at roof-wall intersections without effective air seals. Figure 1 shows photographic and thermographic images taken within a freezer of a corner suffering such problems. Frost has formed there as warm moist outdoor air infiltrated into the freezer. The bright portion of the thermogram is the area warmed by infiltrating air. The adverse effects of air infiltration on the thermal performance of freezer roofs deserves further study.*

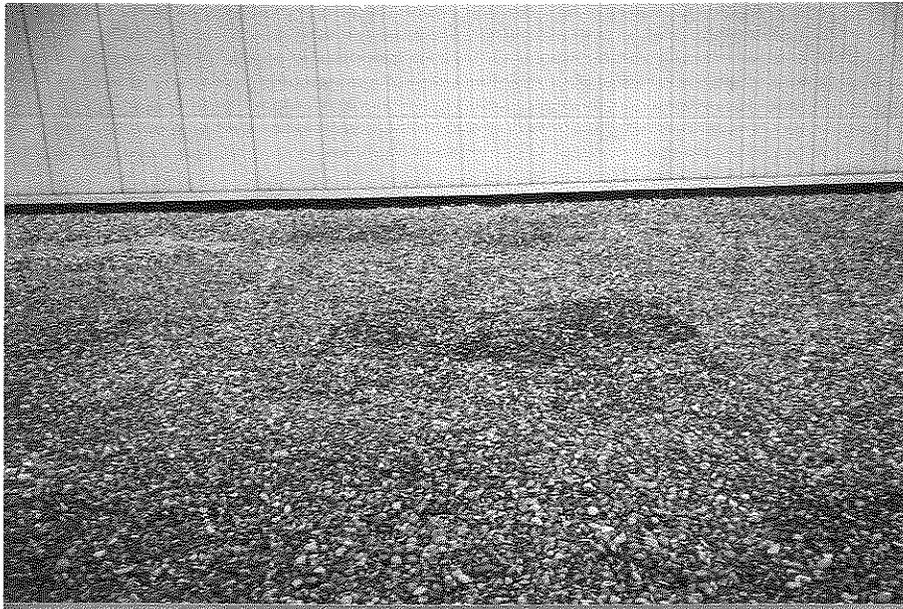
*Figure 2* Photograph and thermogram of a thermal anomaly on a freezer roof with a ballasted EPDM membrane. A small cut was present in the membrane here. A core sample taken in the middle of this anomaly found wet phenolic insulation.

*Of all the insulations examined, permeable fibrous glass was the most susceptible to wetting by air infiltration. While fibrous glass insulation may be able to be dried out (by warming up the freezers), the rapidity at which cancers of wet insulation can grow in it make it somewhat ill-suited for use in freezers and coolers where vapor drive and air movement are both usually inward. Some wetness was due to leaks caused by flaws in the roofing membranes and their flashings. Figure 2 shows photographic and thermographic images of a ballasted roof that contained wet phenolic insulation due to an inch (25 mm) long cut in the EPDM rubber roofing membrane there. The phenolic insulation had lost almost all of its insulating ability and thus the surface of the roof appeared colder (darker) in the thermogram than does the roof of the surrounding area where the phenolic insulation was dry and effective.*
