The Hygrothermal Performance of External Walls with Inside Insulation

ABSTRACT

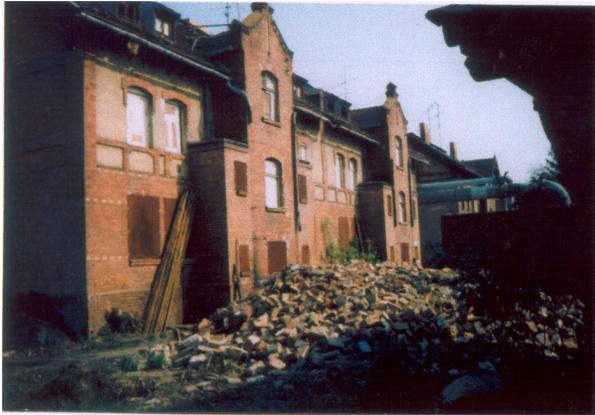
Figure 1 *Building before restoration.*

Tradition is a basic of mankind. Traditional architecture induces an identification with the immediate environment. The individual structures, materials, and colors of facades promote engagement with it (Hauser 1999). Figures 1 and 2 demonstrate an example for an engaged retrofitting of small buildings in the eastern part of Germany with insulation on the inside of the outside walls. All in all, the authors manage five different types of test houses.

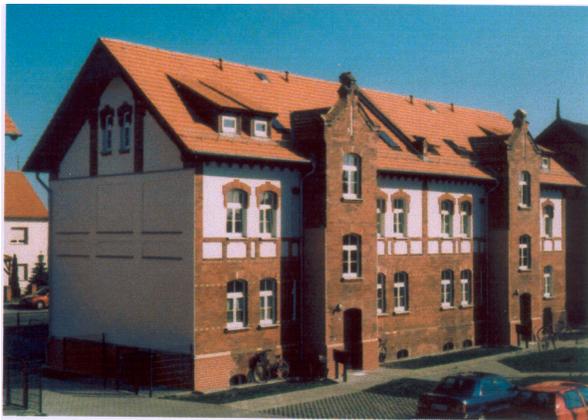
Figure 2 *The restored building.*

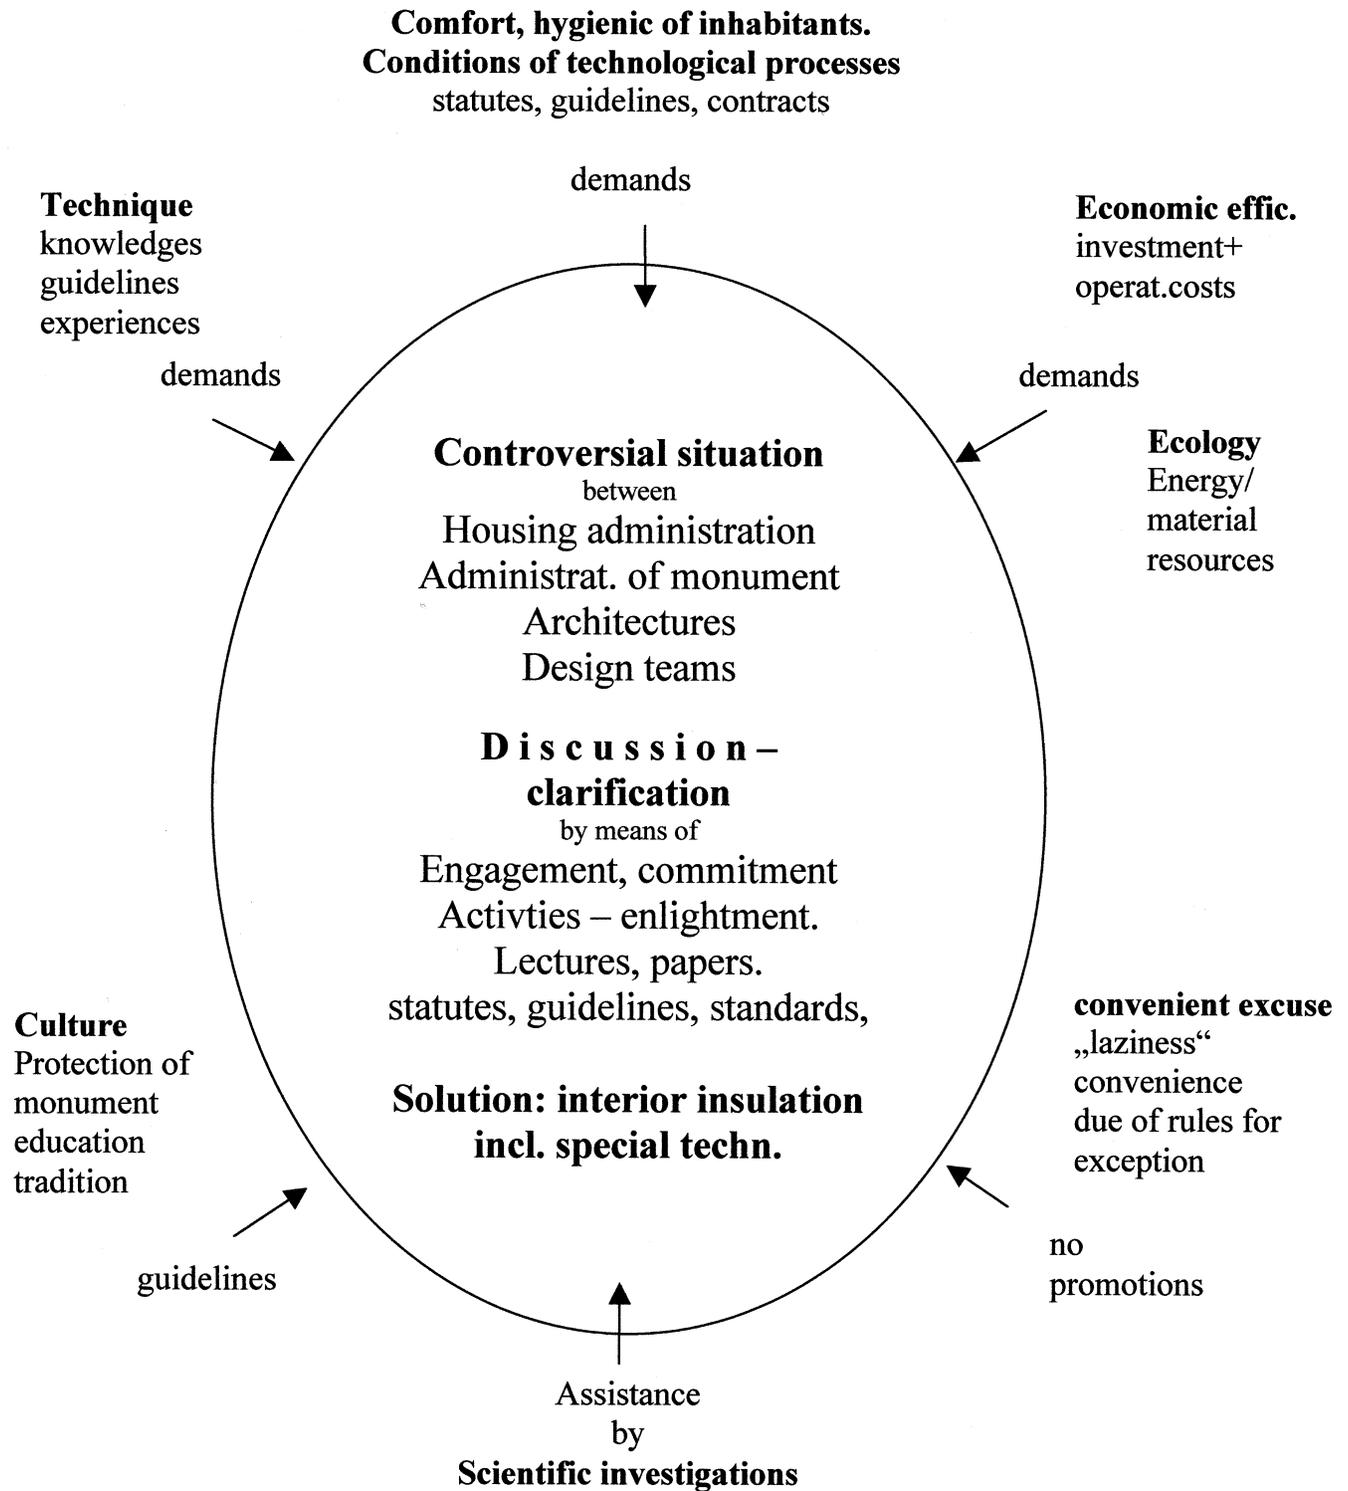
Figure 3 Influences on the decision-making process for inside insulation systems.

A model and a computer code for the numerical simulation of the coupled heat and moisture transfer were developed and validated to evaluate and to judge the hygrothermal performance of envelope parts and in order to reduce the experimental investigations (Grunewald et al. 1996; Häupl et al. 1995). We need ways of thinking and acting as engineers. Politicians and administrators should give only supporting (not determining) activities. The following survey (see Figure 3) demonstrates the contradictory influences on the decision-making process.

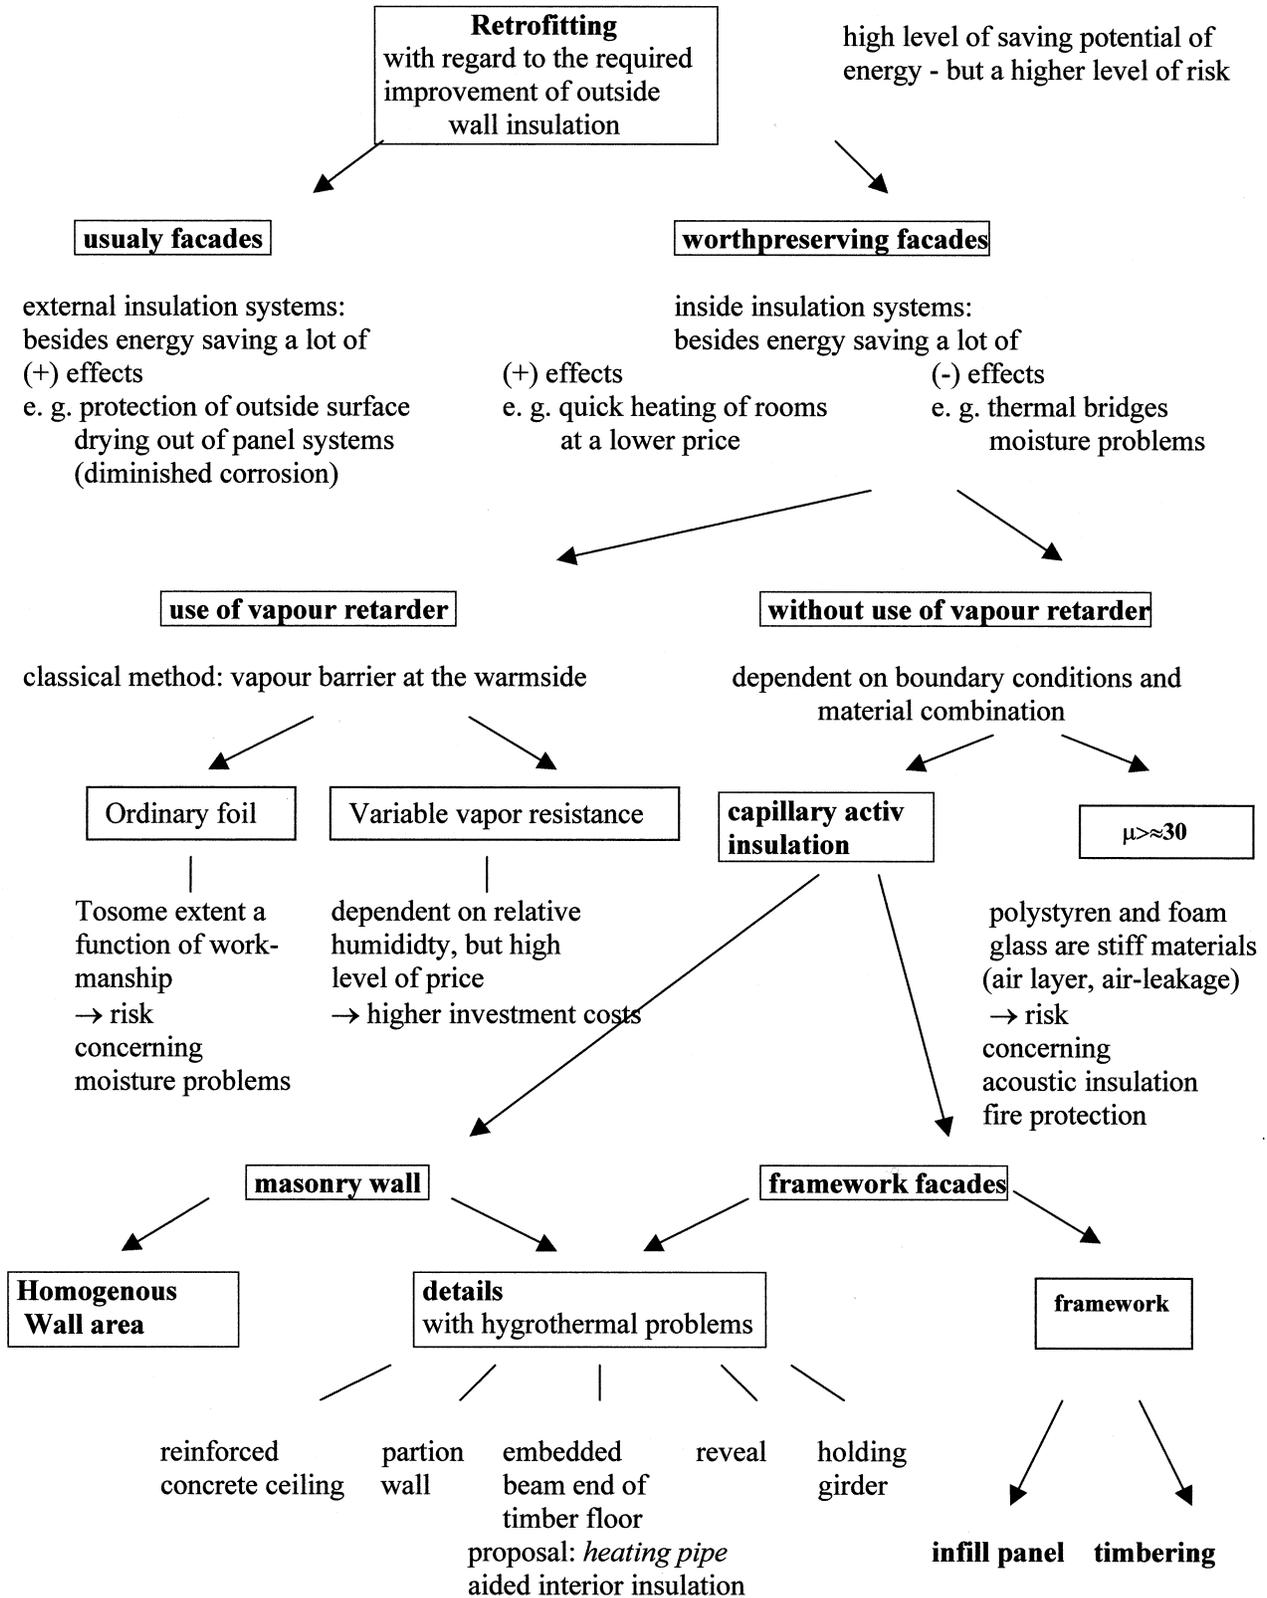
Figure 4 Several versions of envelope systems with interior insulation.

Figure 4 shows the variety of inside insulation systems from the hygrothermal point of view.

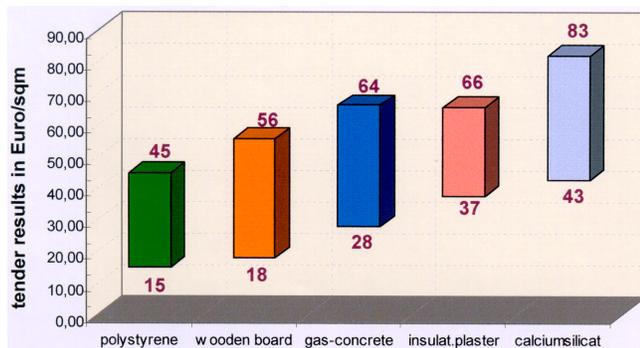
Figure 5 Costs of inside insulation systems (labor costs included).

Depending on the materials and the technologies, the costs vary. Figure 5 demonstrates the range of variation of costs, including the labor costs for the five following inside insulation systems:

These data represent the average of the current German situation in the year 2000, but the relative differences between the systems can be transferred approximately to the Middle European markets. The graph includes the material prices and the expenses for workmen. Figure 5 shows that all five insulation systems could be carried out at a cost of about 44 Euro. The financial assessment of the different inside insulation systems should be discussed in connection with the total costs of a restoration. In the case of the retrofitted building shown in Figures 1 and 2, less than 3% of the total cost of the restoration was invested for thermal improvement of the outside walls by an inside insulation system with expanded polystyrene covered by gypsum board.

Besides cost, other characteristics must be considered too. Polystyrene combined with gypsum board is the cheapest insulation system, but it is a product using oil sources. The acoustic resonance and, in the case of fire at least, poisonous damp are to be considered. Calcium silicate is actually the most expensive material. Maybe this capillary active insula-

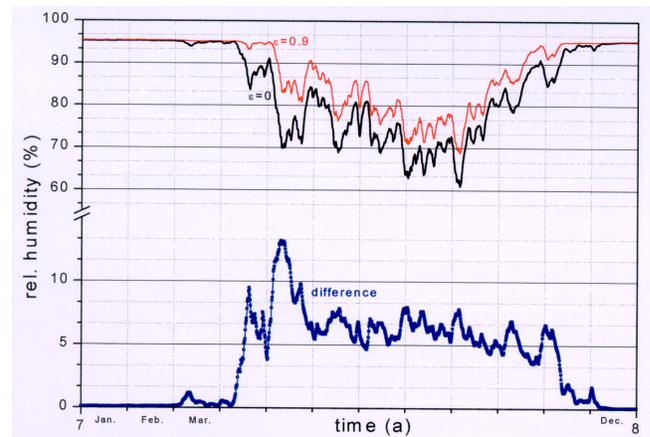
Figure 6 Course of relative humidity at the cold site of the thermal insulation layer.

The temperature profile of an outside wall insulated on the inside can be influenced in a favorable way by low-emission coatings on the facade (Häupl et al. 2000). Due to reduced emission of radiation, the temperature at the exterior surface and, thus, the temperature at the cold side of the thermal insulation, reaches a higher level. This means a decreased relative humidity and a shorter condensation period (Figure 6). Figure 7 shows

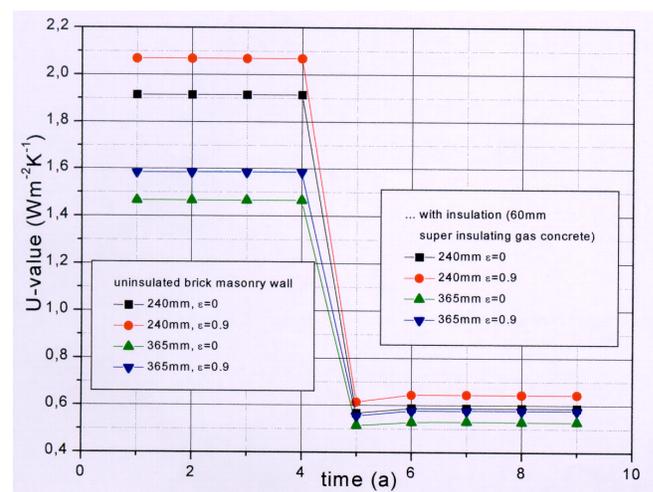
Figure 7 Comparison of U-factors influenced by infrared reflecting coatings.

the improvement of the heat transmission coefficient U-factor of an uninsulated and insulated outside wall by low-emission coatings.

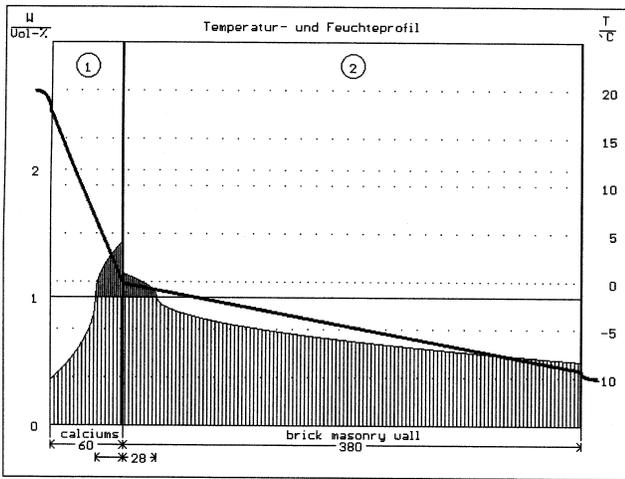
Figure 8 Moisture distribution calculated by method COND: calcium silicate inside insulation.

In spite of a missing vapor retarder, the over-hygroscopic moisture content (condensate) under the condition of a strong winter period is only 0.1 kg/m². The distribution of the moisture (over-hygroscopic: dense hatching; hygroscopic: wide hatching) is represented in Figure 8. Without the effect of the capillary water activities (so-called Glaser scheme), the condensation is more than 1.5 kg/m² because the distribution of the over-hygroscopic moisture and, connected with it, the

The measurement equipment in the test house has worked only one winter period. For the structure illustrated in Table 1 and Figure 8, moisture and temperature values have been measured for four years.

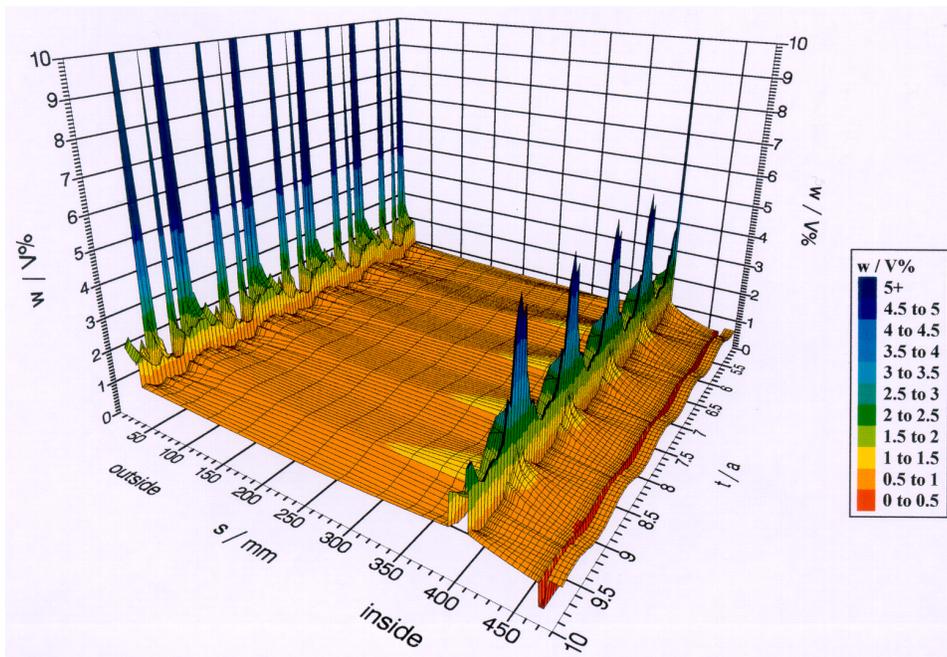
Figure 9 Inside insulation: aerated cell-concrete; numerical simulated moisture distribution.

The aerated cell-concrete ($\mu = 3$, $K = 5.10^{-8}$ m²/s) results in more than 1.2 kg/m² condensate under this strong outdoor climate. However, under the moderate climatic boundary conditions of the TRY Essen, representing the lowlands of Middle Europe, the last one results in an acceptable over-hygroscopic moisture content. By means of the computer code DIM 3.1 (Grunewald 1997), Figure 9 demonstrates the numerical simulation of the moisture field. Due to the drying out during summertime, a quasi-stationary state is reached and the over-hygroscopic moisture content in the winter period is limited to 0.050 kg/m².

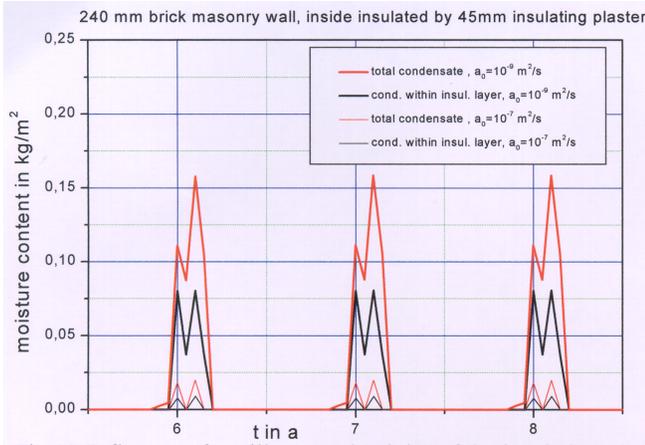
Figure 10 Influence of capillary conductivity of the insulating plaster on the total condensate and the condensate within the plaster.

In Figure 10, the influence of the capillary properties on hygrothermal performance is shown again (a_o = maximum capillary conductivity [Häupl et al. 1999]). For an inside insulating plaster under the climatic conditions of TRY Essen, owing to an increase of the capillary conductivity, the total condensate and the condensate of the insulation layer, respectively, would decrease from 0.150 kg/m² to 0.040 kg/m² and from 0.080 kg/m² to about zero.

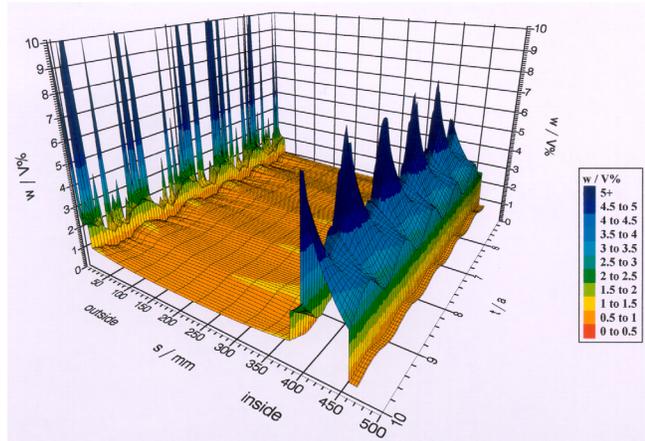
Figure 11 Numerical simulated moisture field, inside insulation: laminated wooden board.

Another important material property with regard to the hygrothermal performance of inside insulation systems is the hygroscopicity. Figure 11 shows the moisture field of a brick masonry wall insulated on its inside by means of laminated wooden board with the gypsum board having a maximum

hygroscopic moisture of 8 V%. The moisture values do not reach this limit, and condensation does not take place in the case of TRY Essen. But due to the larger hygroscopic moisture content, the U-factor increases from 0.56 W/m²·K to 0.63 W/m²·K ($\cong +10\%$) as the hygroscopicity of the wooden board rises from 5 V% to 8 V%.

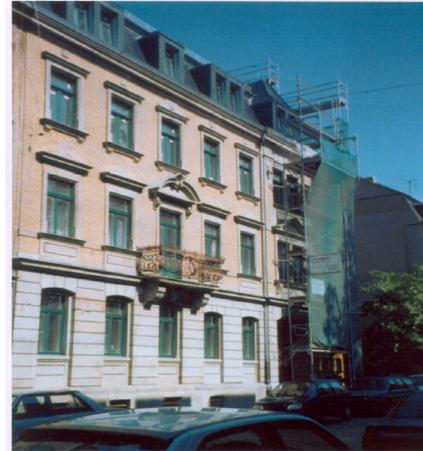
Figure 12 Street front of the building after the reconstruction.

Figure 12 shows the street front of the building. The exterior wall of the main front is a two-layer, one-skin brickwork covered with sandstone or clinker. The thickness of the wall toward the street reduces with each story (720 to 400 mm). The main clinker “Gründerzeit” facade, with its rich sandstone

decorations, is the signature of the building and is, as such, under the protection of historic preservation. The ground level is dominated by the sandstone rustics. The window framing and breasts of that level lie 120 mm behind the facade. The upper finish of the wall is realized by a sandstone cornice. Beside the facade, the appearance of the building is also determined by the mansard roof, with its vertical dormer windows together with the slate roofing.

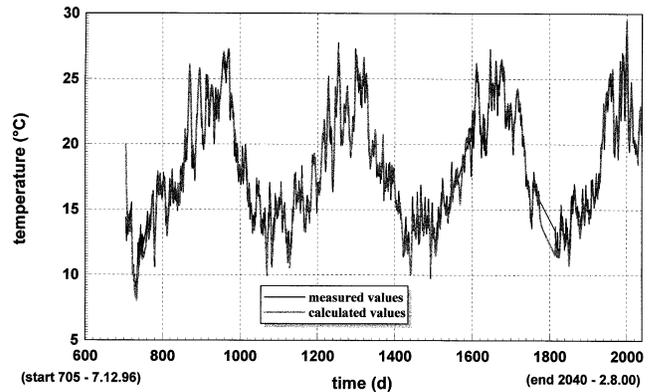
Figure 14 Comparison of measured and calculated temperature between the inside insulation and the old inside plaster, first floor, December 7, 1996, to August 2, 2000.

In the temperature curve at the cold side of the insulation layer (Figure 14), measured and calculated data correspond especially well. The temperature lies without exception above

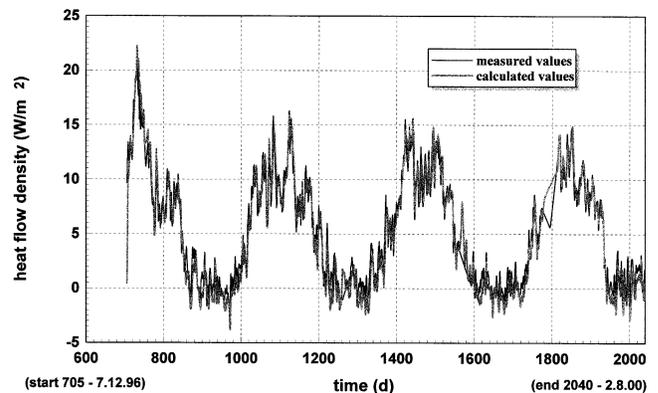
Figure 15 Comparison of measured and calculated heat flow density from inside into the construction, first floor, December 7, 1996, to August 2, 2000.

0°C. The heat flow densities vary between 25 W/m² in the winter and -2 W/m² in the summer (Figure 15). From that, and with the exterior air temperatures, effective heat transfer values of $U = 0.61 \text{ W/m}^2\text{K}$ in the first level result for the heating periods. The U-factor contains the energy gains from the shortwave radiation, but also the losses by the moisture content, the moisture movement, and the phase change in the structure. In the opinion of the authors, this represents an optimum value for building structures with interior insulation.

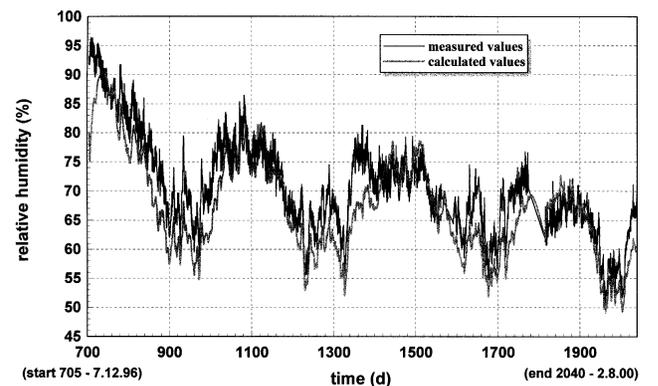
Figure 16 Comparison of measured and calculated relative humidity between the inside insulation and the old inside plaster, first floor, December 7, 1996, to August 2, 2000.

As Figure 16 shows, the measured and the calculated moisture data agree quite well for the critical section behind the insulation layer. Here, too, it becomes obvious that only in the first winter, the area of over-hygroscopic moisture was reached with $\phi > 90\%$.

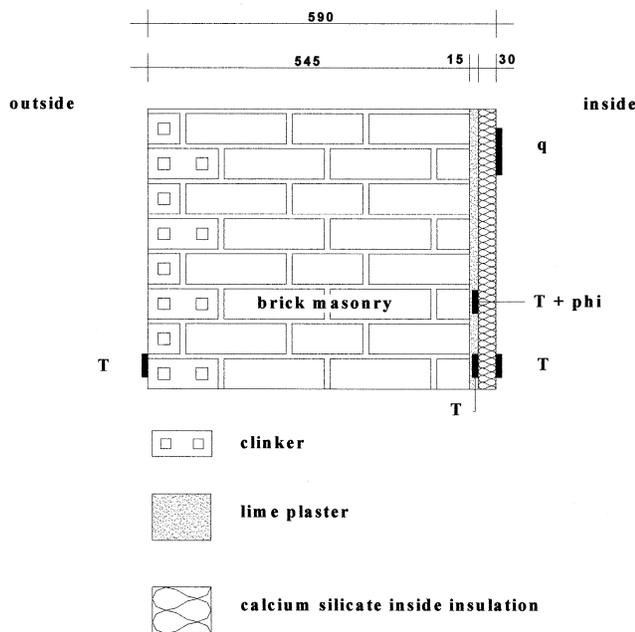
Figure 13 Outside wall in the first floor with arrangement of the measurement sensors.

The modernization includes the thermal retrofitting of the building. The exterior wall to the street—in the ground level brick with sandstone, upper stories brick with clinker—was insulated from the inside with 30-mm-strong fiber-dotted capillary-active calcium silicate boards. The main emphasis of the scientific investigation of the project lies here. Since October 1996, the house has been occupied again. Parallel to the listed work, the building climate measuring technology, with about 60 measurement probes, was installed in 1996.

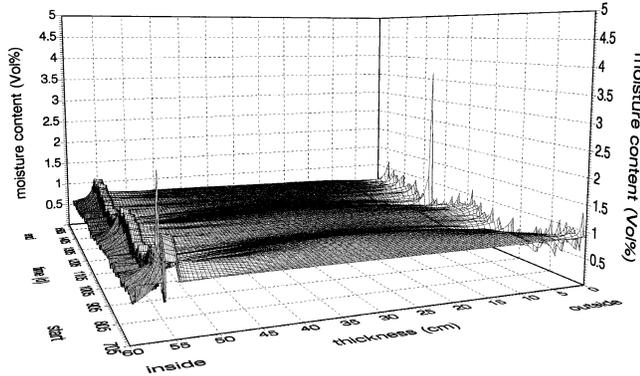
Figure 17 Moisture distribution in the construction, December 7, 1996, to August 14, 1998, first floor. Construction: (inside) 30 mm calcium silicate—3 mm adhesive—15 mm plaster—455 mm brick—90 mm clinker (outside).

In Figure 17, the moisture field within the first level for the first time period (December 1996 to August 1998) is demonstrated (inside left hand, outside right hand). The moisture content is always below 3 Vol%. Only in the cold winter of 1996/97, some condensate forms at the cold side of the interior insulation and penetrates capillary in the calcium silicate layer and in the old interior plaster. The peaks at the outside (right hand) result from specific rain events. However, the driving rain stress at the east side is extremely low. The computer code DIM enables the judgement of the hygrothermal behavior of newly built and renovated buildings.

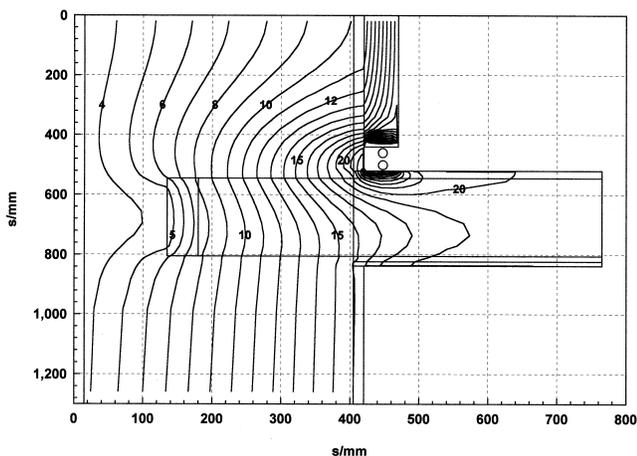
Figure 18 Isotherms (TRY Essen, January 29), heating operating.

A deficiency of thermal inside insulation is beam heads. Wooden beams are especially dangerous if condensation of water vapor takes place. The idea is to avoid the formation of condensate by a heating channel in the insulation layer at the bottom (Gnoth 1998). A numerical simulation of the coupled heat and moisture transport at this area demonstrates the effect of this measure. Figure 18 represents the isotherms in the case of operating heating. The increase of temperature is about 2° at the beam head during the winter under climatic conditions of TRY Essen in comparison with a completely covered outside wall by the insulation layer of 50 mm calcium silicate, if the air temperature within the channel is 35°C.

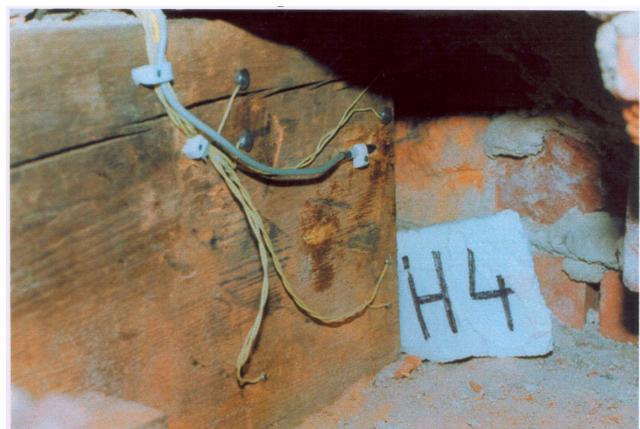
Figure 19 Installed sensors at a wooden beam.

In order to be sure, measurements must be carried out. Figure 19 represents installed sensors at the top of inside insulated beam heads.

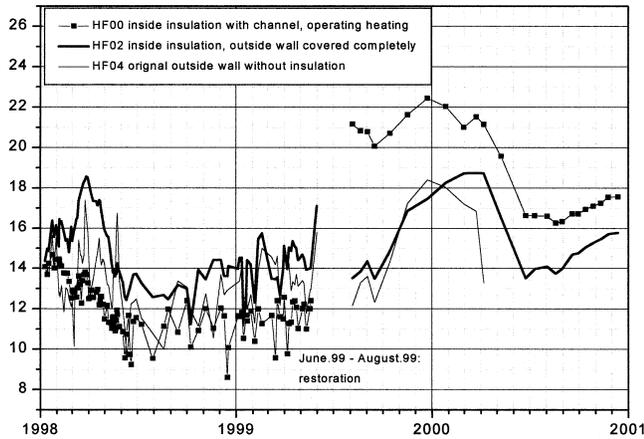
Figure 20 Course of wooden moisture and temperature at the beam heads.

Figure 20 shows the course of measured wooden moisture depending on time. The light blue colored line represents the result of the original wall structure (brick masonry wall, thickness 0.36 m) without interior thermal insulation and without impact of an additional heating pipe. The moisture values fluctuate by the influence of the outdoor and indoor climates. The red-colored line describes the additionally heated beam area 1 by an operating heating pipe. In spite of an interior thermal insulation, only a small “heating channel” is blocked out near the floor—the moisture of wood runs at a reduced level. Opposite to this, the wooden moisture at the beam end, measured during the same time under the condition of a completely

inside insulation (dark blue, no heating channel), reaches the highest level.

The interruption of the measured values is caused by the total retrofitting of the building from summer 1999 to April 2000. Probably during this time, water due to rain or workmanship came to head area 1. After the building work, both beam heads are subjected to the same indoor and outdoor boundary climatic conditions. Therefore, the measured values of wooden moisture should be at the same level after a sufficient long time.

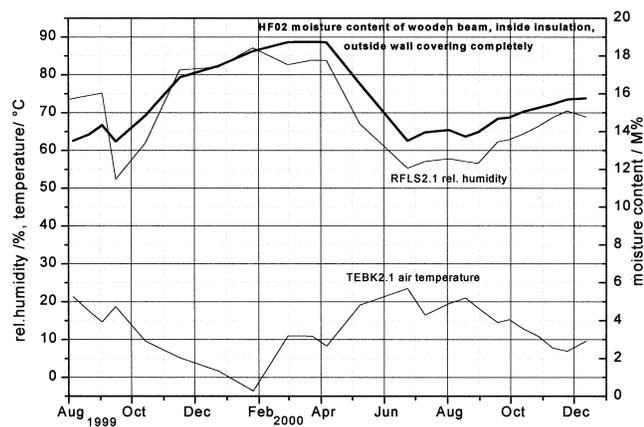
Figure 21 Relative humidity, air temperature of the air gap around the wooden beam head.

Figure 21 demonstrates the course of air temperature and relative humidity of the air gap at the top of the beam within the brick masonry wall and the dependence of the wooden moisture on it.

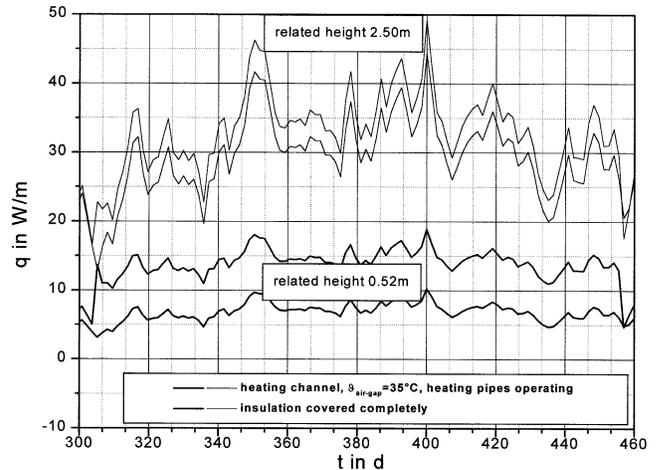
Figure 22 Heat flow per 1 m width of the wall.

Var. 1: height of the wall area $h = 2.50$ m, thin lines.

Var. 2: height of the wall area $h = 0.52$ m, thick lines

The blocked out material of the inside insulation at the bottom of the insulating board for the heating pipe causes an increased thermal bridge (Gnoth et al. 2000). The effect depends on the dimensions of the channel and the wall construction. The calculations by means of a two-dimensional simulation represented in Figure 22 are carried out with a height of the heating channel of 80 mm and a thickness of the thermal inside insulation calcium silicate of 50 mm. For this reason, the results show the additional heat losses in case of an infinitely wide wooden beam. Therefore, the embedded infinite ceiling of a wooden “beam head” is replaced by brick masonry material in order to receive the most heat losses by the thermal bridge. The red-colored lines describe the heat flow per width of 1 m in the case of a heating channel with operating heating pipes; the blue one shows the effect of a completely covered inside insulation. In variation 1, the heat flows add up to the total height of the room of 2.5 m; in the second one, the height is only 0.52 m (impact of the thermal bridge). Depending on the related height, the differences are approximately 10% to 50% during the heating period.

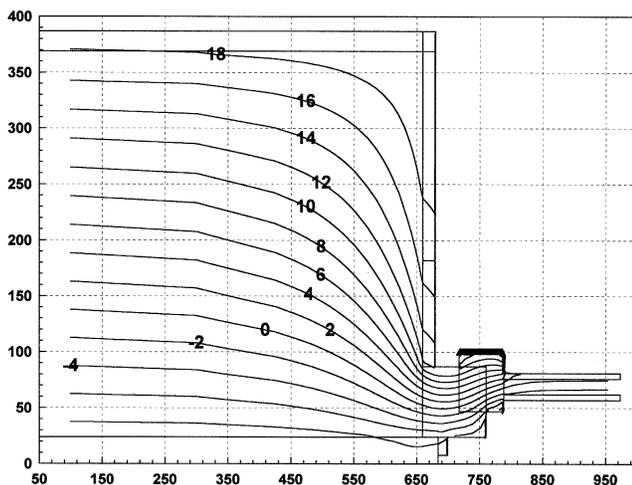
Figure 23 Isotherms, brick masonry wall, 20 mm lime-cement plaster on the jamb of window.

The outside wall is a brick masonry wall, 390 mm thick. The initial situation shall be the usual lime-cement plaster with a thickness of 20 mm. In Figure 23, the 12°C isotherm runs through the edging of plaster/blind casing. The dew point is reached with an air temperature of 20°C and a relative humidity of 60%.

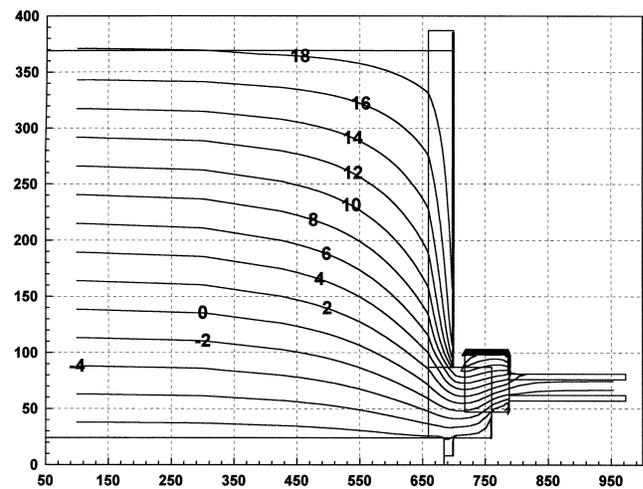
Figure 24 Isotherms, brick masonry wall, 40 mm insulating plaster at the jamb of window.

Due to an insulating plaster of 40 mm, the temperature at the same position decreases to a value of approximately 9°C (Figure 24). This means energy saving and no condensation at the whole interior surface of the jamb except at the edging of jamb/blind casing. In the last area, the situation gets worse with regard to the hygrothermal situation. Figure 25 represents the moisture distribution in the case of 40 mm insulating plaster added as an inside insulation to the jamb area consisting of a homogenous brick masonry ($\lambda = 0.18 \text{ W/m.K}$).

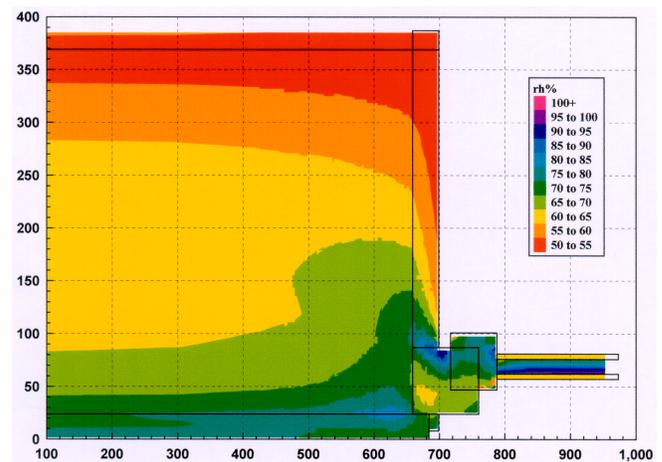
Figure 25 Isohyrics of the humidity, brick masonry wall, 40 mm insulating plaster at the jamb of window.

An alternative can be an insulating plaster. In all cases, the individual situation is to be considered and a calculation should be carried out. Figures 23 through 25 demonstrate the coupled heat and mass transfer in connection with different plasters at the jamb of a timber window. The climatic boundary conditions are chosen according to the German standard 4108. This means outdoor $-10^{\circ}\text{C}/80\%$ relative humidity and indoor $20^{\circ}\text{C}/50\%$.
