Extending the Life Span of Concrete Buildings in Germany/Middle Europe by Applying an External Thermal Insulation System

Erich Cziesielski, Ph.D.

ABSTRACT

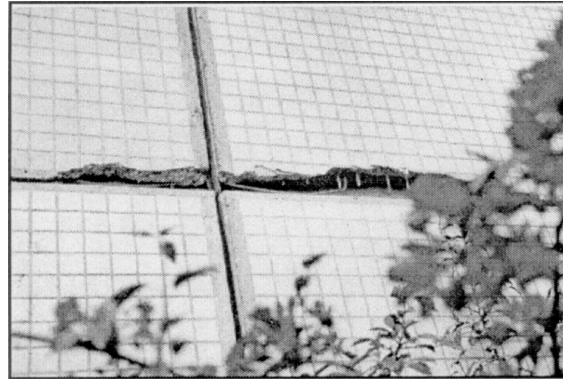
Figure 3 Cracks in the weather protection layer of a concrete sandwich wall.

- Cracks in the facing layers (Figure 3) and partly powdering wall surfaces.
- Thermal bridges due to an inadequate constructive con-

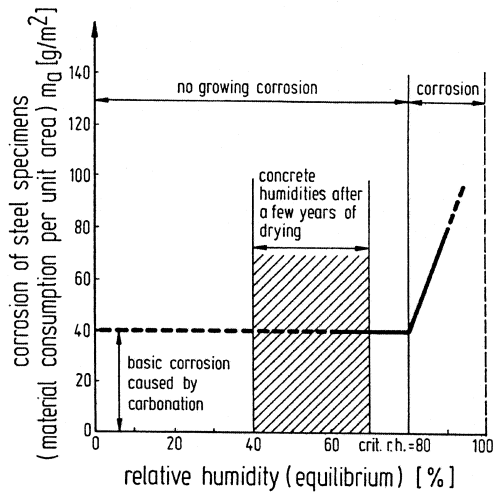
Figure 8 The critical moisture content for corrosion of the reinforcement rod in the carbonated concrete is $\phi = 80\%$ to 90% relative humidity.

The protection of concrete through exterior thermal insulation reduces the relative humidity to only 50% to 70% (Figure 8), so that by application of additional thermal insulation on the exterior wall, the corrosion process can be effectively slowed down. This principle of corrosion protection has been proven efficiently in laboratory and field tests as follows:

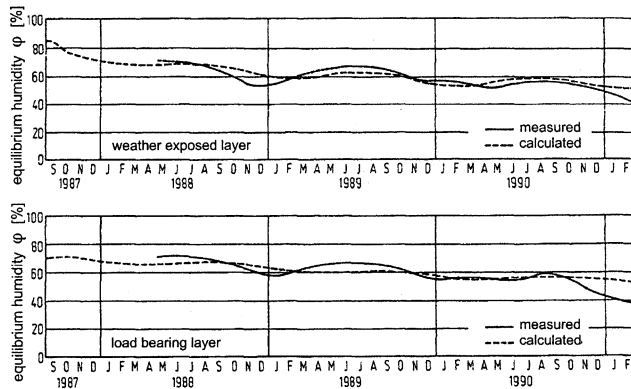
Figure 9 Measured and calculated relative humidities in the weather exposed concrete layer and the load bearing concrete layer of a sandwich wall element with an additional curtain wall.

The measured relative humidities in the concrete layers—with and without subsequently applied thermal insulation—lay in the range of 40% to 70%. The measuring time was 2.5 years. Instationary calculations had, as a result, relative humidities laying between 45% and 65% after about three years of drying out. The correlation between measured and calculated results can be regarded as good enough (Figure 9).

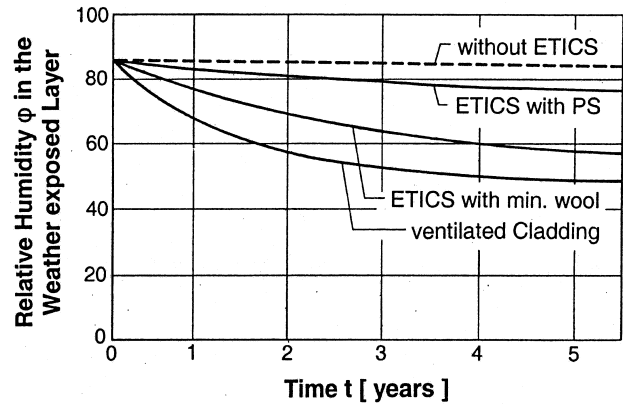
Figure 10 Drying behavior of the facing layer of concrete sandwich walls with supplementary application of ETICS or curtain-type exterior wall constructions in relation to walls without any application (upper curve).

In the conducted measurements, the initial values of relative humidities were between 60% and 70%. In order to investigate the drying-out behavior of higher initial relative humidities, the drying-out behavior for this case was examined numerically. The simplified result is shown in Figure 10. According to this figure, the outer concrete layers of sandwich walls dry out rapidly under the critical value of 80% in the case that a diffusive cladding (curtain wall) is applied. The drying out is also rapid if a mineral thermal insulation composite system is applied.

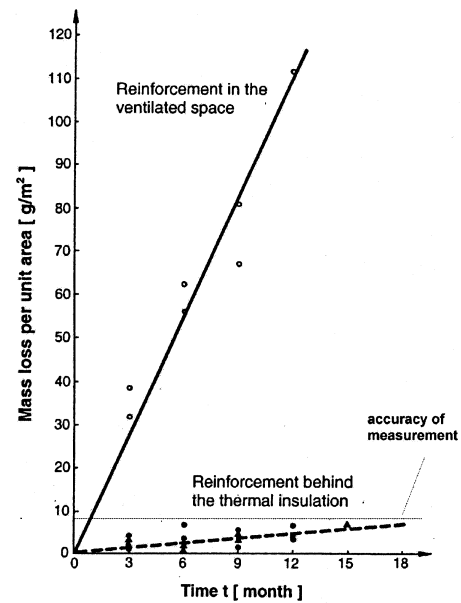
Figure 14 Reduction of corrosion on reinforcement steel on a completed building during a 1.5 year observation period—the steel, which was placed behind a thermal insulation, did not show any signs of corrosion, whereas the protected steel was considerably corroded.

In summary, it can be said that efficient corrosion protection of the reinforcement in the facing layer can be achieved by exterior application of thermal insulation measures on concrete sandwich walls. This was certified by measurements on completed buildings (Figure 14).

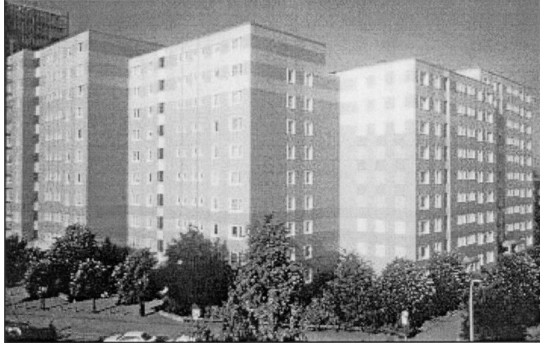
Figure 15 Restored building.

Figure 15 shows an example of a building that was restored according to this method.
