Using a Heat and Moisture Transfer Simulation to Diagnose Moisture-Related Expansion/Contraction Problems in an Exterior Roof/Wall Assembly

J. Lawrence Elkin, P.E.

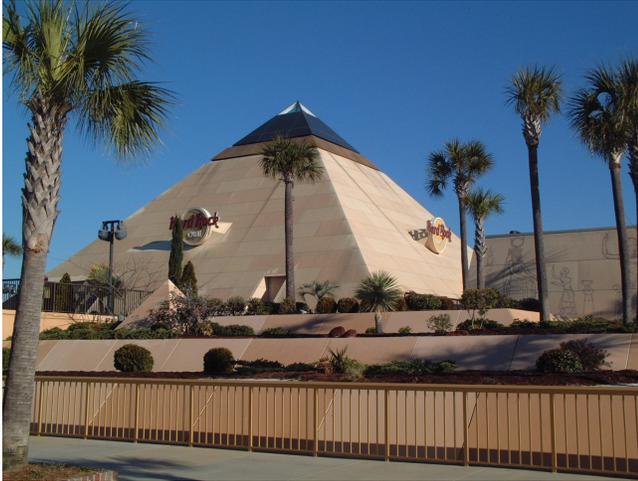
Figure 1 Overview of the subject facility. The synthetic stone panels extend approximately 75% up the building's façade from grade to a row of metal louvers.

first level is mostly below grade with cast-in-place concrete walls and a concrete floor slab. The upper three floors have wide-flanged steel beams supporting corrugated steel decking and concrete floor slabs (see Figure 1).

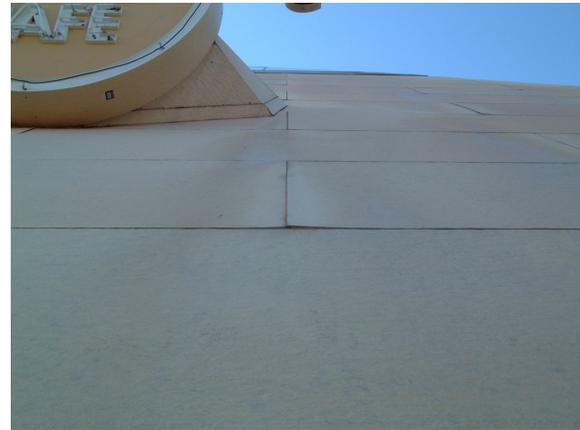
Figure 3 View up the inclined face of the north wall showing curled panel edges and ruptured sealant joints.

The exterior wall cladding was installed in early April 1995. Around the end of October 1995, the synthetic stone panels were visibly deformed (McCarty 1995). The deformations consisted of upward curling of the panel edges, outward pillowing of the panel centers, and combination pillowing/cupping in several panels (see Figure 3). In addition, many of the silicone sealant joints between adjacent panels had compressed beyond the designed minimum widths and some joints had ruptured.
