Indoor Air Humidity of Massive Buildings and Hygrothermal Surface Conditions

ABSTRACT

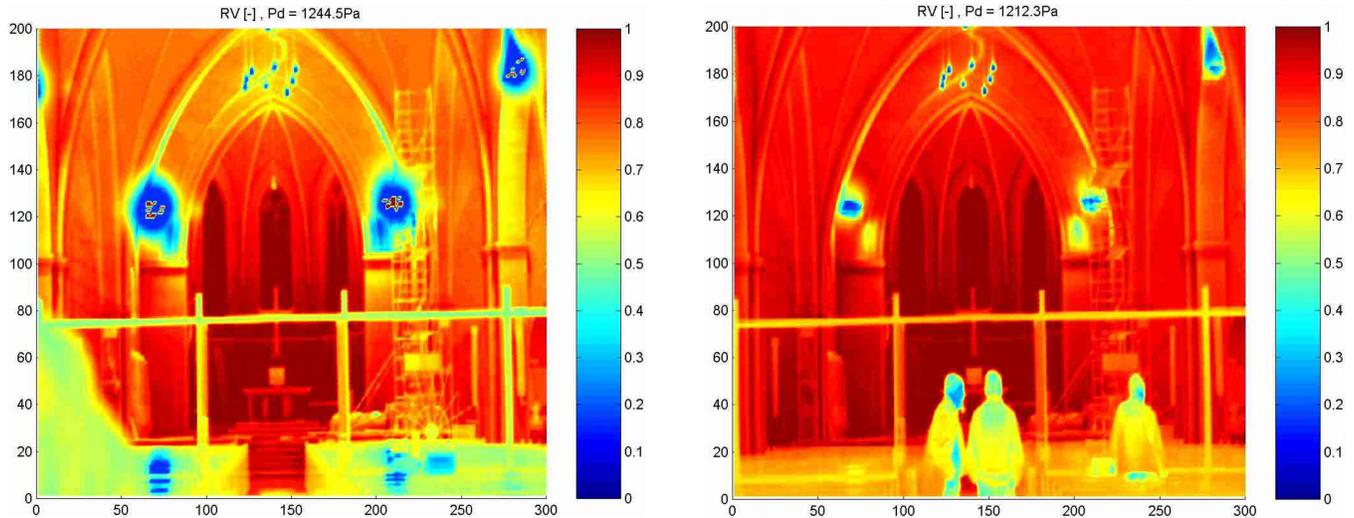
Figure 1 Relative humidity near the surface as calculated from absolute humidity and thermographic surface temperatures (left) during two hours of heating and (right) directly after heating.

Figure 1 shows the results of the near surface relative humidity as it was calculated from the measured absolute humidity and the thermal infrared imaging measurements. For some points on the glass and on the walls, the results were compared with local temperature and relative humidity measurements. The results were within the calculated accuracy (about $\pm 5\%$).

A two-hour operating period of the gas infrared heating devices led to most serious surface condensation on stained glass windows, walls, and floor. The figures show the most critical condensation surfaces to be lying in the shadow of the infrared heating devices in the choir. Furthermore, it is clear from these images that the most critical time for surface condensation on cold surfaces is a little while after stopping the heating: the temperatures decrease in a short time and where the infiltration rate is low, the relative humidity nearly reaches its maximum. In this Bommel church the combination of a large source of moisture production and a relatively small infiltration rate was a serious threat to the building and its interior.

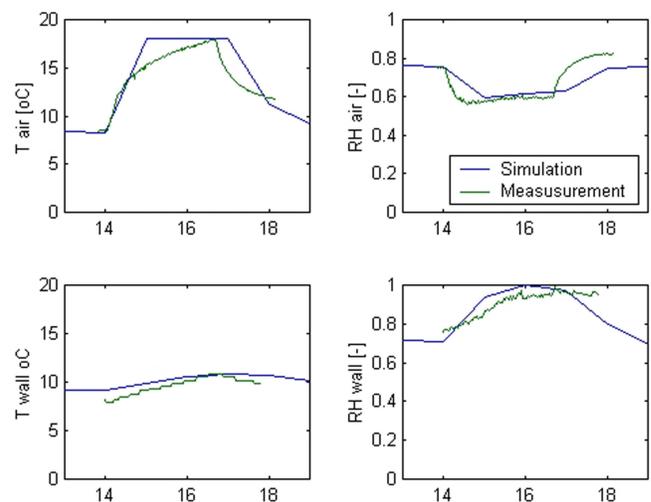
Figure 2 Comparison of WaVo calculation results (blue) and results of measurements (green): air temperature (left above), relative humidity (right above), choir wall temperature (left below), and relative humidity near choir wall (right below).

A simulation run with WaVo on the Bommel church's characteristics was completed and the results have been compared with measured results. A typical graphical representation of the measured and simulated results is shown in Figure 2. The figures represent the air temperature (left above), relative humidity (right above), choir wall temperature (left below), and relative humidity near the choir wall (right below). The agreement at that time of simulation (1999) was not very good, mainly due to the restriction of one-hour time steps, enforced by the time steps of the weather file. Later (2000, see Walloon church below) linear interpolation of weather data improved the quality of the results.

When we look at the relative humidity in the church, we note that due to the temperature effect it will drop during heating. Directly after heating, however, the relative humidity will increase due to the enlarged specific humidity in combination with the cooling down of the church and the relatively small infiltration rate. From the pictures of the relative humidity near the choir walls, it is clear that a two-hour use of the system will lead to severe condensation on the choir walls and glazing in the church.

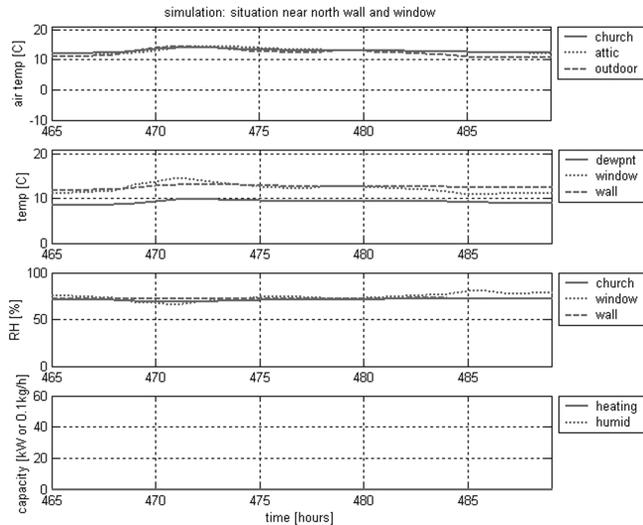
Figure 3 Weekday without a service, situation near wall and window in north façade.

Weekdays Without a Service. Figure 3 shows the situation during a weekday without a service. The indoor air temperature and the relative humidity remain quite stable at about 10°C and 75%, respectively. The relative humidity does not drop below 40% so there is no need to humidify the indoor air.

The temperature near the northern wall follows the indoor air temperature and is about 10°C. The relative humidity remains around 70%-75%. The temperature near the northern glazing varies from 10°C to 15°C while the relative humidity near the glazing is about 70%-80%. There is no condensation on the glazing.

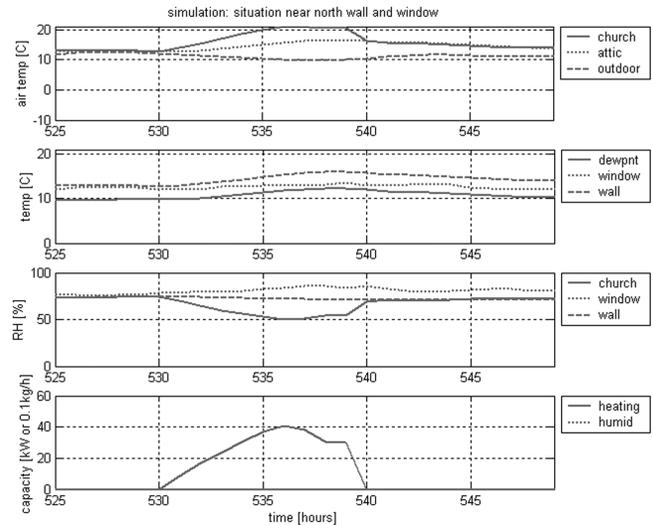
Figure 4 Sunday with a service and a minimum outdoor temperature of 10°C.

Sunday with Service and a Minimum Outdoor Temperature of 10°C. Figure 4 shows the situation during a Sunday, with a service held at a minimum outdoor temperature of 10°C. The air in the church is heated up to the desired value of 20°C, and, as a result of this temperature rise, the relative humidity drops from 75% to almost 50%. However, the humidifier does not have to be put into operation. During the

service the relative humidity increases slightly as a result of the moisture produced by the people present in the church. When the heating system is shut off after the service, the relative humidity returns quickly to a value of 75%, which is about the same value as before the service.

The temperature near the walls follows the indoor air temperature with a slight delay. The relative humidity near the walls fluctuates around 75%.

During the service the indoor air warms up the glazing, but as a result of the remaining low surface temperature of the glazing, the relative humidity near the glazing fluctuates around 80%. The risk of condensation on the glazing is present: as a result of the temperature rise, the relative humidity near the glazing surface decreases during the service to 80% but increases to 90% when the heating system is shut down right after the service.

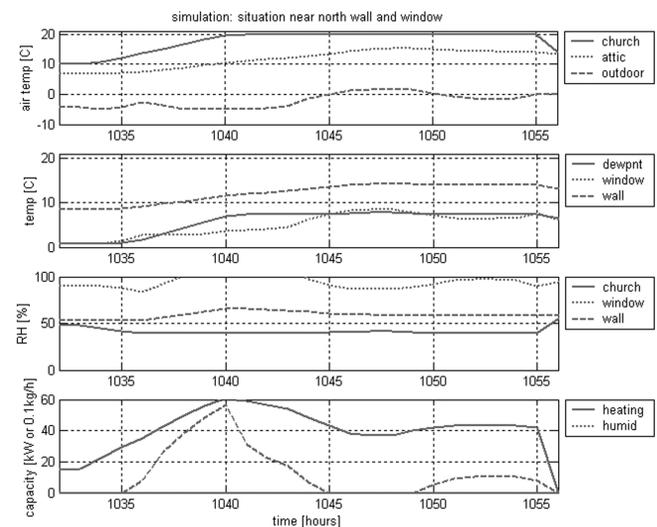
Figure 5 Sunday with a service and a minimum outdoor temperature of -5°C .

Sunday With a Service and a Minimum Outdoor Temperature of -5°C . Figure 5 shows that the indoor air is heated from the primary temperature of 10°C to the desired comfort temperature of 20°C . The hygrostatic control starts the humidifier at a minimum value of 40% RH. As a result of the rise in temperature, the relative humidity tends to drop from 52% to below 40% and the humidifying load shows the humidifier has to be put into action. While heating the indoor air, the relative humidity is held at 40% with help of the humidifier. When the heating system is turned off right after the service, the relative humidity increases rapidly to a value of 65%. This is a clearly higher value than before the service.

The adjustment control of the humidifier is closely connected to the adjustment control of the air heating system. If the relative humidity drops below 40% the humidifier starts working to reach its maximum load at $t = 1040$. The simulations show that a capacity of 5.5 kg/h is needed to restrict the relative humidity to a lower limit of 40% during a period with an outdoor temperature of -5°C .

As shown in Figure 5, the temperature near the walls follows the indoor air temperature with a slight delay. The relative humidity near the wall drops as a result of heating the indoor air, but it rises as soon as the humidifier is turned on. The relative humidity reaches a value of 65% at the point $t = 1040$. After that the temperature of the wall increases and the relative humidity near the wall again decreases. The relative humidity near the northern wall thus reaches a maximum value of 60% to 70% the moment the humidifier is working. There will not be a long-lasting moistness, resulting in fungal growth. At a primary temperature of 10°C in the church, the air temperature near the glazing is about 2°C and the relative humidity about 85%. Humidifying the indoor air during the service will increase the relative humidity near the glazing even more. As a result of this, there will be condensation on the glazing. This condensation period is shown in Figure 5 from $t = 1038$ to $t = 1043$ hours. This period can be detected from the RH graphs as well as from the dew-point/surface temperature graphs.

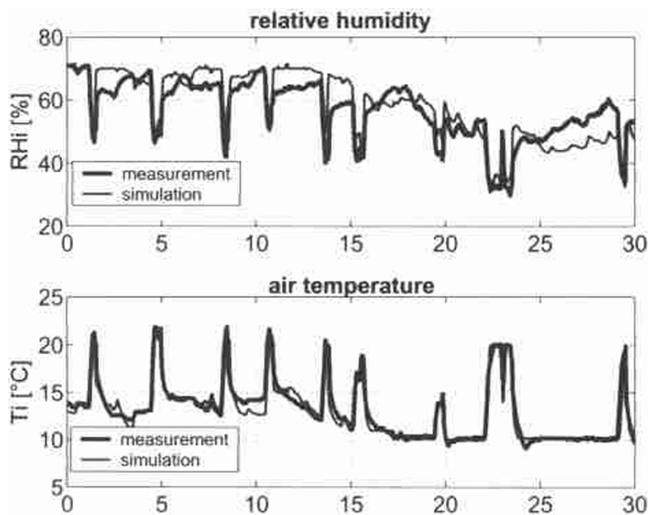
Figure 6 Comparison between simulation and measurements.

Since in the Walloon Church in Delft an air velocity of 0.2 to 0.3 m/s was measured, the heat transfer coefficient of the walls in the simulation model was adjusted from 2.5 to $5 \text{ W/m}^2\text{K}$. After making these adjustments, the course of the indoor air temperature is very close to the measured values (Figure 6), but there are still some slight differences, probably due to several causes:

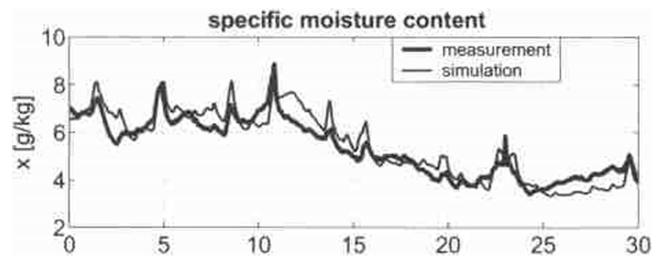
Figure 7 Comparing measurements and simulations.

Specific Moisture Content. Because of the temperature dependence of the relative humidity, it is difficult to compare the measurements and the simulations. Therefore, it is better to compare the specific moisture content of the indoor air. Figure 7 shows differences in the specific moisture content between the measurement and the simulation. These differences can have several causes.
