# The Function and Performance of Weather-Resistive Barriers during Building Construction

**Theresa A. Weston, Ph.D.**  
Member ASHRAE

**Xuaco Pascual**

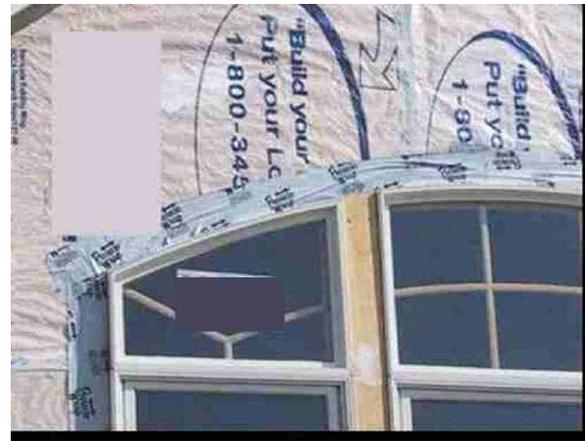
**Figure 2** Rain has intruded directly through a perforated housewrap.

Housewraps with low water resistance can allow water to penetrate. Figure 2 shows rain that has intruded directly through a perforated housewrap during construction. When subjected to a direct water spray test, perforated housewraps will allow water to pass while nonperforated housewraps resist water entry. This is demonstrated in a simple laboratory test method (AATCC 1990b). The weather-resistive barrier sample is placed over a blotter paper and sheathing and then sprayed with a calibrated nozzle (see Figure 3). Water penetration is measured by weighing the change in weight of the blotter paper. Figure 4 shows the results for three perforated housewraps, all of which allow water to penetrate to the blotter

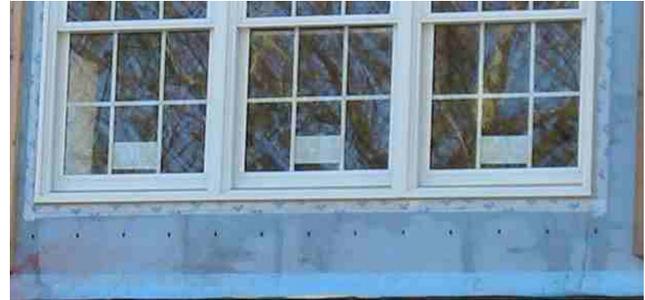
Figure 5 House during construction with water intrusion behind weather resistive barrier at window opening.

Field studies have also shown that water can intrude behind the weather-resistive barrier at interfaces, such as those with windows (see Figure 5). In a field study of building failures in Vancouver, BC, 62% of incidences of water intruding past the sheathing paper (WRB) were due to discontinuities or at flashings or penetrations (Morrison Hershfield 1996). Closer attention to the design and implementation of window installation and flashing details is required to reduce this water.

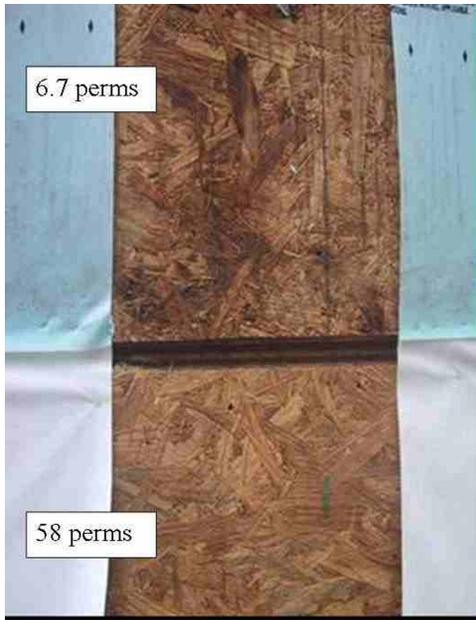
**Figure 6** *Overlap area between the high- and low-permeability housewraps.*

behind any of the areas where the high-permeability housewrap was installed, indicating that while the high-permeability housewrap is allowing the moisture to dry, it is being trapped by the low-permeability housewrap. Additionally, there was a stark contrast in the areas where the two housewraps overlapped. Areas behind the low-permeability material indicated moisture distress, while the areas behind the adjacent high-permeability material were clean and dry. This was true regardless of what product was on top or below. Figure 6 shows a typical area with overlap of the two housewraps. The upper area of the sheathing shows signs of moisture distress and staining, while the lower area is clean and dry. These areas correspond to the low- and high-permeability housewraps, respectively. It was also noted that the area where the two membranes overlapped had moisture trapped between the membranes when the low-permeability product was oriented toward the exterior. This further substantiates that the low-permeability product was, in effect, trapping moisture behind it that was trying to escape or dry toward the exterior.

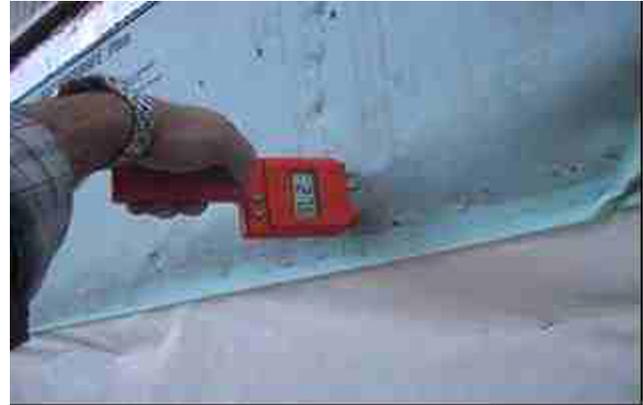
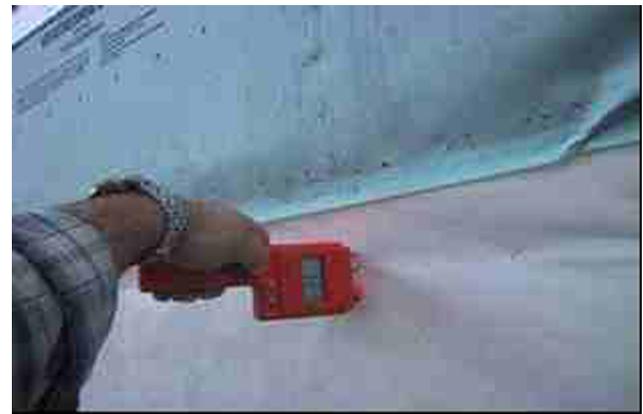
(a) Low-permeability housewrap.

(b) High-permeability housewrap.

**Figure 7** *Moisture readings being taken at housewrap overlap.*

Moisture readings were taken at several locations around the building, concentrating on the north and west exposures since these indicated widespread signs of moisture distress that were easily accessible. Moisture readings were taken using a Delmhorst contractor grade moisture meter, model BD-2100, serial# 19456. Figure 7 shows moisture readings being taken at representative areas where the two products overlapped. In each of these cases, moisture readings were taken at adjacent points where one housewrap ended and the other started. For every one of these cases, the moisture read-

ings in the sheathing behind the low-permeability product exceeded 25% moisture content. In the adjacent areas where the high-permeability product was installed, moisture readings never exceeded 13.1% and decreased rapidly as the distance from the overlapped area increased. Based on the weather conditions and the exposure of the building, it would be expected that the moisture content of the sheathing would likely be <15% depending on exposure and orientation. The average moisture content in the sheathing behind each WRB for each orientation of the building is shown in Table 2. In general, moisture readings in the sheathing behind the low-permeability housewrap ranged between 20% and 30%. Prolonged exposure in these ranges is sufficient to produce decay in wood products. Several areas in the field of the low-permeability housewrap yielded readings >40% moisture content. This is the upper limit of the moisture detection device used.
