# Air Barriers in High Interior RH Specialty Buildings: Considerations for Control of Moisture-Laden Air in Museums, Labs, and Natatoriums

Paul E. Totten, PE  
Member ASHRAE

Sean M. O'Brien, PE  
Member ASHRAE

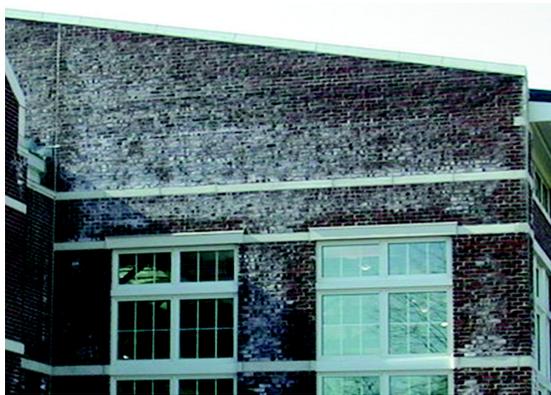
During the first winter of the building's operation, the owner reported widespread efflorescence on the exterior brick masonry (Figure 1) and significant accumulation of icicles at the roof eaves (Figure 2). We investigated the building during the winter, when these problems were the most severe, and performed an infrared (IR) scan of the building to look for "hot spots," or areas of increased temperature on the exterior of the building that, when the building is positively pressurized, are indicative of warm air leaking from the interior of the building.

**Figure 1** Efflorescence on exterior brick masonry.

Based on our investigation, we developed a scope of repairs to address air leakage through the building enclosure. As per the direction of the architect, we developed a phased repair plan for the building to install air barriers in critical locations. Phase 1 included removing the existing roof, installing an air barrier assembly integrated with the walls and surrounding buildings, and installing a new roof system to match (aesthetically) the existing roof system. Part of Phase 1 included installing air barriers at interior partition walls and wall-to-roof intersections. Since these locations were all visible from the interior, the air seals had to be concealed using painted ornamental sheet metal designed to “blend in” with adjacent components. Phase 2 included the addition of interior air barriers between the natatorium and adjacent zones, as well as removal of the exterior masonry to install an air barrier in the exterior walls at the roof eaves.

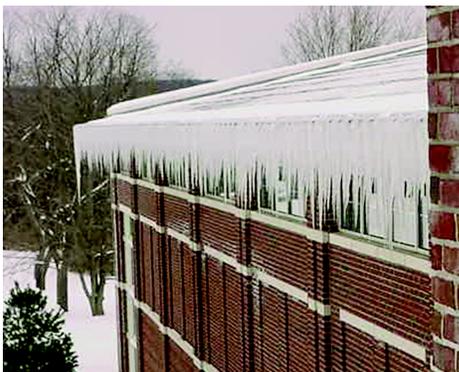
**Figure 2** Heavy icicle formation at roof eaves.

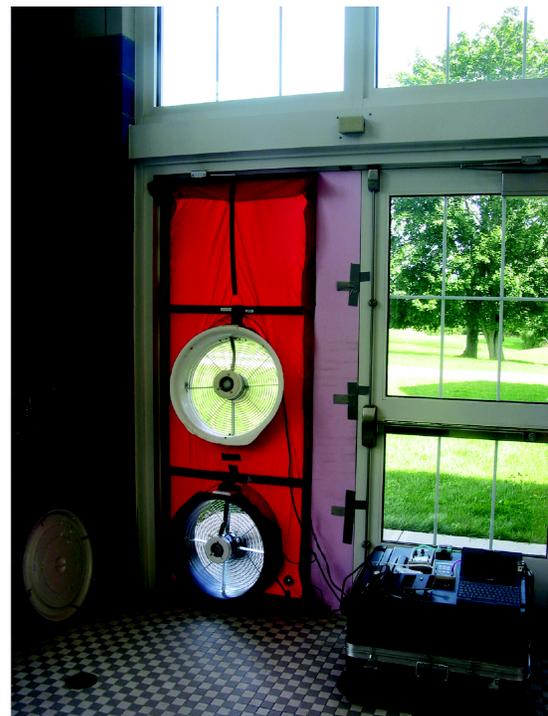
In addition, we measured the overall air leakage through the building enclosure using a dual-fan blower door assembly (Figure 3) performed in accordance with ASTM E779.

**Figure 3** Dual-fan blower door used to test whole-building air leakage rate.

min]). The magnitude of air leakage through the enclosure indicated massive gaps in the building enclosure and the lack of a complete air barrier system.

Following the Phase 1 repairs, we performed a second blower door test to measure the air leakage rate through the building enclosure. Prior to our testing, we reviewed the American Society of Heating, Refrigeration, and Air Conditioning Engineers (ASHRAE) requirements for air pressure control in natatoriums. ASHRAE recommends that the air pressure within natatorium spaces be maintained approximately 12 to 37 Pa (0.048 to 0.149 in. of water) below the exterior (or adjacent interior) space. At a differential pressure of -12 Pa, we measured an overall airflow of approximately 3260 L/s (6900 ft<sup>3</sup>/min) through the natatorium enclosure.

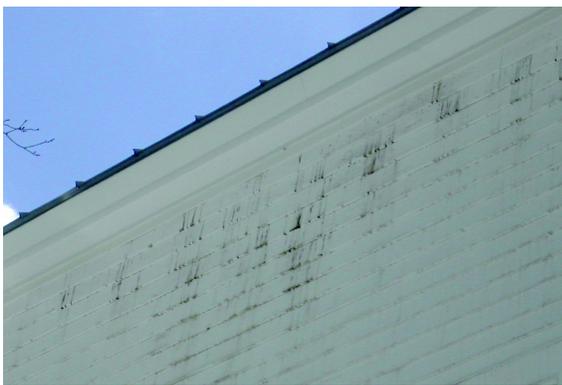
We found widespread staining of the exterior siding, originating at the roof eaves and extending downward several feet (Figure 9). In some areas, we could see reddish-brown drip marks emanating from the lap joints between clapboards. At one set of strip windows, icicles had formed on the exterior clapboards, again emanating from the clapboard joints (Figure 10). We did not observe this phenomenon anywhere but below the windows and roof eaves. Upon closer inspection

**Figure 9** Dark staining on exterior clapboard siding of museum.

Air leaking through the roof-to-wall joint condensed on cold surfaces near the top of the wall, and the resulting condensation ran down the back of the clapboard siding. Air leakage from the window sills produced similar condensation. Although the cedar clapboards were back-primed, the constant exposure to water eventually led to a phenomenon known as “extractive bleeding.” Extractive bleeding occurs when water dissolves natural substances within the materials (tannins), creating a colored solution that stains the surface of the wood as it flows downward. We observed this process occurring in several areas of the building. Bleeding appeared to be concentrated near the eaves, where the heaviest condensation occurred, although moisture levels far from the air leaks still indicated wet conditions behind the clapboards.

Remedial work to the building was predicated on the condition that disruption to the building operation would be minimized. We developed a phased remedial repair plan to address the air leaks at the main roof eaves first, with the understanding that secondary air leaks around the building may become problematic once the primary leaks are “plugged.”

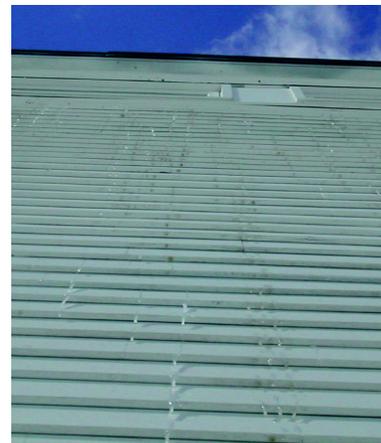
**Figure 10** Icicle formation below windows on exterior clapboard siding.

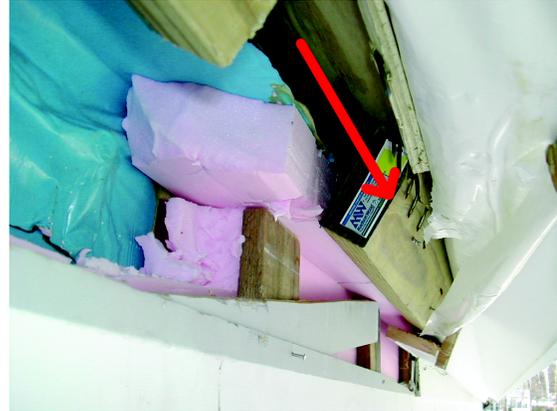
*Figure 11 Primary air leakage path at roof eaves, where wall membrane terminates below the roof.*

The high moisture content of the clapboards that we sampled indicated that they had been exposed to high moisture levels for an extended period of time. The primary air leakage path in the exterior enclosure was the roof-to-wall joint, where the air barrier on the wall was not sealed to the roof. Even if the plastic sheet on the roof was continuous and airtight, the joint between the membrane and the plastic would not be as reliable as a membrane-to-membrane joint. At interior conditions of 21.1°C (70°F) and 40% RH, condensation would occur on all surfaces below approximately 7.2°C (45°F). Given the location in the northeastern U.S., airflow into the exterior walls through the discontinuous air barrier would produce condensation in the wall system for a large portion of the year.

Repairs at the eaves consisted of installing wood blocking to cover the gap between the top of the wall and the roof eaves, then covering that blocking with new self-adhered membrane (Figure 12). For the first phase of repairs, the plastic sheeting from the roof was integrated with the new membrane in lieu of removing parts of the roof system.

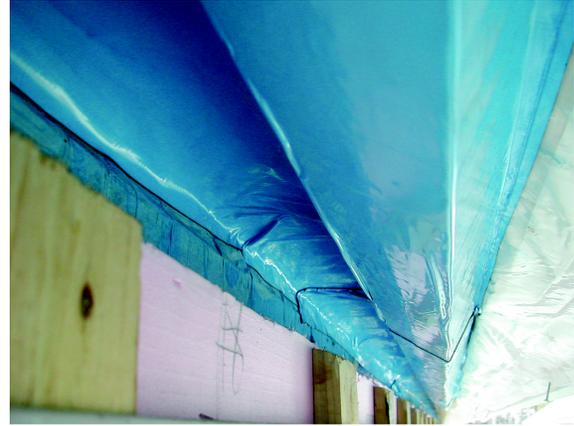
*Figure 12 Initial repairs at roof eaves to address primary air leakage path.*

Following the repairs, we performed a second blower door test using the same parameters as our initial test. We measured a leakage rate of 5.445 L/s/m<sup>2</sup> (0.239 ft<sup>3</sup>/min/ft<sup>2</sup>) (at a pressure differential of 75 Pa [0.3 in. of water]). This represented approximately a 25% reduction in airflow through the building enclosure. Although this was a reasonable improvement, the building occupants reported new staining on the exterior siding during the first few months of the following winter. In response to these reports, we performed an additional IR scan of the building to locate the contributing air leaks. Our scans showed that the “hot spots” due to air leakage at the main roof eaves were greatly minimized by the repairs but that new hot spots had developed in other areas of the building. This was consistent with our expectation that sealing the primary airflow paths in the enclosure may make the secondary airflow paths more problematic. The magnitude of leakage below some of the windows (which were not addressed in Phase 1) had also increased.
