Field Monitoring and Hygrothermal Modeling of Interior Basement Insulation Systems

ABSTRACT

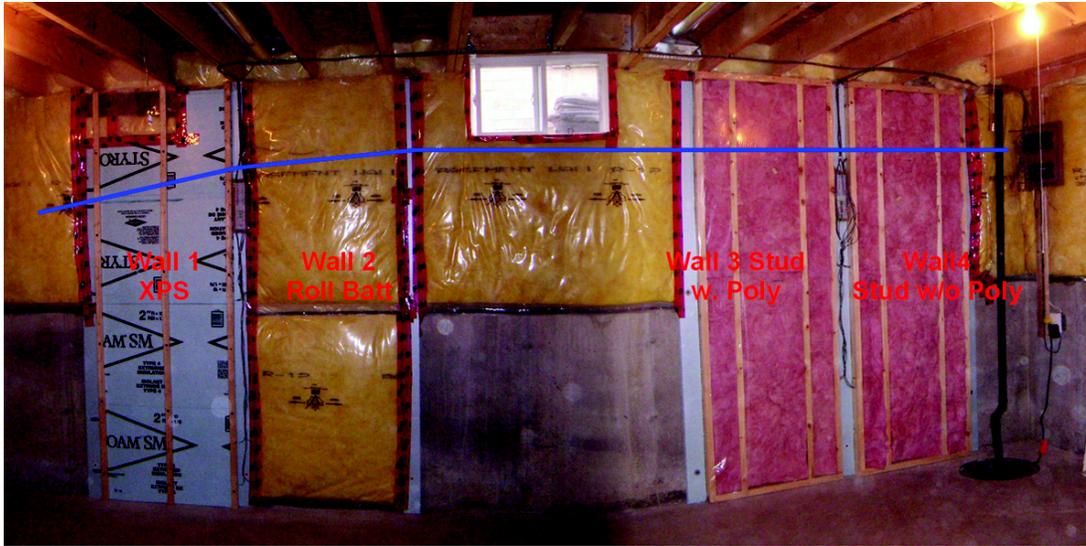
Due to the walkout condition the grade level changes at the side of the house; the test sections were installed to minimize this effect, as shown in Figure 1. Thermal anomalies such as the foundation corner and basement window were avoided. There is a house adjacent to the test walls; it is located 9 feet (2.8 m) away from the test house, resulting in differential solar

Figure 1 Test panels at Kitchener site (pre-drywall); approximate grade level shown.

flows, it still strongly changes the behavior of the assembly. Third, the framing was air sealed, but not vapor sealed at the sides and top of the frame/polyethylene wall. Although vapor diffusion through 1-1/2" (38 mm) of wood is low (0.26-3.6 perms/15-205 ng/(s·m²·Pa); Straube and Burnett 2005), the permeability of polyethylene is so low that this vapor "flanking" could result in a noticeable change in the overall permeability of the assembly. Note that this effect is disproportionately large in this test installation, given the large exposed framing fraction (see Figure 1).

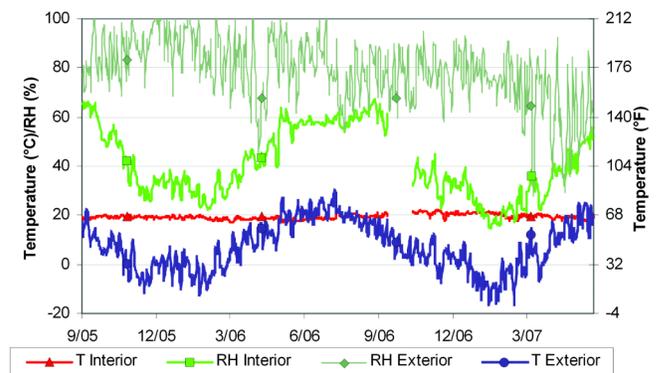
Interior and exterior temperature and relative humidity conditions are shown in Figure 2 (daily average values). Interior humidity varied from a low of 20-30% (wintertime) to 60% (summertime); this is equivalent to wintertime dew points of 25-40°F (–5 to 5°C), and summertime dew points of 50-60°F (10-15°C). This is representative of Canadian basements and matches data collected in a cross-Canada survey of 50 houses by Ruest (1993), which showed wintertime dew points in the same range (–5 to 5°C), except in British Columbia (a more humid and milder Pacific marine climate).

Figure 2 Interior and exterior temperature and humidity conditions (daily avg. values).

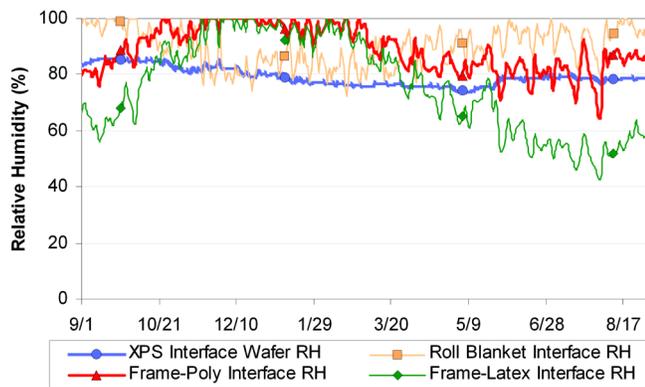
concrete and the insulation (see Figure 3). The sensor is located at the upper part of the wall, which is roughly at grade level. Note that the relative humidity sensor was placed mid-thickness in the batt insulation; the plotted relative humidity values are calculated based on the dew point at the sensor location, and the temperature of the concrete surface. However, the vapor resistance of batt insulation is very low, so this is a reasonable assumption for the purpose of this calculation. In the XPS wall, no RH sensor was available at that location; however, a moisture content wafer was placed at the concrete-insulation interface. Based on previous calibration data and a standard sorption isotherm for wood (Straube and Burnett 2005), a curve fit was used to provide estimated relative humidity values in the XPS wall.

The data show that two of the walls (frame/polyethylene and frame/latex paint) both experience high relative humidity during the winter at the concrete-insulation interface. In contrast, the roll blanket wall has lower wintertime humidities (80-90%), but shifts into the 90-100% RH range during the following summer. In contrast, during the spring and summer, the frame/latex paint wall drops to 50-60% RH, and the frame/polyethylene drops to roughly 80%. During the entire monitoring period, the XPS wall maintains a stable RH, close to 80%. These results indicate that in terms of wintertime condensation issues, both the frame/polyethylene and frame/latex paint wall seem to be at risk. In addition, the results show that inward drying is available in the more permeable frame/latex paint wall: during the summer, it is the driest wall. Also, it is notably drier during the first summer (start of monitoring), compared to the frame/polyethylene wall (which does not allow any inward drying).

Figure 3 Monitored data: relative humidity at concrete-insulation interface; above-grade.

The XPS wall shows a much more stable wafer moisture content, remaining close to 15% throughout the year, which is equivalent to the 80% RH level seen in Figure 3.

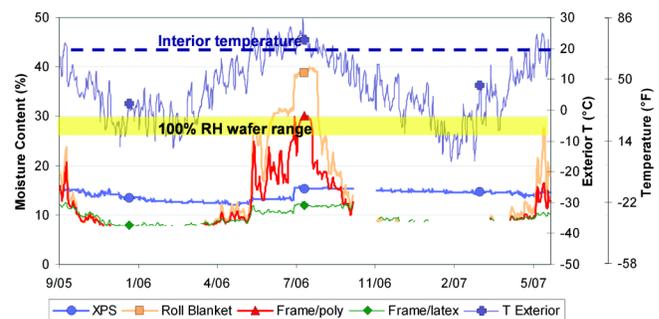
The graph clearly shows the inward vapor drive described earlier: during the spring and summer, the moisture content of the wafer rises sharply. The roll blanket wall shows a greater rise in moisture content (peak at 40% MC) than the frame/polyethylene wall (peaks near 25%). Laboratory calibration of the wafers showed that 100% RH roughly corresponds to 25-30% MC; the roll blanket data indicates liquid water condensation.

The pattern of moisture accumulation at the wafer is tied to outdoor temperature, as indicated by the matching spikes; this is reasonable given that inward vapor drives are proportional to the temperature of the saturated layer (concrete). The interior temperature is roughly plotted on the graph; the wetting of the wafer is tied to an inward temperature gradient. When exterior temperatures drop below interior temperatures (as in fall 2005, and mid-June 2006), the moisture content falls.

Figure 4 Moisture content wafer response, interior side, above grade, with exterior temperature (daily average values).

The frame/latex paint wall, in contrast, does not show this sharp rise in moisture content during the summer. Although there is a slight jump with the onset of warm weather, moisture content peaks at roughly 12%, which is well within the safe range for wood. This indicates that the inward vapor drive passes through the gypsum board and latex paint, and does not accumulate in the cavity.

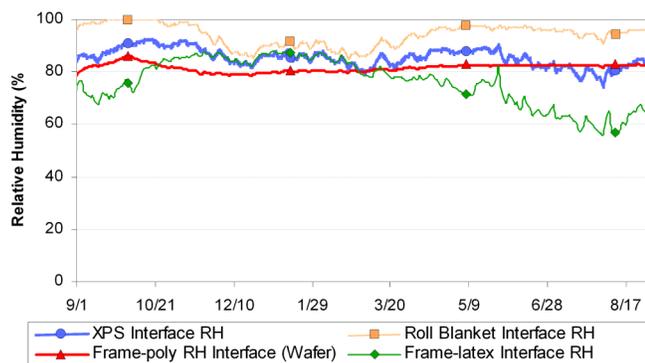
The plot shows that moisture accumulation roughly corresponds to the vapor resistance of the assembly. The polyethylene roll blanket shows the highest sustained RH levels: near saturation in fall, spring, and summer, dropping to ~90% RH in winter. The XPS wall has vapor permeability an order of magnitude higher, and shows RH levels in the 80-90%

Figure 5 Relative humidity, concrete-insulation interface, mid-height (daily avg. values).

range. The frame/latex paint wall has permeability an order of magnitude higher than XPS, and shows the lowest humidity levels (55-85%), indicating drying of the assembly. In this wall, RH values are at their peak during winter when the concrete wall is coldest. The frame/polyethylene wall shows relatively low calculated RH levels (80-85%); this matches data collected after replacement of the damaged RH sensor.

Below Grade. The below-grade simulations presented a smaller challenge for matching temperatures, due to the use of measured boundary conditions, the lack of any solar influence, and the slow temperature variation over time (e.g., all diurnal variations are damped out). Hence, agreement was good between measured and simulated temperatures. Simulation relative humidity levels at the mid-height concrete-insulation interface are shown in Figure 10, which can be compared to the monitored results in Figure 5.

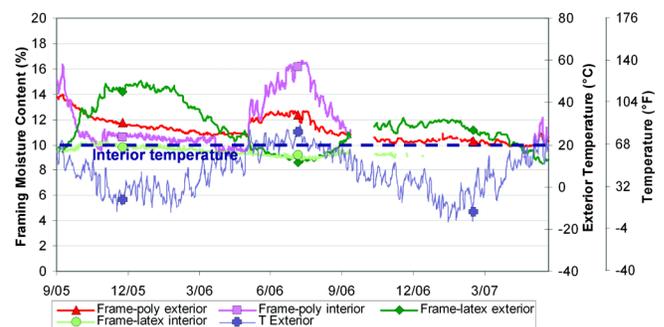
Framing Moisture Content. When assessing the risk of a wall assembly, the danger is not necessarily condensation *per se*, but mold growth and damage to moisture-sensitive portions of the wall, such as the framing. The moisture content of the framing at the upper portion of the wall is plotted for the monitored period in Figure 6. Moisture contents were measured at the inboard and outboard edges (3/8" or 9 mm from the faces) of the stud. The summertime increases in the frame/polyethylene wall are seen at the interior side, similar to the moisture content wafer; however, peaks are roughly 17% MC, which is in the safe range. A similar rise in wintertime moisture content is seen at the outboard side of the frame/latex paint wall; again, the MC remains within the safe range (15% peak). Overall, moisture contents at all of these upper framing locations presented minimal concern for mold growth; based on close to two years of data, the cycles do not appear to worsen over time.

Figure 6 Framing moisture content for upper portion of stud walls.

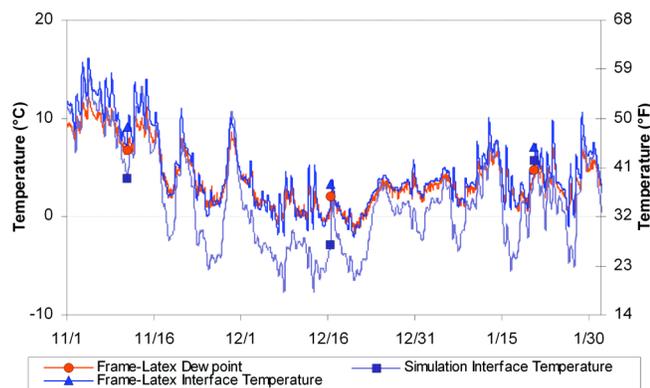
Above Grade. Using the boundary conditions described above, three of the test assemblies were simulated: XPS, roll blanket (fiberglass & polyethylene), and frame/gypsum board with latex paint. Typically, the first step for validation is to compare temperatures through the assembly for correspondence, and then to compare moisture levels. However, the model shows a lack of temperature correspondence, especially in the winter, as shown in the plot of the temperature (and dew point) at the concrete-insulation interface, Figure 7. The model predicts temperatures that drop to 19°F/-7°C, while measured data is substantially warmer, with minimums of 28°F/-2°C. Typical differences between measured and

Figure 7 Upper height concrete temperature, monitored vs. model (winter detail).

coupled to a hygrically massive material such as concrete. In Figure 7, the dew point falls somewhat below the concrete surface temperature, but not by a large margin—nowhere near the 18°F/−8°C lows seen in the simulation.

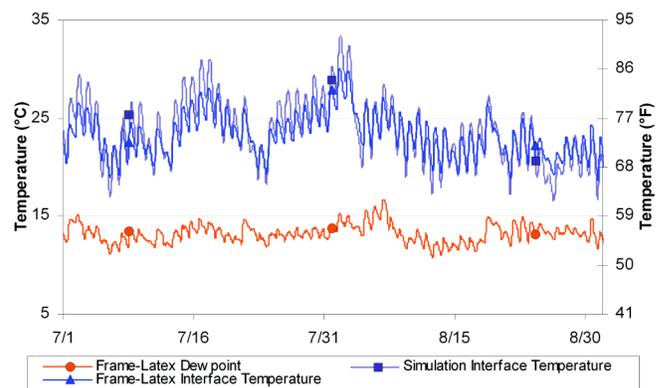
modeled are much smaller in summer; as shown in Figure 8; peak differences are roughly 5°F/3°C, and only occur during daytime peaks. Also, part of that difference might be explained by shading from the adjacent house (not included in the model).

Figure 8 Upper height concrete temperature, monitored vs. model (summer detail).

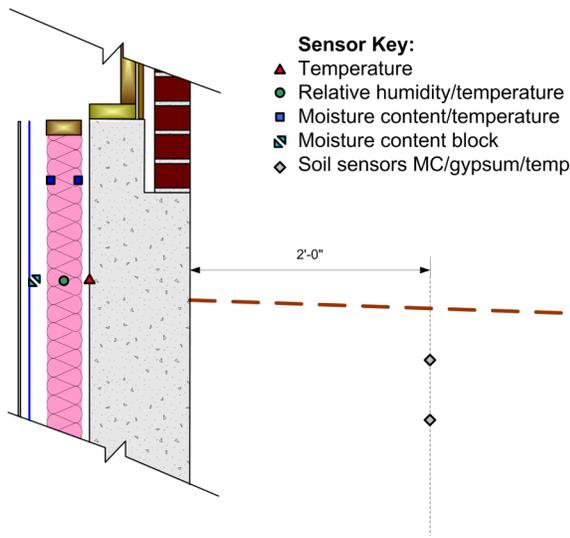
Another question is whether the specific placement of the temperature sensor (at grade level) causes this poor correspondence when using above-grade boundary conditions. For instance, it seems plausible that the upper portions of the above-grade concrete wall are closer to modeled behavior. However, wintertime measurement of the vertical temperature distribution showed that the above-grade wall was at the same temperatures as the sensor location. In addition, the dew point in an assembly cavity with high vapor permeability tends to be "pulled down" to the lowest temperature in the cavity, when

Figure 9 Detail of the above-grade monitoring location.

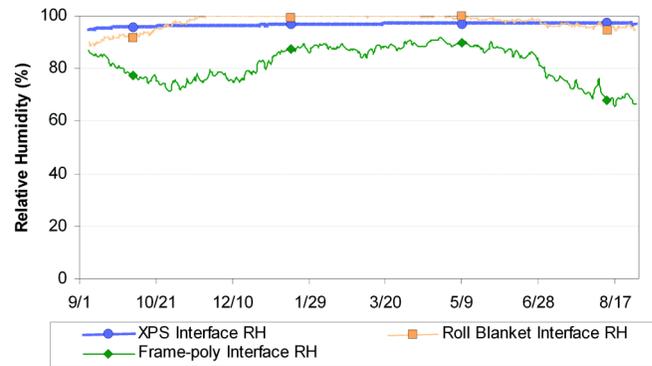
The behavior of the two low-permeance systems (roll blanket and XPS) is quite different from monitored data. In the simulation, relative humidity levels quickly rise to the 95–100% range for both of these walls, and remain at that level for the rest of the simulation. In contrast, the monitored data shows humidity levels of 85–100% for the roll blanket, and 80–90% for the XPS.

Figure 10 Simulation data: mid-height RH at concrete-insulation interface.

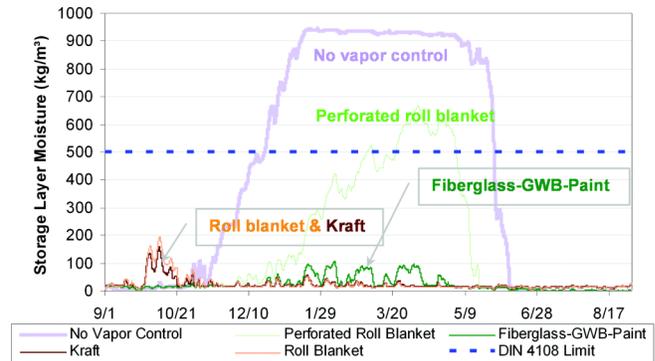
Figure 11 Condensation layer moisture accumulation, Toronto wintertime above grade, low RH.

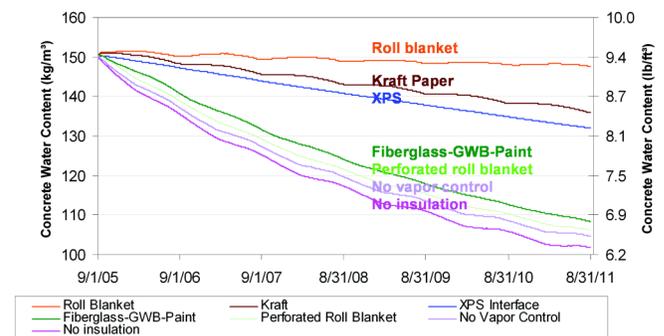
Figure 12 Concrete water content, lower location, “low” humidity conditions.
