Evaluation of Water-Resistive Barrier Performance in Stucco Walls

Neil P. Leslie, PE

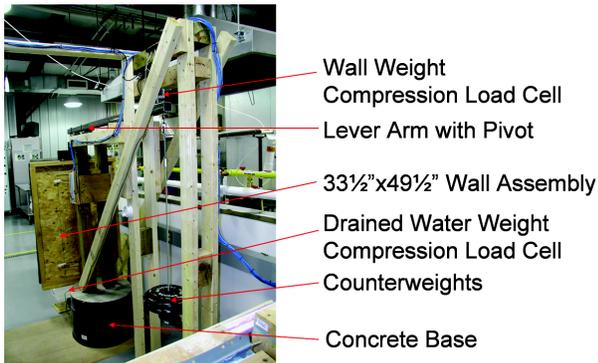
The load cell test stands were designed and constructed at the laboratory to provide precise measurements of wall assembly weight (Figure 1). Each test stand included

Figure 1 Wall weight load cell apparatus.

Wall assemblies were hung from each fixture and counterweights were added to provide approximately 5 lb (2.3 kg) net weight on the compression load cell (20% of full range) when dry.

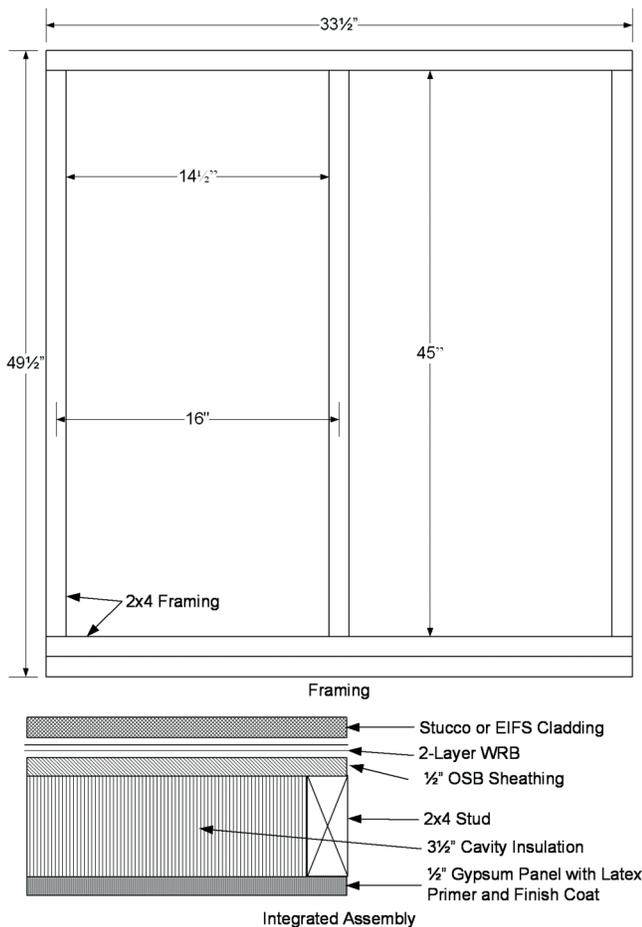
Figure 2 Stucco wall assembly construction for moisture measurement experiments.

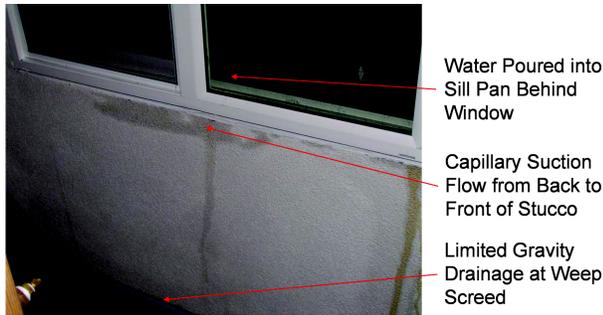
Water Drained Slowly from Sill Pan, with Capillary Moisture Transport to Front of Stucco Dominating Gravity Drainage

Figure 3 Capillary-dominated drainage with water poured into sill pan.

Stucco drainage mechanisms impacted WRB drainage capacity and leak risk. Capillary moisture transport (liquid wicking/soaking) provided relatively slow drainage at the interface between stucco and the WRB and transported liquid water to both sides of the stucco cladding as well (Figure 3).

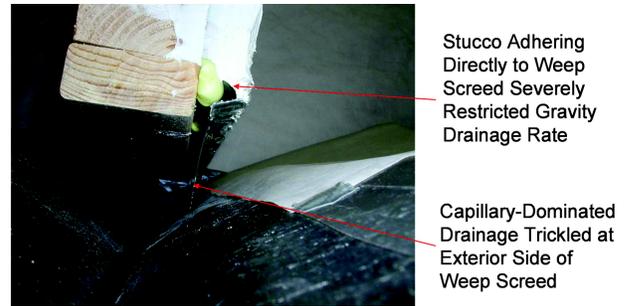
Capillary-Dominated Drainage Capacity Was an Order of Magnitude Lower Than Effective Gravity Drainage

Figure 4 Drainage channel at weep screed for three-coat stucco wall.

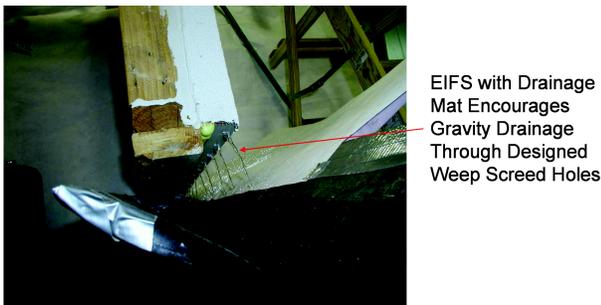
Gravity Drainage Dominates in EIFS Wall with Drainage Mat and Designed Weep Screed with Functional Holes

Figure 5 EIFS drainage through screed.

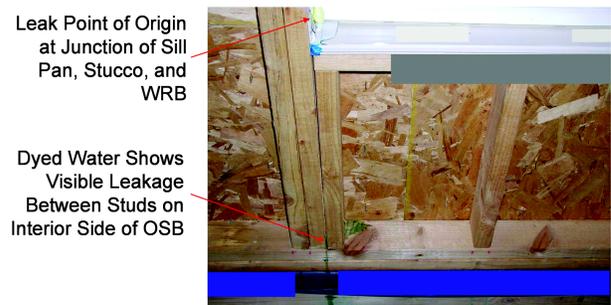
Leak to Interior Side of OSB Sheathing Due to Capillary-Dominated Drainage and Head Pressure from Water in Sill Pan

Figure 6 Leakage with sill pan and OSB sheathing.

Reduced gravity drainage capacity from capillary-dominated moisture transport caused leaks from bulk water collected by sill pan flashing. Sill pans effectively collected water leaking through window frames. However, bulk water under head pressure (due to height between the sill pan and leak site with restricted drainage) leaked through small holes in the WRB at sill pans/WRB joints or through staple holes (Figure 6). Bulk water collected by the sill pan did not leak

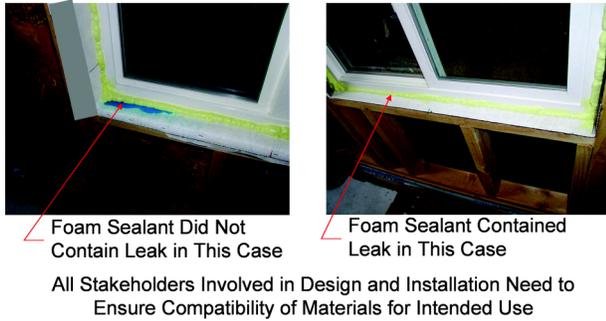
Figure 7 Leak with foam sealant due to misapplication/incompatibility.

Low pressure expanding foam sealant (an air barrier) improved WRB performance at the sill in some cases (Figure 7). The sealant contained leaks when a full seal was achieved. The sealant did not contain leaks when misapplied or incompatible with its substrate.

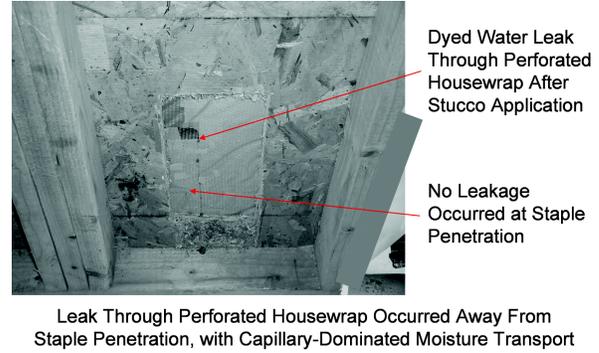
Figure 8 Leak through perforated housewrap during 15-minute blue dye spray test.

Perforated housewrap leaked through perforations with and without stucco cladding. No observable leaks occurred on the interior side of OSB sheathing at window/wall interface. However, leaks occurred when the moisture drainage mechanism was either liquid water or possibly capillary moisture flow after application of stucco cladding based on destructive disassembly (Figure 8).

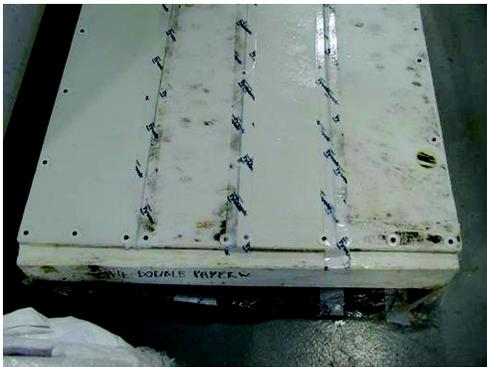
Figure 9 Mold-resistant panels vs. conventional gypsum panels.

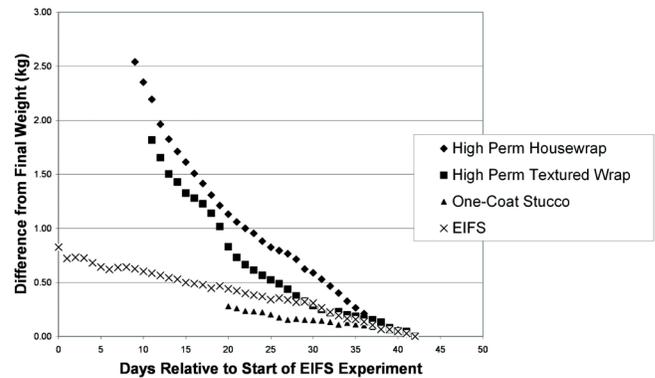
Figure 10 Wall weight profiles normalized to end date.

Wall assembly moisture weight profiles showed differences in evaporative drying rates for different cladding and insulation options. Both walls with exterior insulation were similar to each other and dried more slowly than the two walls with housewrap and no exterior insulation, which were also similar to each other (Figure 10). Heating the gypsum pane with infrared lights slightly increased the drying rate of each wall.

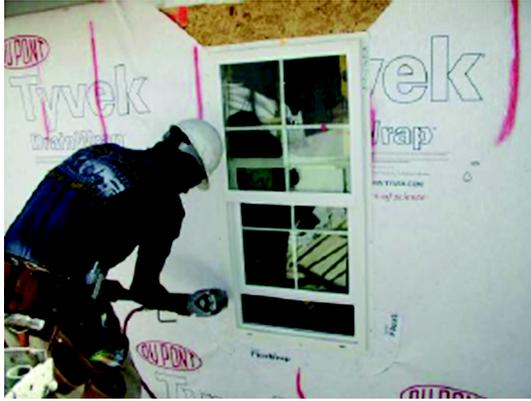
Figure 11 Window installation, ASTM E 2112-01R Method A1.

Demonstration homes were production homes built over a nine-month period using commercially available products. All demonstration homes were sold to consumers. Innovative assemblies and practices incorporated into demonstration homes included several WRB options and related construction sequence, self-adhering flashing options, ASTM E2112-01R window installation methods (Figure 11), mold-resistant

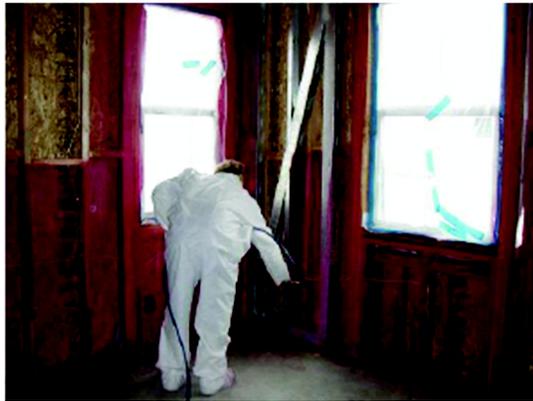
Figure 12 Application of mold-resistant sealer.

sealer (Figure 12), mold-resistant interior gypsum panels, and bath ventilation control.
