Failed Fenestration: New Materials Require New Techniques

James D. Katsaros, PhD

Barry G. Hardman

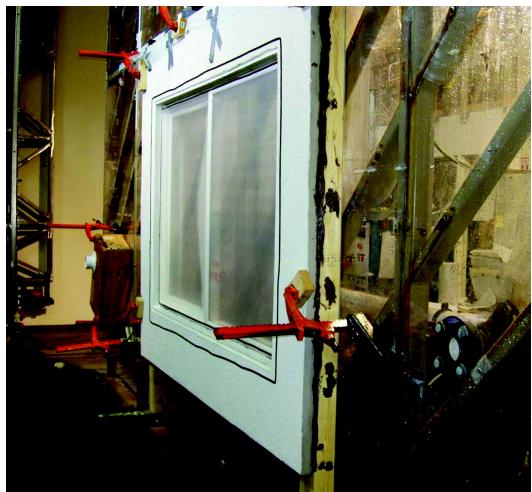
Figure 2 Testing of four-sided receptacle integrated with a waterproof membrane.

The photographs in Figure 2 depict the testing of a prototype system which employs a 4-sided receptacle that is easily integrated with a waterproof membrane. In this case the claddings were part of an EIFS system; however, the same technology can be utilized for any cladding over a waterproof membrane. Figure 3 is an exploded view of a receptor installation into a wall. The photographs below were of testing of the complete wall assembly including the receptor and window, completed at ETC Laboratories in 2005, where the system was tested using ASTM E 283 for air, ASTM E 331 for water, and ASTM E 330 for structural.

- ASTM E 330 Test Method for Evaluation of Structural Performance – The combined wall and fenestration products achieved a 45 psf positive and negative using a fenestration product that was rated at 25 psf.
- ASTM E 331 Test Method for Static Water Penetration - The combined wall and fenestration products achieved 12 psf for 15 minutes.

- ASTM E 289 Air Infiltration - Both combined wall/fenestration products measured 0.03 cfm per square foot (54 sq. ft. samples).

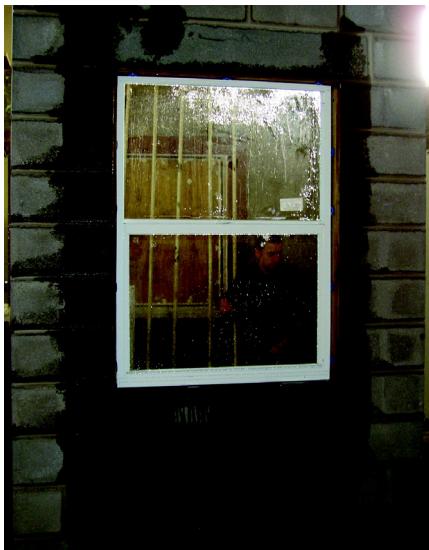
Figure 5 Interior view of saturated CMU.

no stucco coat. Windows were installed per Florida building code. See Figure 5.

A spray rack was placed on the exterior of the wall in accordance with ASTM E 331. The wetting pattern seen in Figure 5 shows 100 percent saturation of the CMU block on the interior. The pattern of wetting mimics the outline of the chamber that was placed on the interior. The test was stopped after 5 minutes of a usually 20-minute test because the water pouring through the CMU was uncontrolled. Cracks in the mortar and the concrete sill displayed water leakage within 5 seconds of the administration of the water on the exterior, and before any negative pressure was applied to the chamber.

From the tests described above and the results seen in Figure 5, which investigated the various pathways of leakage and the weakness in the current system, a new and revised mock-up wall was built, which incorporated principles not currently utilized in the southeast United States.

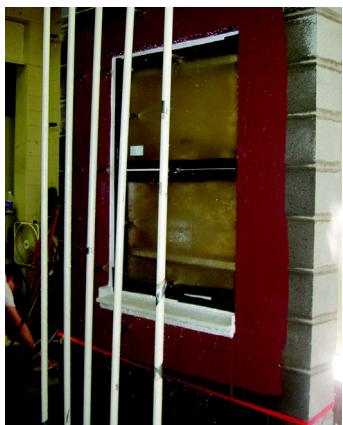
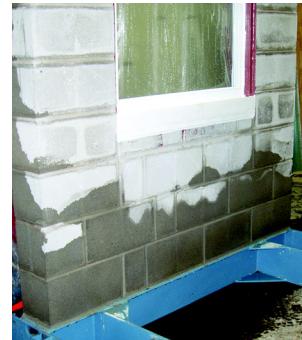
Figure 8 Interior wall after testing.

Figure 8 shows the interior of the wall after undergoing both ASTM E 283 air test and E 331 water test. With the coatings and proper application of the sealer, along with the plastic sill, the air infiltration was 0.15 scfm, or none. The water test was conducted for 20 minutes at 9 pounds pressure. Note: no

water leakage occurred around the interior perimeter of the window, either through the lintel or under the sill.

With the window specimen completely sealed with plastic the specimen passed 24-minute water tests at DP 55. With the window installed in the in-situ condition, the specimen passed 24-minute water tests at DP 55 for 3 cycles and at DP 60 for 1 cycle.
