# Feasibility of Using Wind Barriers as Air Barriers in Wood Frame Construction

## ABSTRACT

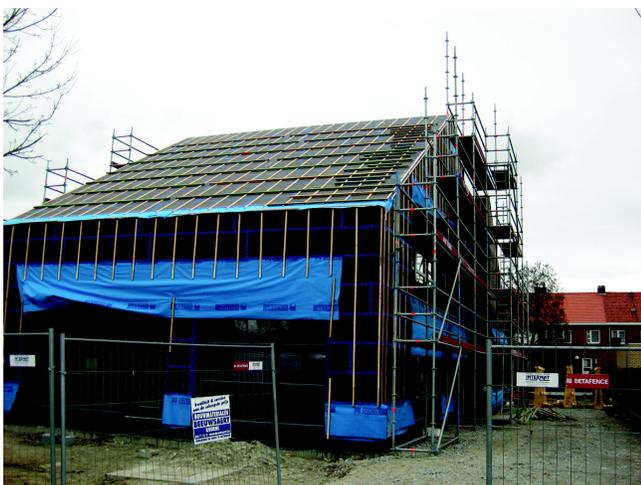
**Figure 1** (a) Wind barrier during construction stage and (b) overall view of the finished house (west and south façades).

\* Most of the joints are located at the corners of the house. Consequently, they cannot be assigned to an orientation in this table. Only the south façade contains wall-to-wall joints, as depicted in Figures 1a and 1b.

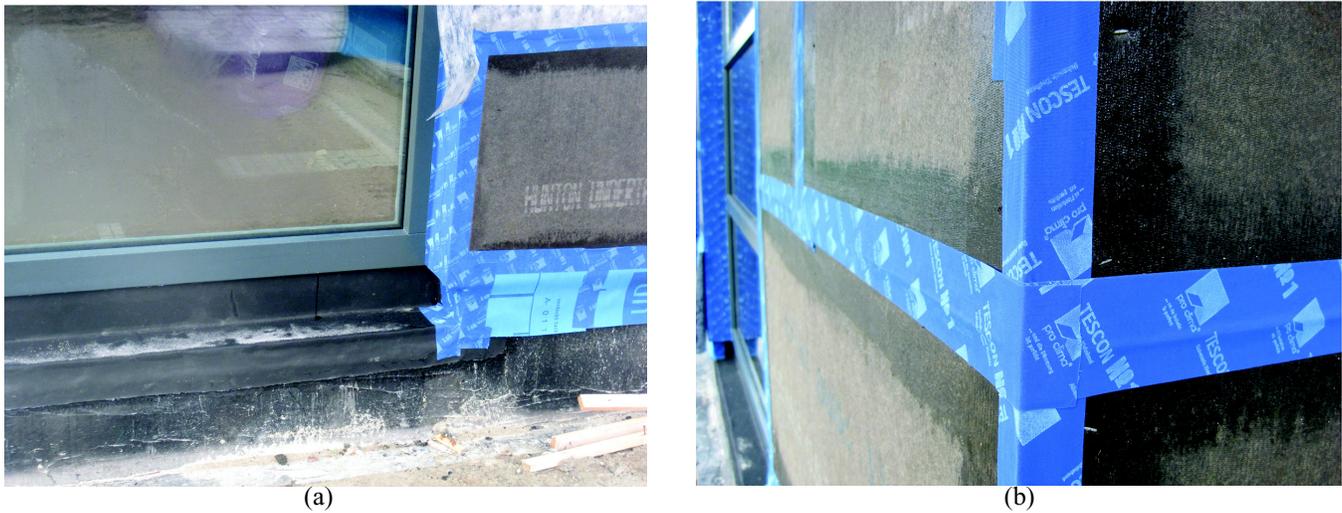
**Figure 2** (a) Wind barrier sealed to foundation and window and (b) sealed connection between two walls and taped tongue-and-groove joint.

Figure 2a shows how the wind barrier is sealed at the windows and at the foundation. Figure 2b illustrates the sealed tongue-and-groove joints and the connections between two walls. To ensure adhesion of the tape on the external fiberboard, a frost-free primer is applied to the joints before sealing.

already injected with polyurethane (PU) foam at seven windows. This implies that there is no measured value available with only the wind barrier installed and none of the joints sealed. Nevertheless, as will be shown later, this value can be derived from the measurement with only seven windows injected and the measured value with all windows injected, taking into account the length of the joints. In step 3, all window and door joints were sealed onto the wind barrier (Figure 2a).

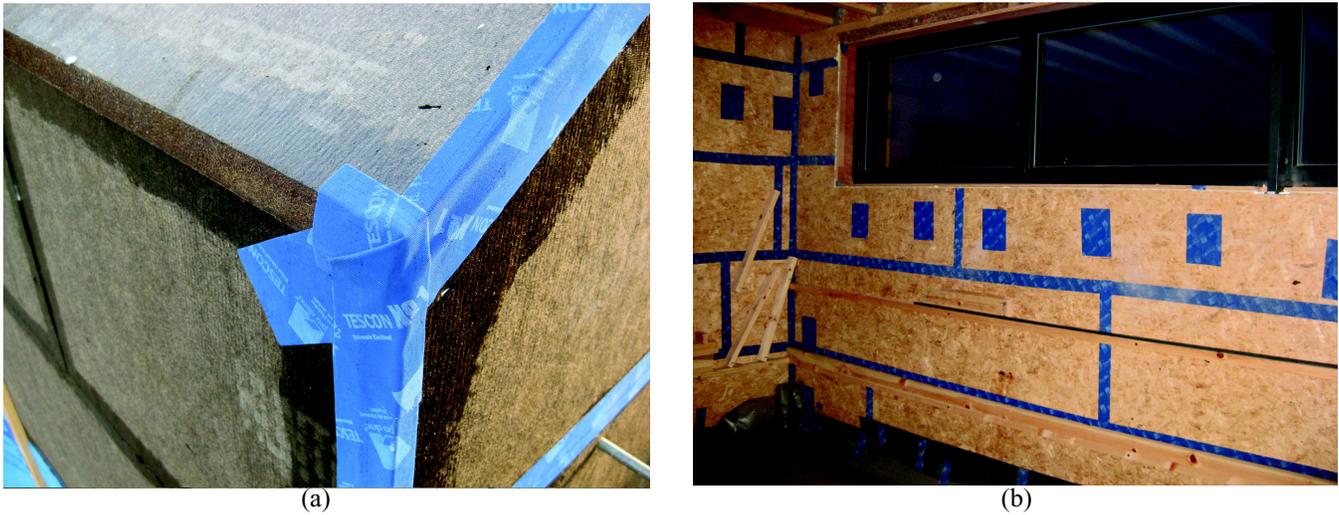
**Figure 3** (a) Connections between wall and roof during sealing phase and (b) sealed tongue-and-groove connection between OSB and sealed inflation holes.

As shown in Figure 3, the connection between the wall and the roof is continuous, which makes the sealing of this joint relatively easy. When the wind barrier joints were completely sealed, the cellulose insulation was blown from the inside through holes in the OSB.

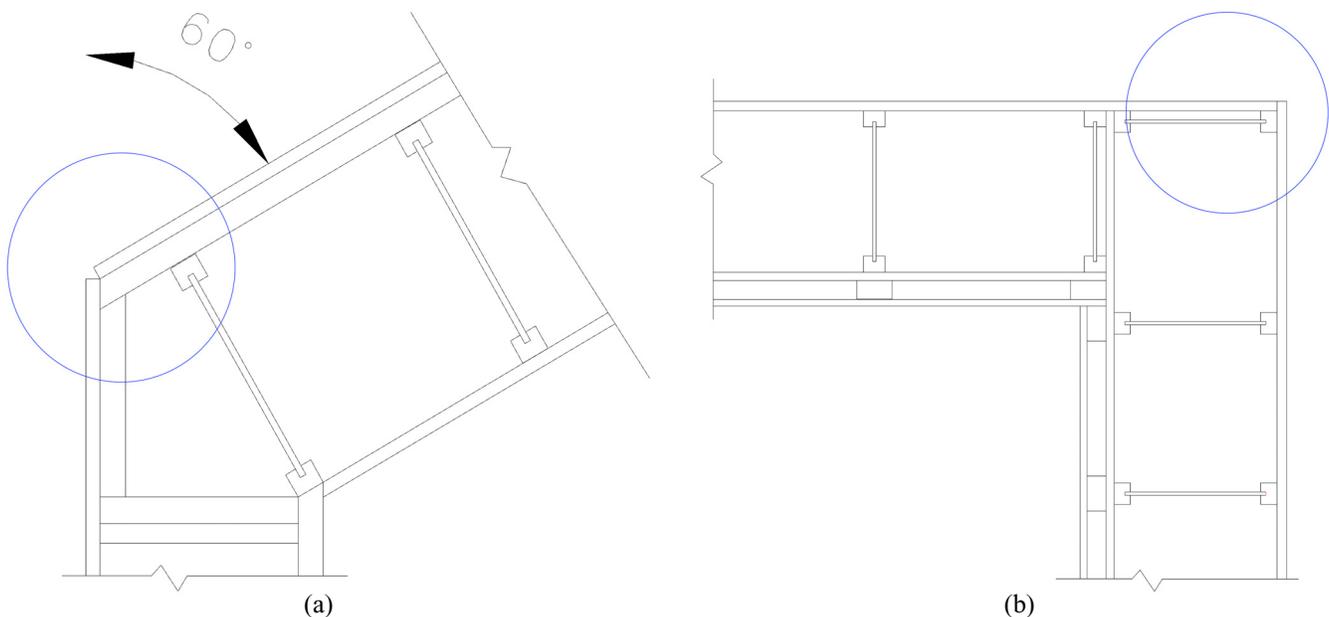
**Figure 4** (a) Wall-to-roof connection ( $30^\circ$ ) of the wind barrier in the west and east façades (21 m [69 ft]) and (b) connections between the walls ( $90^\circ$ ).

In step 4, the wind barrier was connected to the foundation. The next step consisted of sealing all the wall-to-wall and roof-to-wall joints. Since there were only three scaffolds on-site, this step was split into steps 5 and 7. In between, the tongue-and-groove connections in the wind barrier on the north, west, and south façades were sealed. In step 5, already 88 m of the joints were sealed and in step 7 the last 11 m (36 ft) were taped. These corner joints should be differentiated between the ones that describe an angle of  $30^\circ$  (21 m [69 ft]) and the joint that describes an angle of  $90^\circ$  (77 m [253 ft]). Unsealed, less air will escape through the corners of the  $90^\circ$  angle since these joints have more contact and are supported over the entire length by the studs, as depicted in Figure 4.

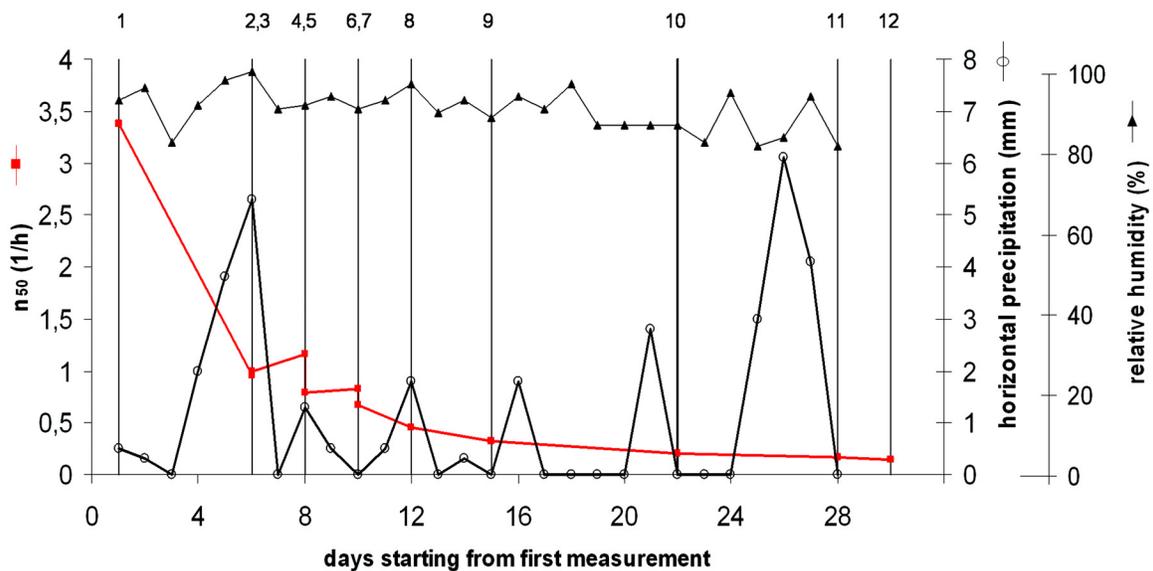
Figure 5 Evolution of the airtightness in the consecutive construction stages (corresponding with Table 2) against the daily horizontal precipitation (mm) and relative humidity (%).

To visualize the influence mentioned above, the evolution of the airtightness is plotted against the daily horizontal precipitation (mm) and the daily outdoor relative humidity (%) in Figure 5. The measurements were performed during the winter, corresponding to high outdoor relative humidities (75%–98%). These averaged weather data were collected every 5 minutes from a Davis Vantage pro 2 station located 3 km from the tested house.

It can be seen that although increased air sealing improvements were completed at each stage, the  $n_{50}$ -value increased between steps 3 and 4 and between steps 5 and 6. Those results can be attributed to the corresponding drying of the wind barrier during these steps. Furthermore, the importance of the moisture content of the wind barrier on the airtightness is confirmed by measurements 7 and 8. Both measurements were conducted in the same construction stage, with the weather being the only variable. At this level of airtightness the increased moisture content of the wind barrier reduces the overall airtightness by more than 30%.

from Figure 5, this is most probably a small overestimation due to the increasing moisture content of the wind barrier during this period.
