Why Do Green Building Enclosures Fail and What Can Be Done about It?

ABSTRACT

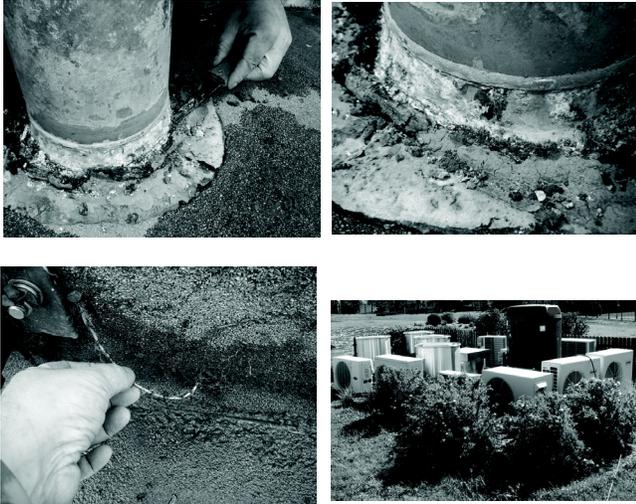
Example 1. The implementation of some green strategies may require that standard components or assemblies be adapted, as this example illustrates. In this case, a green roof was incorporated into the design of the building, as shown in Figure 1. Within two years, water infiltration was reported. The investigation revealed that the aluminum base of the plumbing vents was perforated, at the junction with an extension sleeve. To accommodate the extra height due to the planting medium, it had been necessary to extend the plumbing vents. The problem is that the sleeves were made of stainless steel, which is a noble metal in comparison to aluminum. The combination of these two metals with a very moist environment (the planting medium) led to galvanic corrosion.

Other issues were also identified. As visible in Figure 1, there was no membrane in the system to inhibit root growth. The waterproofing membrane was then directly exposed to the roots, reducing its service life. Furthermore, all the mechanical

Figure 1 Roof case study: aluminum drains are perforated at the base (top pictures); lack of anti-root membrane leading to root growth and deterioration of the waterproofing membrane (bottom left picture); and mechanical equipment located in a cluster (bottom right picture).

equipment was located close together, making it difficult, if not impossible, to achieve proper waterproofing and to maintain it in this area.

The implementation of a green roof, a popular strategy in green buildings, is by no means revolutionary. Systems with good performance records are available and have been installed successfully. However, there are specific considerations such as a potentially wetter environment, living components as part of the assembly, and, although the membrane is protected from UV rays, increased difficulty in accessing the membrane for maintenance and replacement. The selected components should therefore take these constraints into account. One can also see that coordination with the mechanical engineers and long-term vision are paramount.

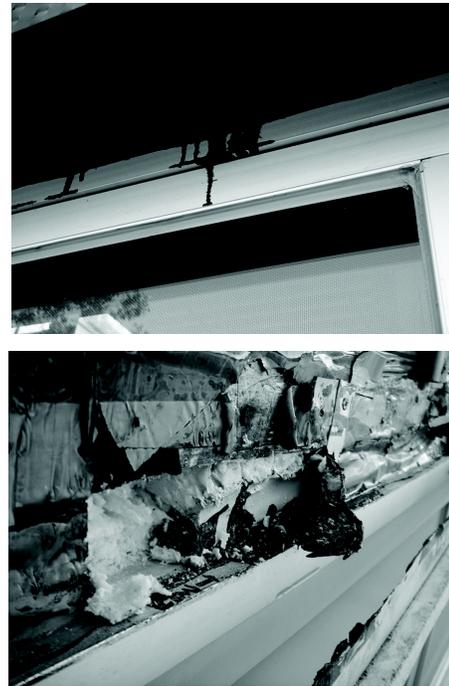
High-performance windows were installed in this wall assembly. After a few years, unsightly bitumen streaks were reported at the window head. An exploratory opening performed at the head of the window revealed that the self-adhered membrane had been applied over a polyurethane sealant. The bitumen of the membrane was completely gone (parts of it were on the window frame, as shown in Figure 2), but the sealant was still in good condition. Eventually, the disintegration of the flashing membrane would have led to water infil-

Figure 2 High performance window case study: Bitumen streaks on the window frame (top); disintegrated flashing membrane but fairly intact sealant with water accumulation and infiltration at head of the window (bottom).

tration. Although it had not gone inside, water was found to have accumulated at the head of the window.

In this example, building science principles, namely taking into account compatibility between materials, were not properly applied. The materials themselves and the issue are not specific to green buildings. However, maintenance and remedial work were greatly complicated by the configuration of the cladding system and shading fins, which had been selected as green features. Here, the improper application of building science principles is complicated by a lack of an integrated and long-term vision.

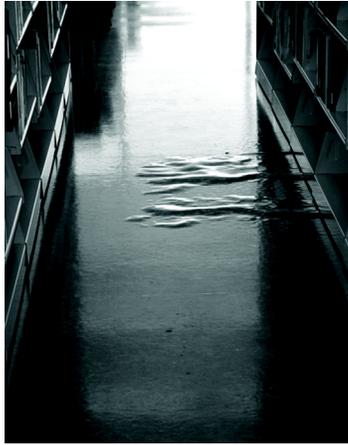
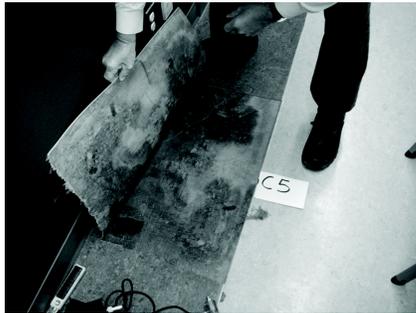
Example 3. The last example relates the case of a linoleum floor installed on a slab on grade with an adhesive without formaldehyde (Figure 3). After a few years, problems with the adhesion of the floor were reported, which were found to be caused by the presence of moisture under the flooring material. When portions of the flooring were removed to investigate, extensive mold growth was observed: the adhesive that had been used did not have formaldehyde but it also had nothing to inhibit the growth of mold.

Figure 3 *Floor case study: blistering of the linoleum flooring (top) and mold growth under the flooring material (bottom).*

This example highlights how important it is to understand products' properties. Greener versions of existing products are available, but it is important to understand their properties and make sure they will be suitable for their exposure conditions.

In this case, the adhesive may be fine for an upper floor where there would be no danger of water, but was probably too sensitive for application on a slab on grade (which had a moisture problem to begin with). The specifier should have asked questions of the representative about installation, location, properties, adhesion, etc.
