Case-Study Analysis on Hygrothermal Performance of ETICS on Concrete Wall after Low-Budget Energy Renovation

ABSTRACT

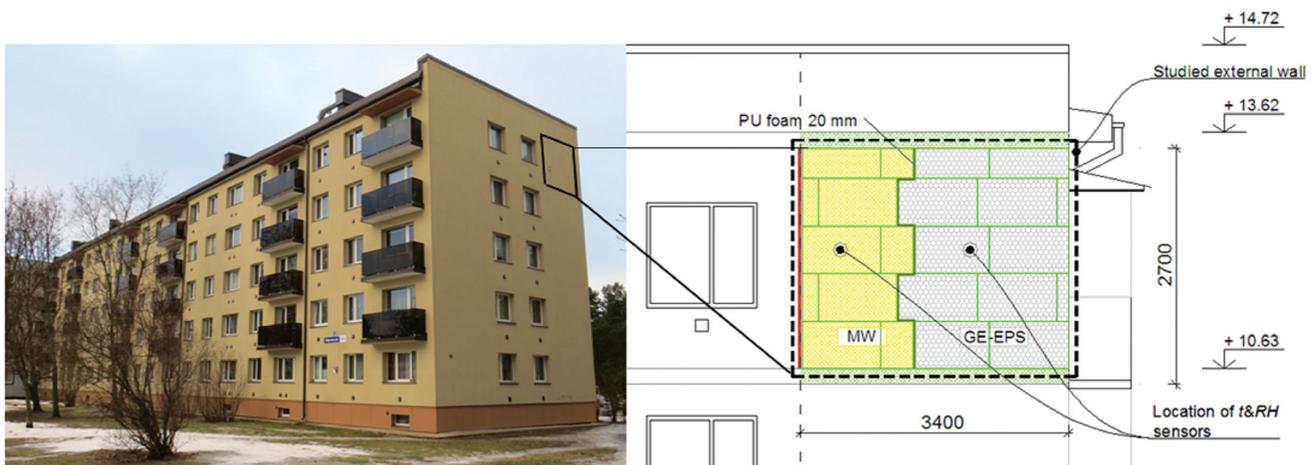
Figure 1 View to the external wall with measurement areas of ETICS.

The case-study building is a five-story block of flats (Figure 1) constructed during 1966 with prefabricated large panel concrete elements. That type of construction was typical in Estonia during the period between 1961–90. Approximately half of apartment buildings in Estonia are composed of prefabricated concrete large panel elements.

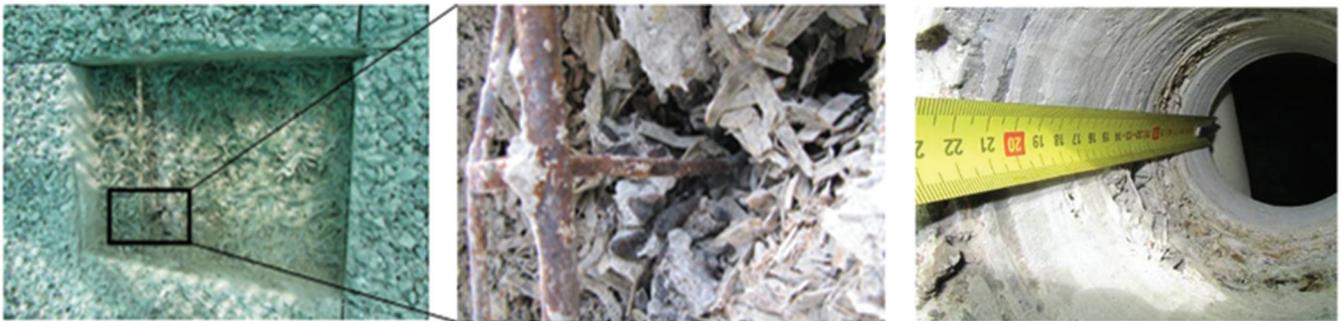
Figure 5 Reinforcement steel between layers of concrete has started to corrode (left and middle). In principle, this steel should be cast into expanded clay concrete, but in reality it is often not so. Cross-section of a concrete wall element (right).

External walls of the analysed building were composed of large-panel prefabricated concrete elements. Fourteen centimeters of wood-cement chip board (thermal conductivity $\lambda \sim 0.12 \text{ W/[m}\cdot\text{K]}$) was used for insulation between two layers of concrete and external surface is covered with rubble bulk. The main problems related to external walls are thermal bridges, corrosion of reinforcement, frost resistance, and large thermal transmittance. The layer between insulation and external concrete core is not ventilated but slightly drained (small tubes installed into the intersection of movement joints). The external core can become wet due to vapour condensation and wind-driven rain. This means that frost damages of concrete and corrosion of reinforcement can occur. Structures and technical condition of a building are shown in Figure 4–6.

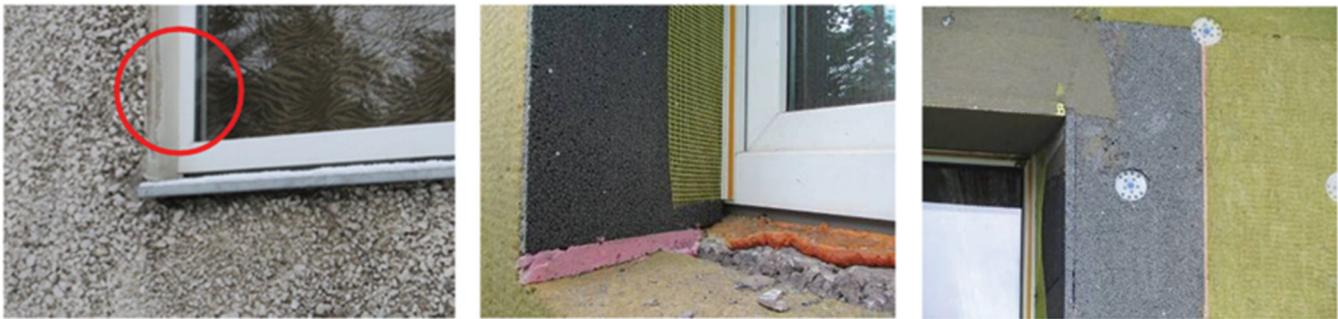
Figure 10 Picture of an old window (left) and of new windows placed at their original position. Most of the jamb is covered and only a thin layer of insulation (5...20 mm) can be attached to the jamb.

It is not possible to install a sufficient layer of insulation (>30 mm) to the window jambs because of the shape of the concrete element that windows are attached to, see Figure 10. To avoid serious thermal bridges around the

windows, all the windows should be placed to the external side of the existing concrete element that moves them more in-line with the additional exterior insulation.
