Construction and Field Monitoring of Exterior Walls Using Vacuum Insulation Panels (VIPs) in a Net Zero Home

Anil Parekh, PEng
Member ASHRAE

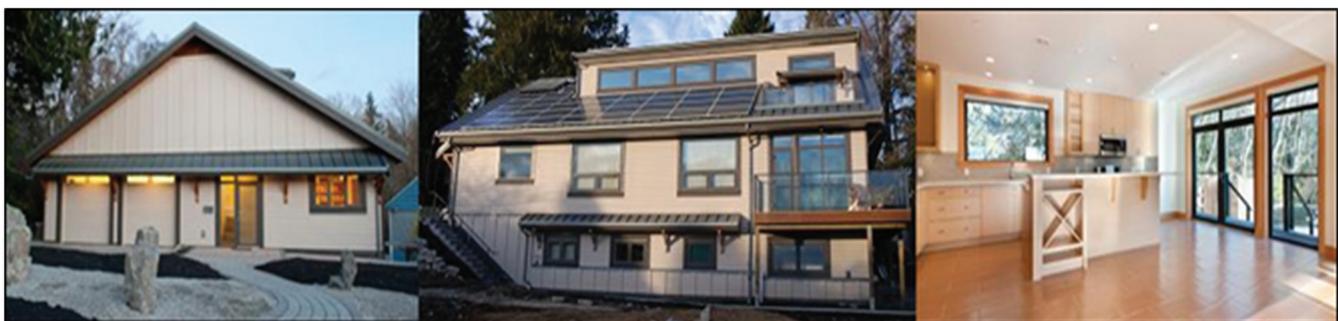
Figure 2 Harmony House Net Zero Energy House front; south elevation showing triple-glazed windows, photovoltaic array and solar domestic water heating system; and interior. (source: www.harmony-house.ca).

The first known Canadian field demonstration of VIPs is in Burnaby, British Columbia near Vancouver, shown in Figure 2. This is a coastal marine climate with heating degree-days of 2925°C (5265°F). The Harmony House project team, successful winner of CMHC’s EQuilibrium™ Sustainable Housing Demonstration Initiative, has built exterior walls using VIPs (CMHC 2010). The Harmony House is a two-story, 438 m² (4714 ft²) home with a basement that includes a self-contained secondary suite and an attached garage.

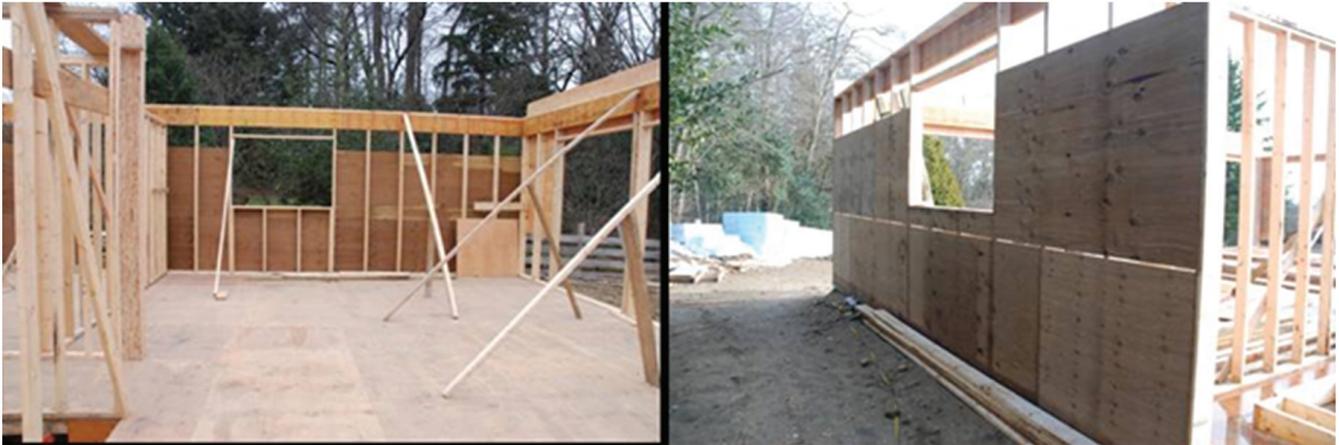
Figure 4 Left photo showing north kitchen wall 38×140 (2×6) advanced framing and second floor rim joist. The let-in laminated veneer lumber (LVL) rim joist allows for the vacuum panels to run up past the edge of the upper floor. Right photo shows north side of north kitchen wall showing preservative treated plywood sheathing.

All exterior walls are framed using advanced framing techniques to minimize lumber and related thermal bridging. The 50 mm (2 in.) thick foil-faced isocyanurate foam board is installed between the studs behind the wall sheathing upon completion of framing and installation of the building wrap and a waterproof membrane on the roof. In order to minimize the possibility of damage, all electrical, plumbing, and heating and ventilation services were installed before the VIPs. All wiring in exterior walls is for electrical receptacles only; this allows the wiring to be kept low and makes for easy installation of the VIPs. All light switches, daylight sensors, and occupancy sensors in the home are wireless and therefore can be surface mounted later on the finished drywall, and therefore do not interfere with the installation of the VIPs. Figures 4 and 5 show photos taken during the construction.

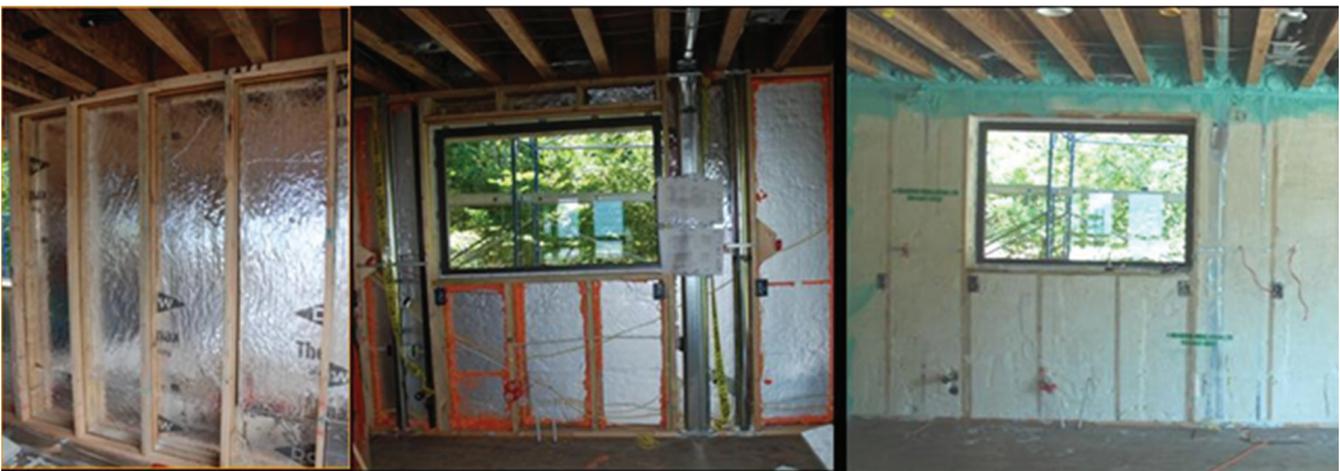
Figure 5 Left: Foil faced isocyanurate foam board placed between the 38×140 (2×6) studs behind the structural sheathing on north wall. Middle: wall after installation of the vacuum insulation panels. Right: interior spray foam application.

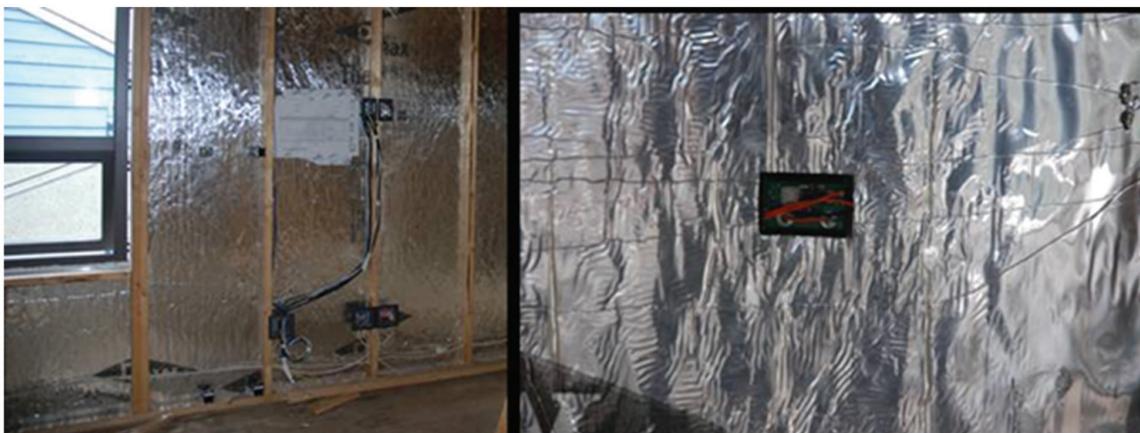
Figure 9 *Left: South wall showing installation of sensors on the inside of the studs and plates. Right: thin profile sensor installed on the inside face of the isocyanurate foam board at the center of the stud bay, to measure temperature and RH immediately outside the VIP.*

During the wall construction process, sensors were installed in the main floor wall assemblies in the four cardinal orientations as shown in the Figures 8 and 9.
