# Highly Insulated, Ventilated, Wood-Framed Attics in Cool Marine Climates

## ABSTRACT

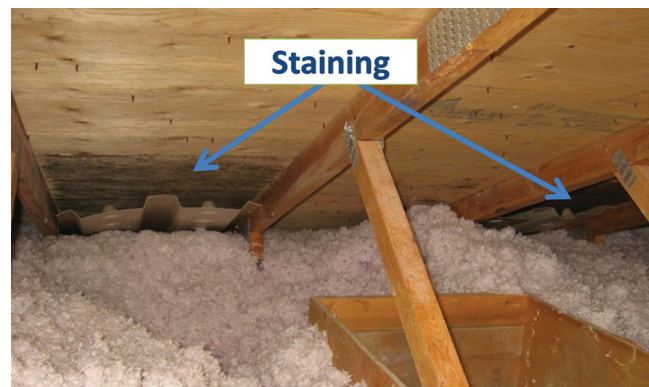
**Figure 1** Staining (mold) at soffit vents in a recently constructed wood-frame project.

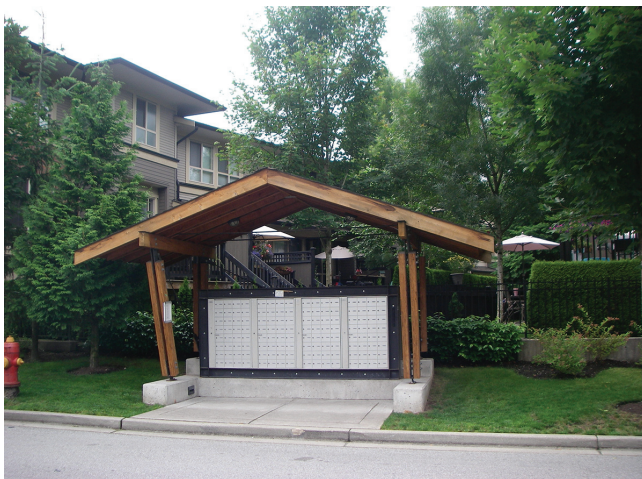
Figure 6 Test (control) roof assembly with Unit 2 in the background.

The test (control) roof assembly shown in Figure 6 was selected because this sloped roof is not subject to moisture sources from an occupied space and has similar weather exposure as the test units. The wood sheathing tested in this assembly allowed us to evaluate the conditions of the roof sheathings in an attic with abundant ventilation. The test roof assembly included monitoring of plywood samples that were installed directly below the roof underlayment and at the underside of R-5 extruded rigid insulation that was attached to the underside of the roof structure. Figure 7 shows the plywood samples for the test roof assembly. This side by side comparison allowed us to also evaluate the impact that condensation due to night-sky radiation and rain-water absorption through the asphalt singles had on the wetting of the plywood samples.

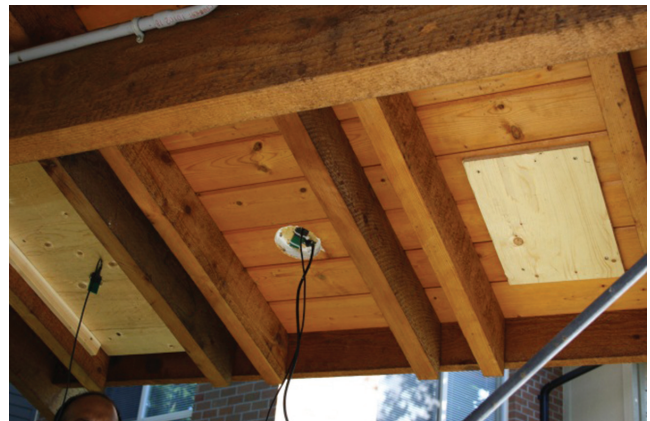
Figure 7 Control assembly sensors.

- a. Moisture content and temperature of the plywood sample installed at the underside of the roof underlayment
- b. Moisture content and temperature of a plywood sample with R5 rigid insulation installed between the underside of the roof structure and plywood sample
- c. Outdoor air temperature and relative humidity
