ORNL-2102
Health and Safety

ANALYSIS OF THOREX PILOT PLANT RADIATION EXPOSURES DURING 1955

W. T. McCarley

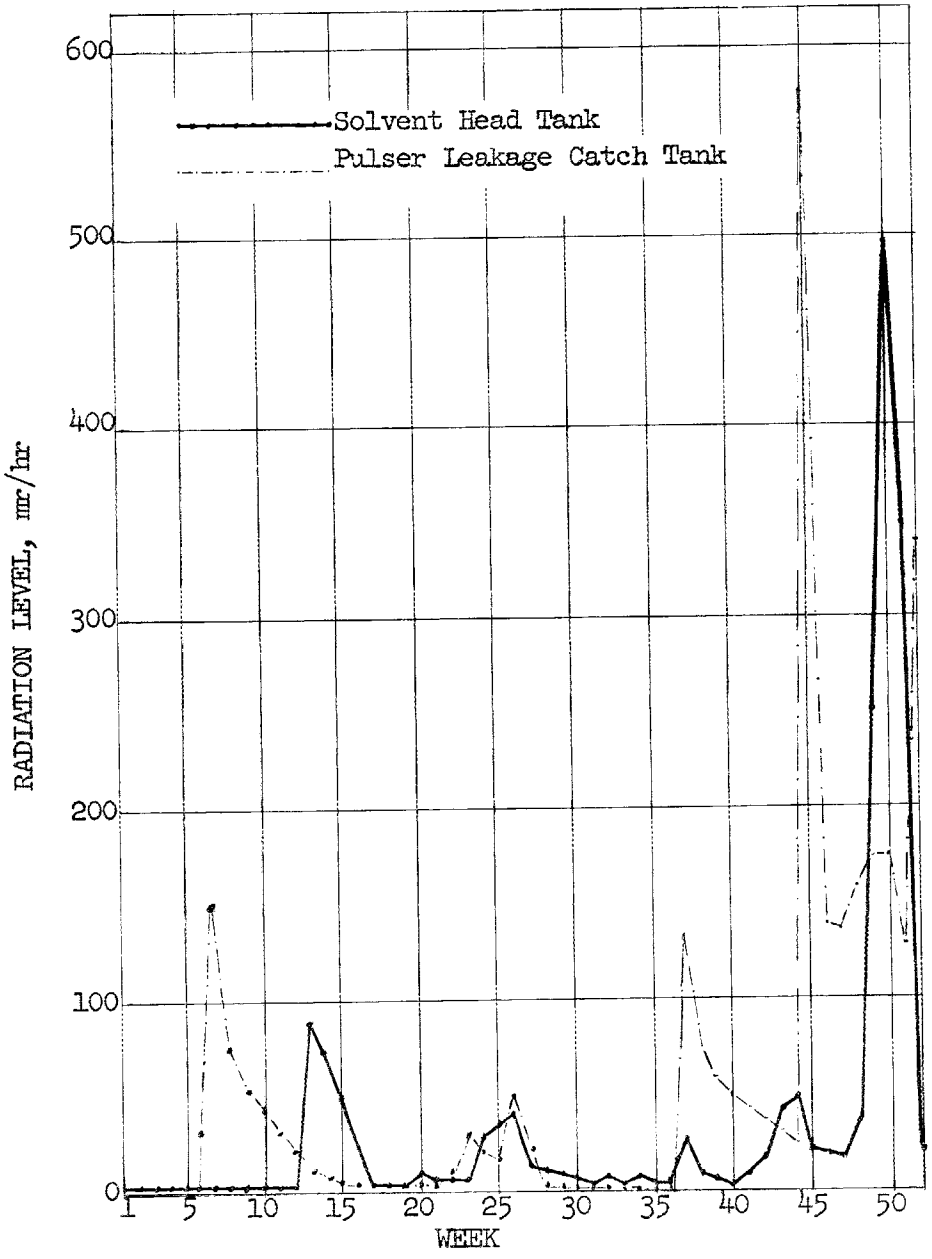
Fig. 5.1 Solvent Head Tank and Pulser Leakage Catch Tank Radiation Level Surveys, Weekly Averages.

Radiation levels in the solvent room were greater than 20 mr/hr during 19 weeks of the year. On one occasion, 493 mr/hr was measured (Fig. 5.1). High readings occurred when aqueous carbonate solution was pumped from the solvent recovery system to the solvent head tanks along with recovered solvent. When this occurred, operators drained the aqueous layer from the head tanks. A second cause of high radiation levels was insufficient decontamination of the solvent. Particularly during the Neptex program, the spent solvent from the Thorex process became highly contaminated from fission products and the solvent recovery system could not sufficiently decontaminate the solvent. Solvent leakage from two Milton-Roy pumps caused surface contamination in the solvent room.

In 11 weeks of the year, the radiation level of the pulser leakage catch tank exceeded 100 mr/hr, and during most of the remaining weeks was below 50 mr/hr (Fig. 5.1). These levels were too high for an area located outside the processing cells.

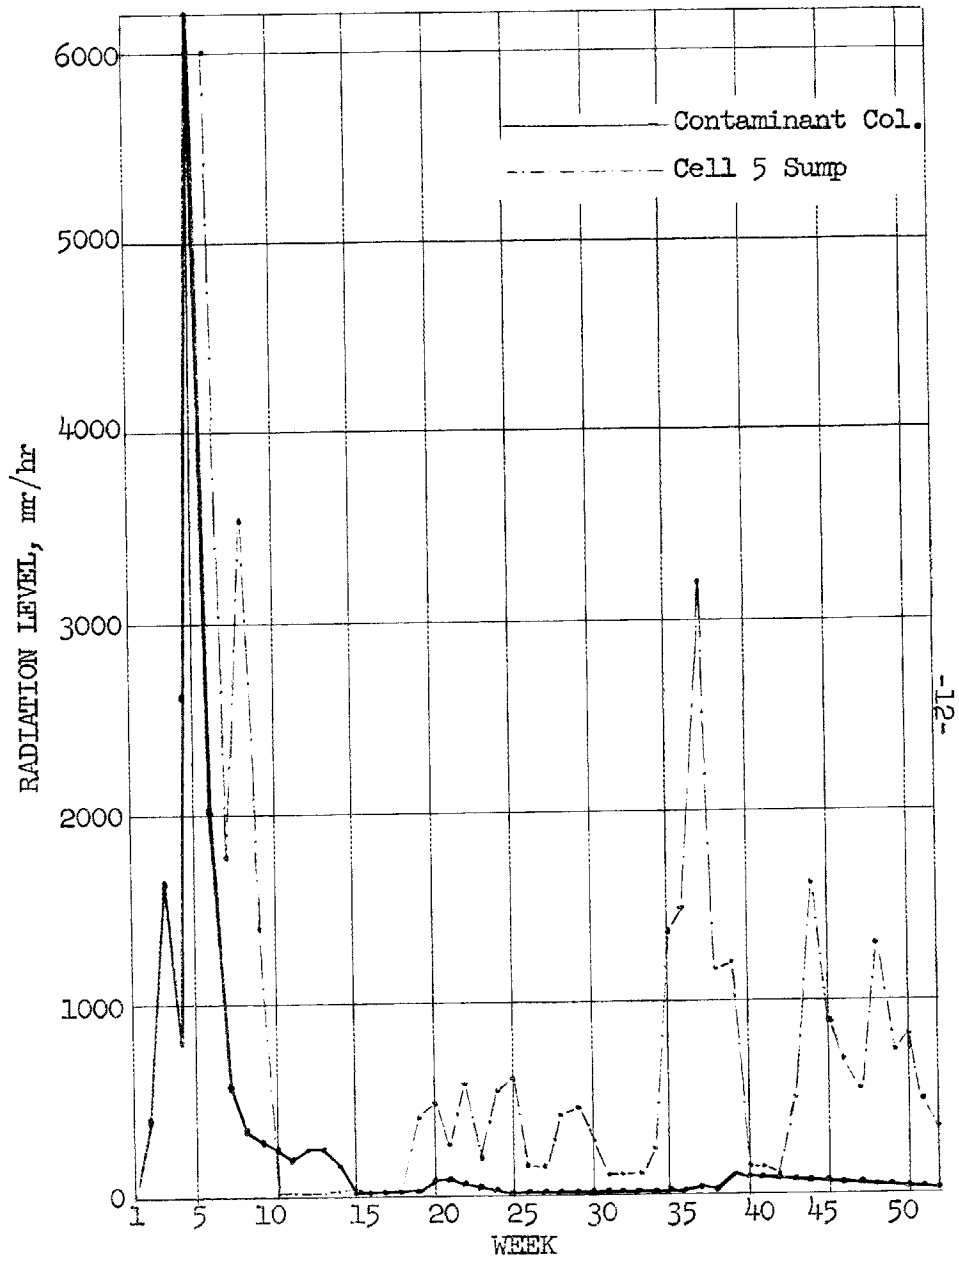
Fig. 5.2 Contaminant Column and Cell 5 Sump Radiation Level Surveys, Weekly Averages.

Isolation laboratory radiation levels increased rapidly during the first 5 weeks of operation. The contaminant column, which removed traces of thorium and ionic contaminants from the U^{233} product, reached a high of 6.2 r/hr in the fifth week (Fig. 5.2). A temporary 1/4-in. lead shield, installed in the seventh week, reduced the radiation level to less than 400 mr/hr. Permanent shielding, consisting of a 1-in. lead front, 1/2-in. lead sides and top, and 1/4-in. lead back, was installed during week 13, and the radiation levels remained essentially below 100 mr/hr for the remainder of the year. Surface contamination during the first 7 weeks of operation resulted when solution that leaked from process lines was tracked throughout the isolation laboratory by operating personnel.

reduced the radiation levels in the isolation laboratory (Fig. 5.2), and, as a result, the average exposure decreased to 3 mr/man-week for the remainder of the year. Operations primarily responsible for exposures in the isolation laboratory were product handling, sampling, and decontamination.

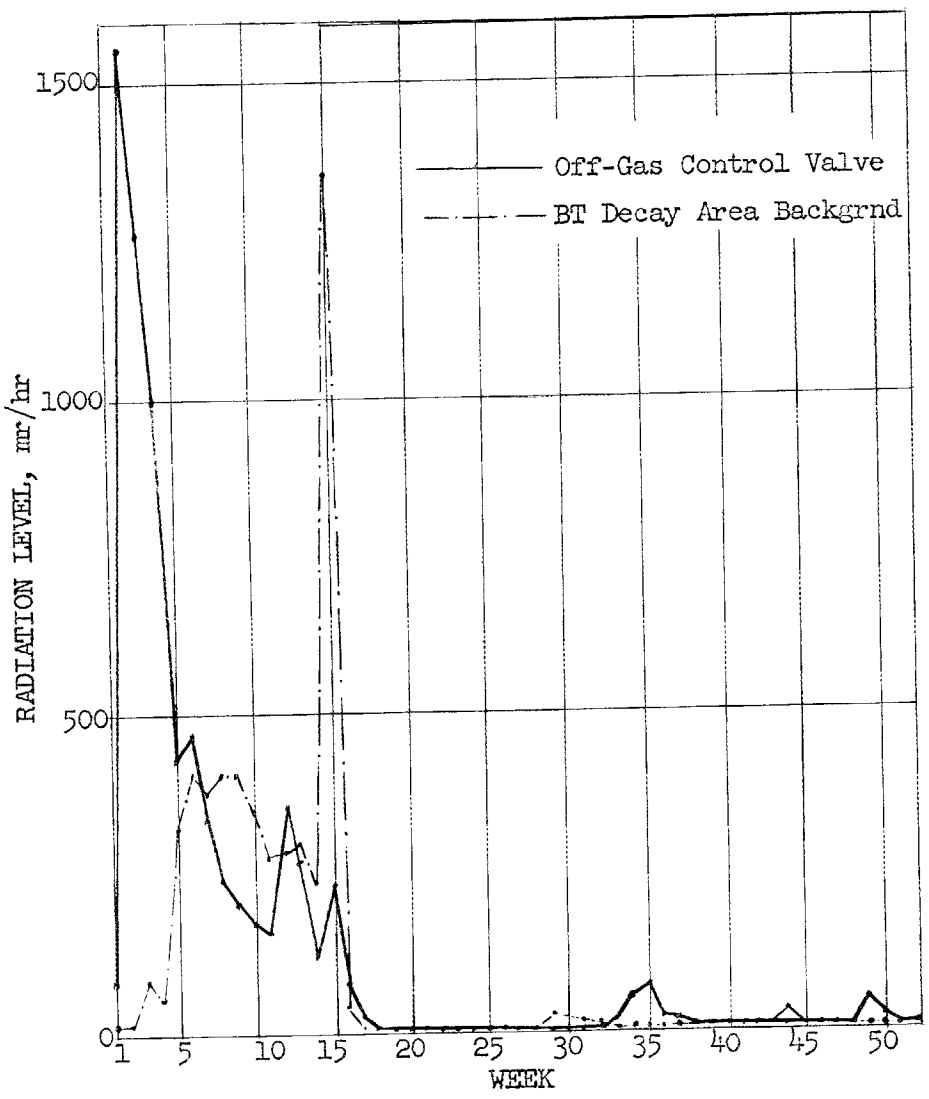
Fig. 5.3 Off-Gas Control Valve and BT Decay Area Background Radiation Level Surveys, Weekly Averages.

In the roof area (Fig. 5.3), radiation from the dissolver off-gas control valves increased to a weekly average of 1500 mr/hr during the second week. Decontamination reduced the radiation level to below 200 mr/hr, but subsequent slug dissolvings doubled this value. Shielding with 1/2-in.-thick lead successfully reduced the radiation level of the dissolver off-gas control valve to less than 5 mr/hr except for two occasions when levels of 75 and 50 mr/hr were recorded during slug dissolvings. A weld leak in the dissolver condenser (S-3) allowed radioactive solution to contaminate the roof area floor to a level of 900 mr/hr during week 19. During subsequent runs with nonirradiated feed, radiation from the condenser decreased to approximately 100 mr/hr and was not shielded. The drain pad under the quick-disconnect panel was contaminated on two occasions (weeks 36 and 44) to a level of 2-3 r/hr by solution spills. Air contamination exceeding tolerance was detected on several occasions during the jetting of the extraction column waste catch tank (N-2) to the tank farm. It was suspected that this air contamination came from the drain line under the quick-disconnect panel, as this line is connected directly to a header which leads to the ORNL storage system.

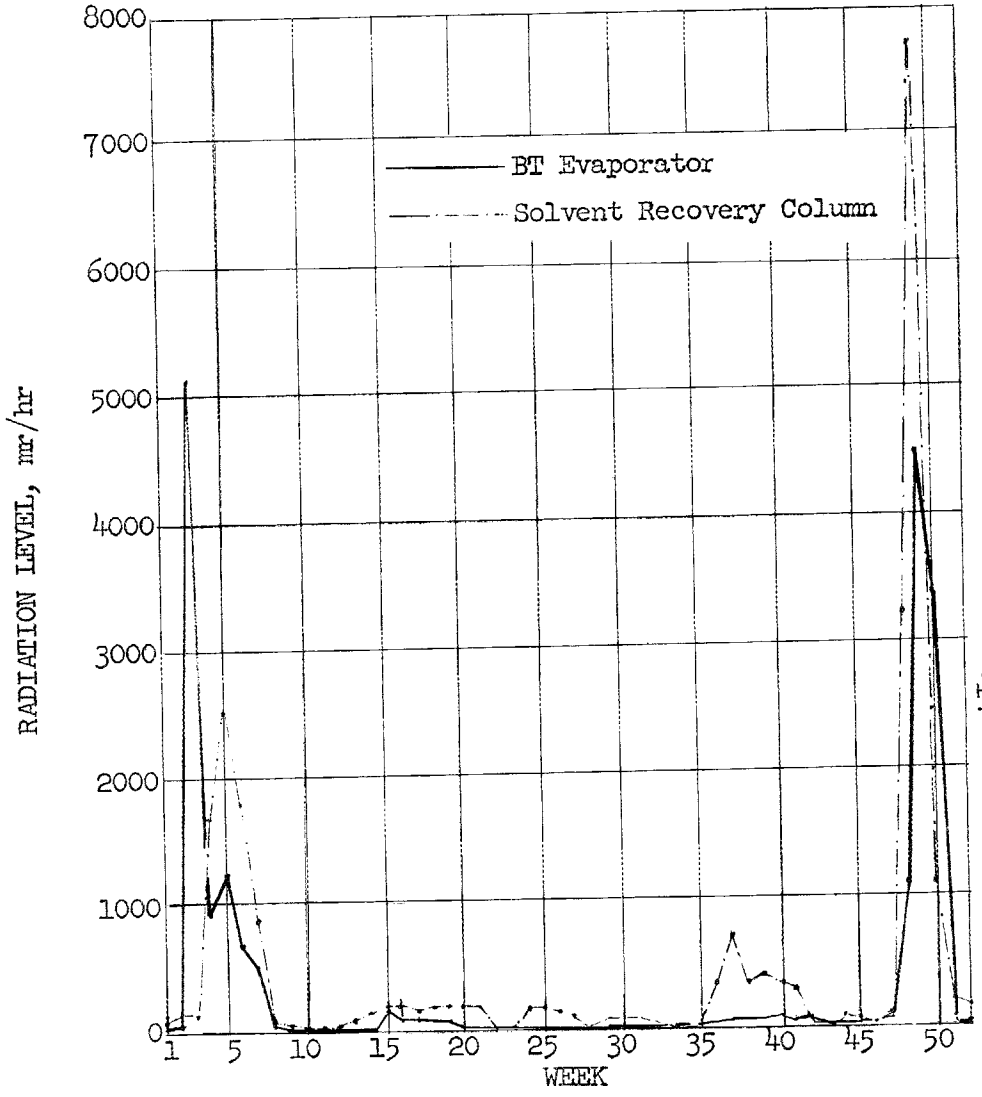
Fig. 5.4 BT Evaporator and Solvent Recovery Column Radiation Level Surveys, Weekly Averages.

During week 3, the background reading at the cell 6 doorway rose to 1.5 r/hr because activity was carried over from the extraction column to the partitioning column and BT evaporator (the evaporator read 5.1 r/hr) and solution leaked from a seal on the thorium product transfer pump (P-3-P). After the first 8 weeks of plant operation, radiation from the BT evaporator remained below 200 mr/hr for the remainder of the year except during the Neptex program in December, the highly concentrated U^{235}-Np^{237} product in the BT evaporator increased the evaporator radiation level up to 4.5 r/hr (Fig. 5.4).

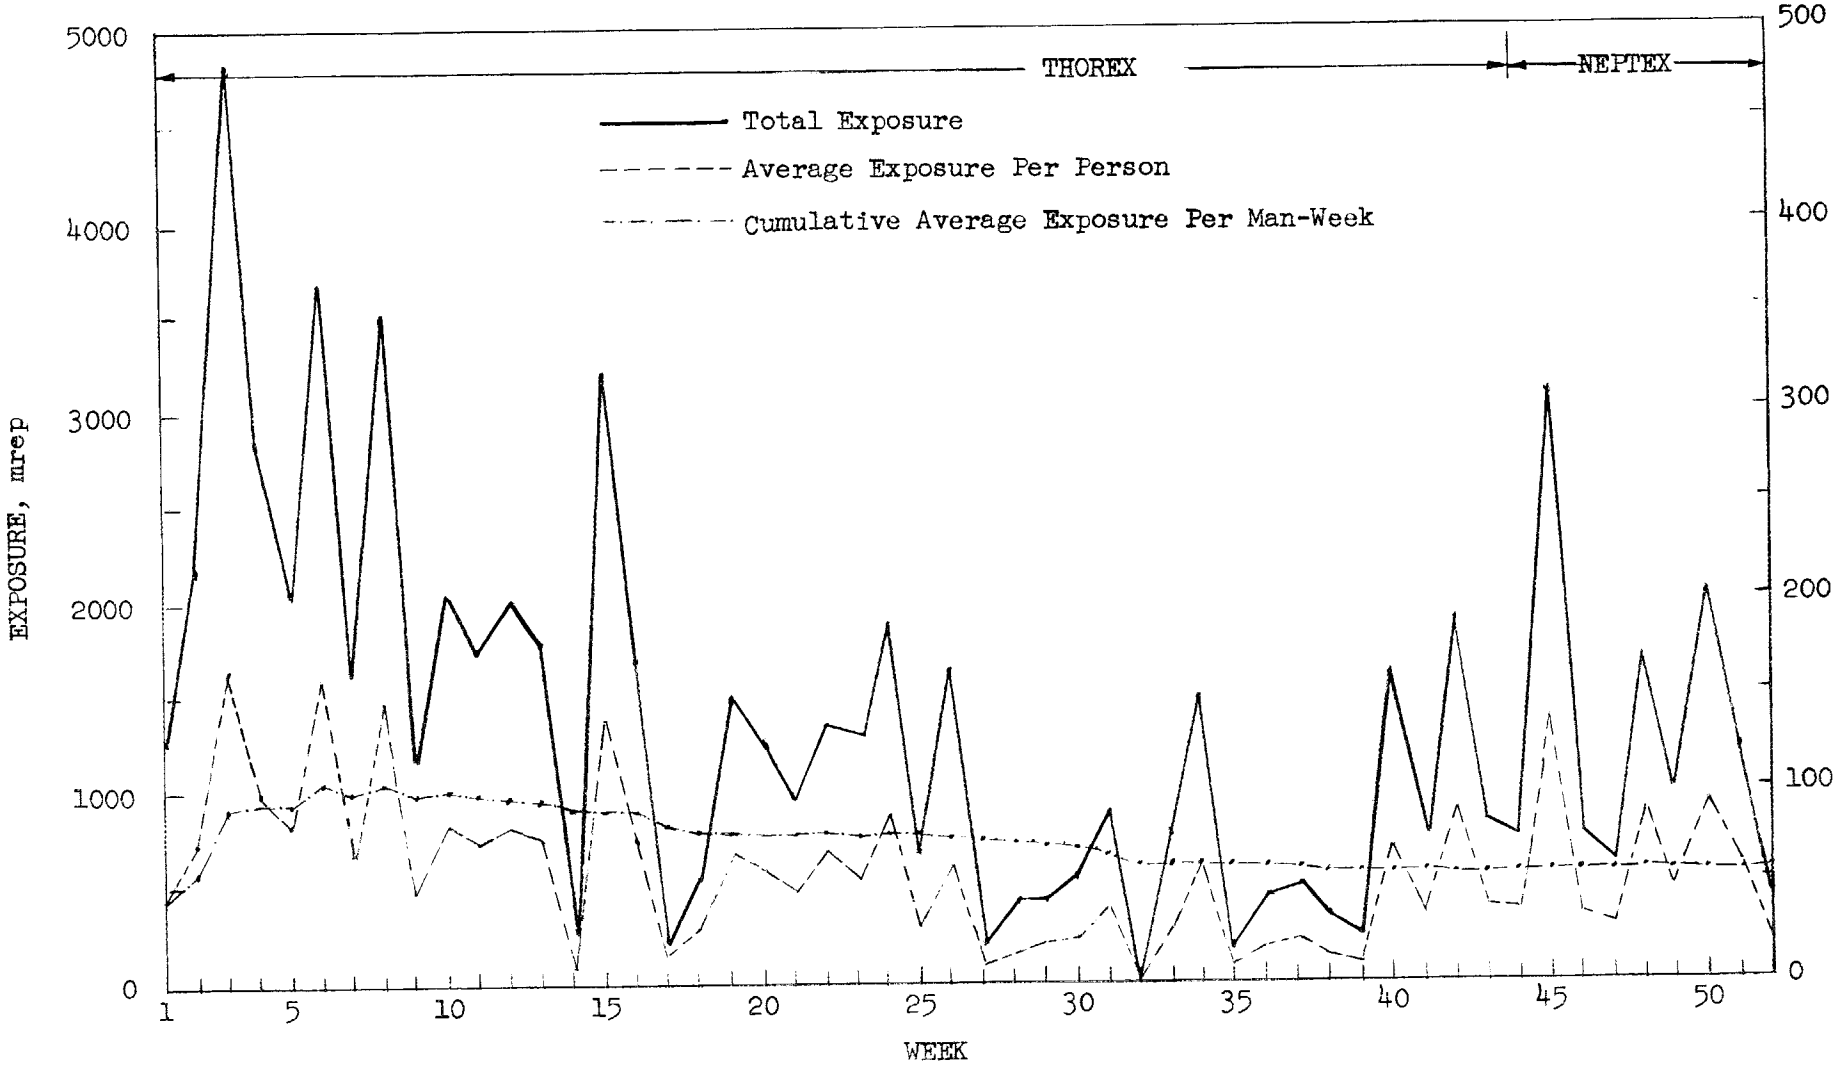
Fig. 6.1 Radiation Exposure Received by Operating Personnel, 1955.

The total and average weekly exposure of operating personnel increased to a maximum in the third week of processing and then generally decreased throughout the remainder of the year, except during the Neptex program in the last 9 weeks of the year (Fig. 6.1). Total radiation exposures, expressed as percentages of the total, for the first through the fourth quarters of 1955 were 43.5, 23.5, 9.3, and 23.7, respectively.

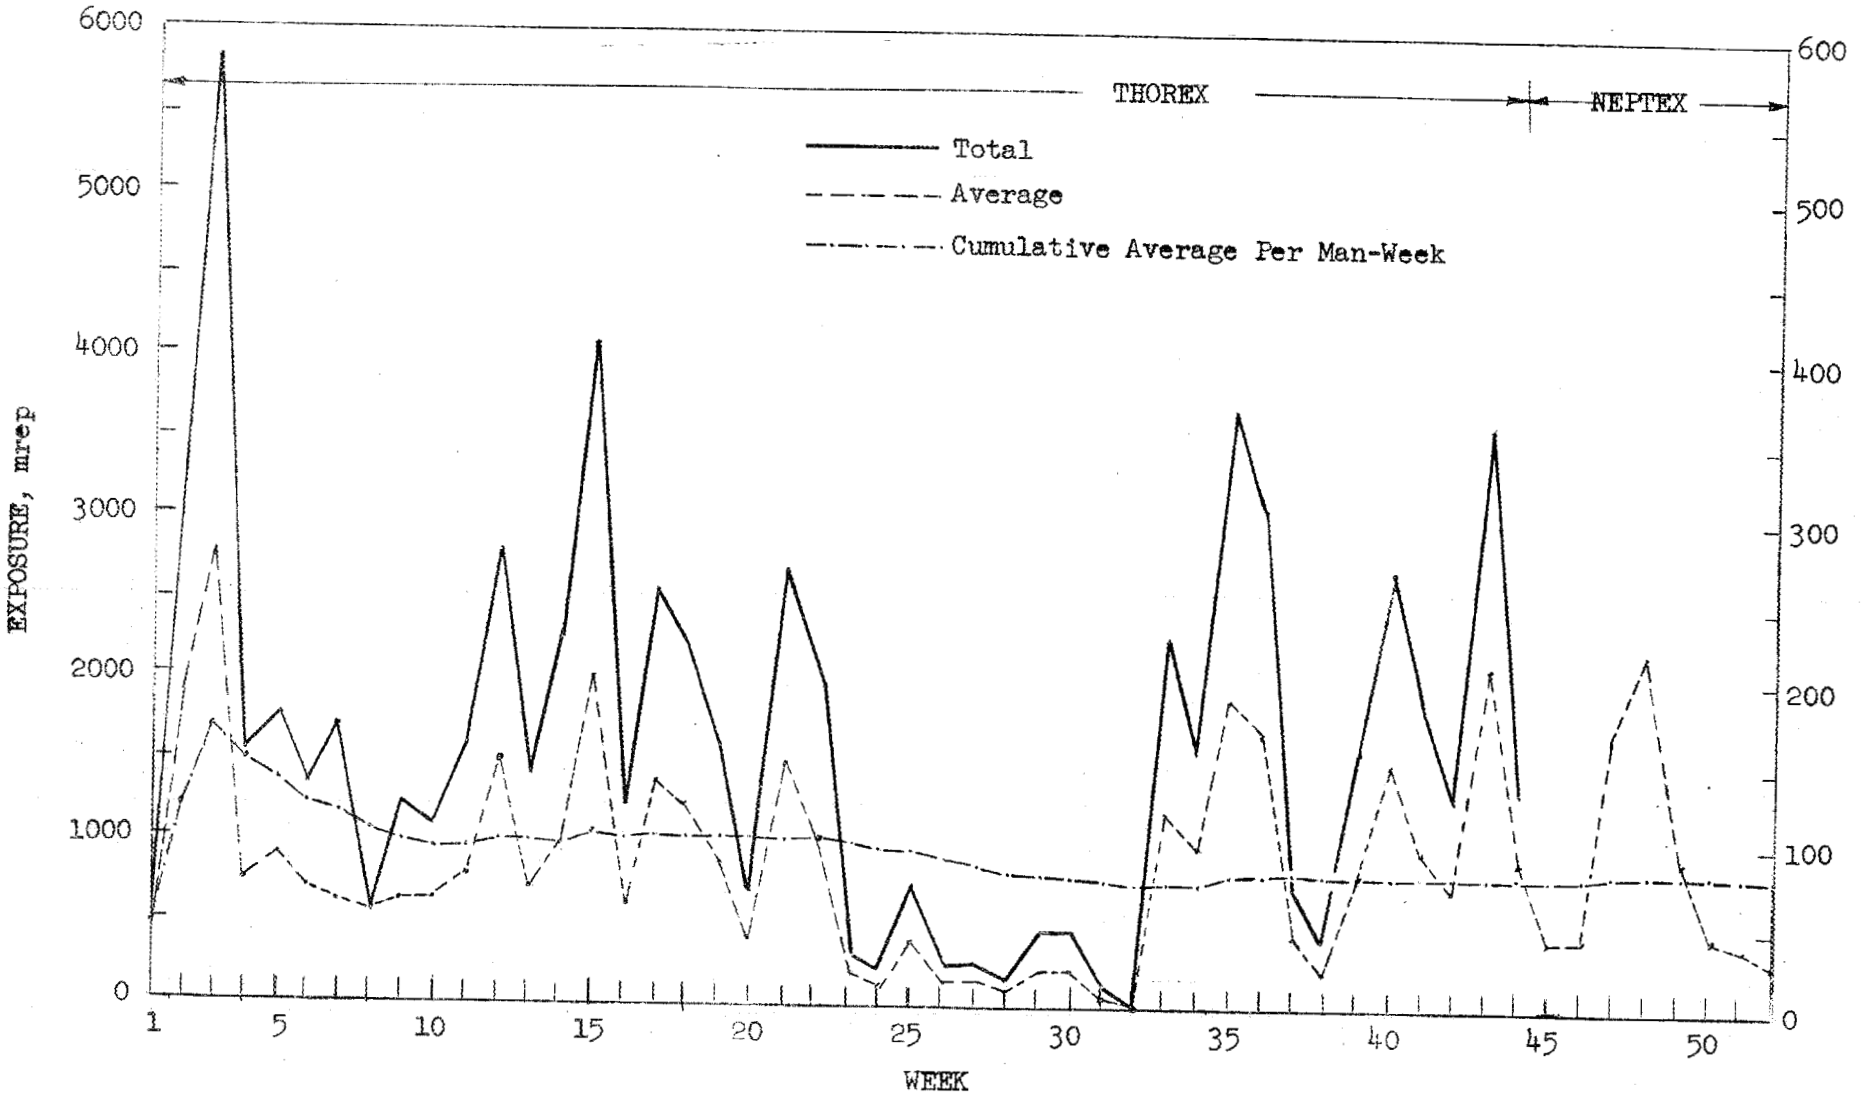
Fig. 6.2 Radiation Exposure Received by Analytical Personnel, 1955.

Analytical personnel who worked on both Thorex and Metal Recovery Plant*samples received a total radiation exposure of 86,465 mrep during 1955, an average of 87.5 mrep/man-week (Fig. 6.2). A yearly total of 43,267 analyses was performed by analytical personnel for the Thorex and Metal Recovery Pilot Plants: 65% of these analyses were made for Thorex. Assuming that the average dosage per analysis was approximately equal for the Thorex and Metal Recovery samples, a total exposure of 56,202 mrep would have been received by analytical personnel from Thorex samples, or an average of 57 mrep/man-week.

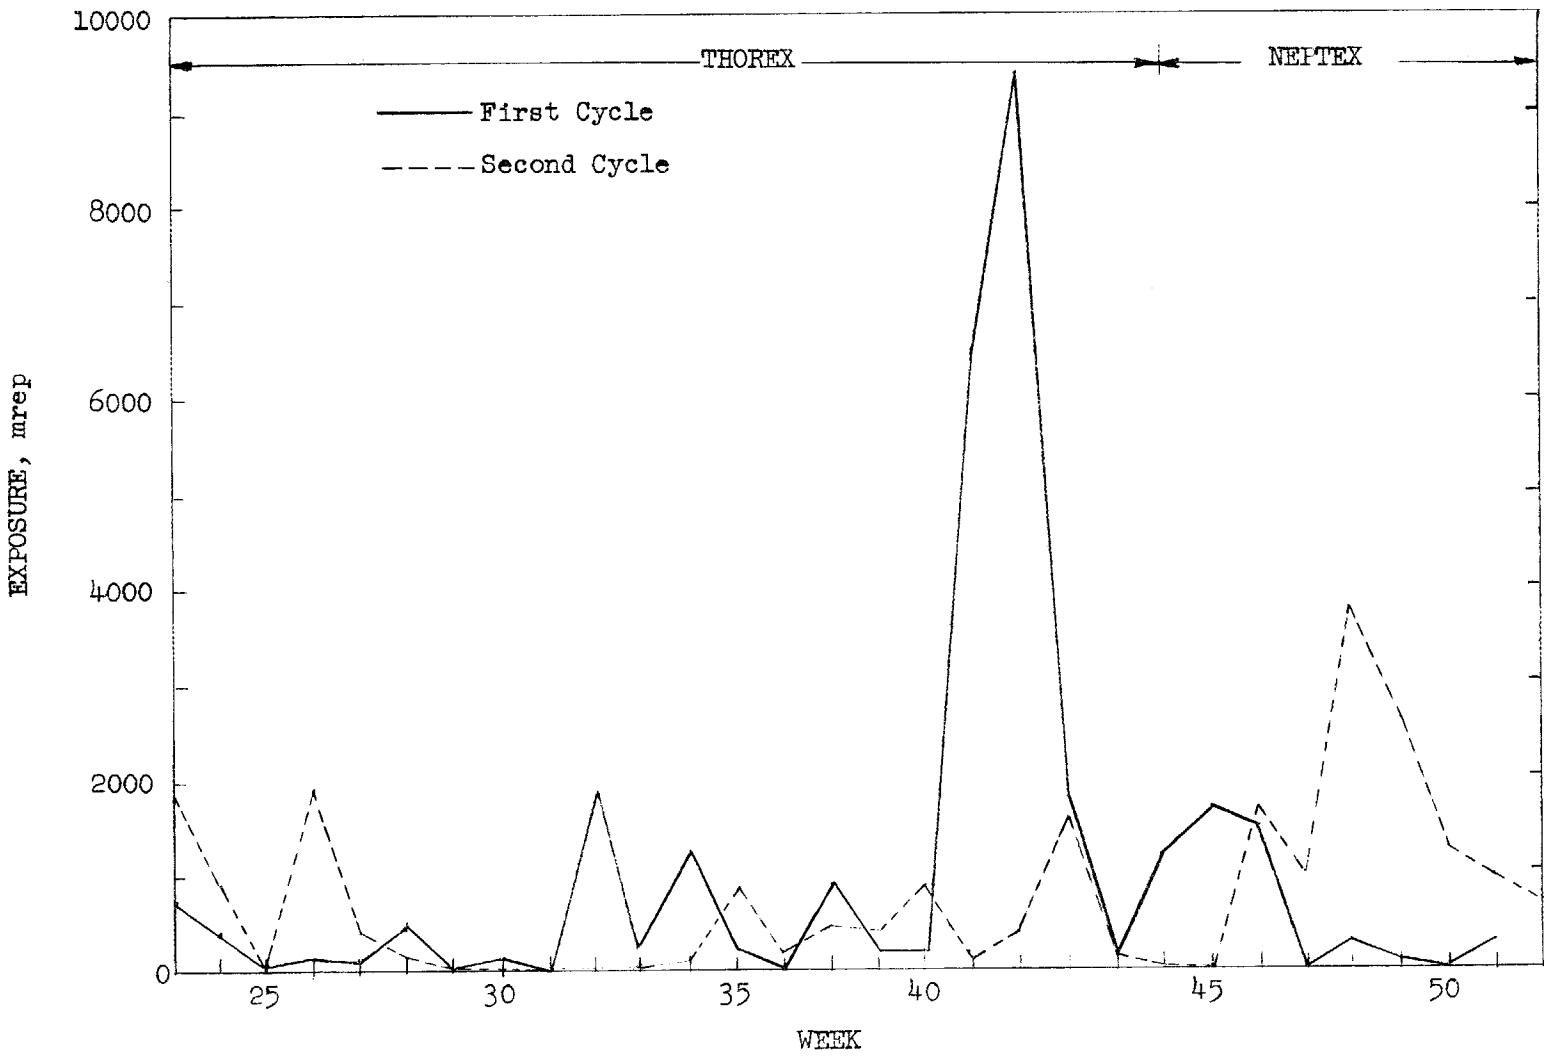
Fig. 6.3 Radiation Exposure Received by Maintenance Personnel, 1955.

Maintenance personnel involved in Thorex first cycle maintenance and modification (including Neptex modification) received a total radiation exposure of 30,180 mrep during weeks 23 through 52 (Fig. 6.3). During this time, 96.8 man-weeks of work was performed, giving an average exposure of

312 mrep/man-week. Seventeen persons of this group were overexposed a total of 3,900 mrep. All overexposures were received within two consecutive weeks, during the installation of an alternate solvent recovery system. The installation of this system was rushed to completion, prior to the startup of irradiated feed run HD-13, and 60% of the total exposure received by first cycle maintenance personnel for the last 30 weeks of 1955 was received during this installation. Neglecting the high exposure received by maintenance personnel while installing this system, the average exposure received by craft personnel while doing maintenance work on other first cycle equipment during this period, weeks 23 through 52, was 166 mrep/man-week.

Maintenance personnel engaged in the installation of second cycle equipment received a total radiation exposure of 22,866 mrep during weeks 23 through 52 (Fig. 6.3). During this time, 144.2 man-weeks of work were performed, giving an average exposure of 169 mrep/man-week. Six persons were overexposed a total of 995 mrep.

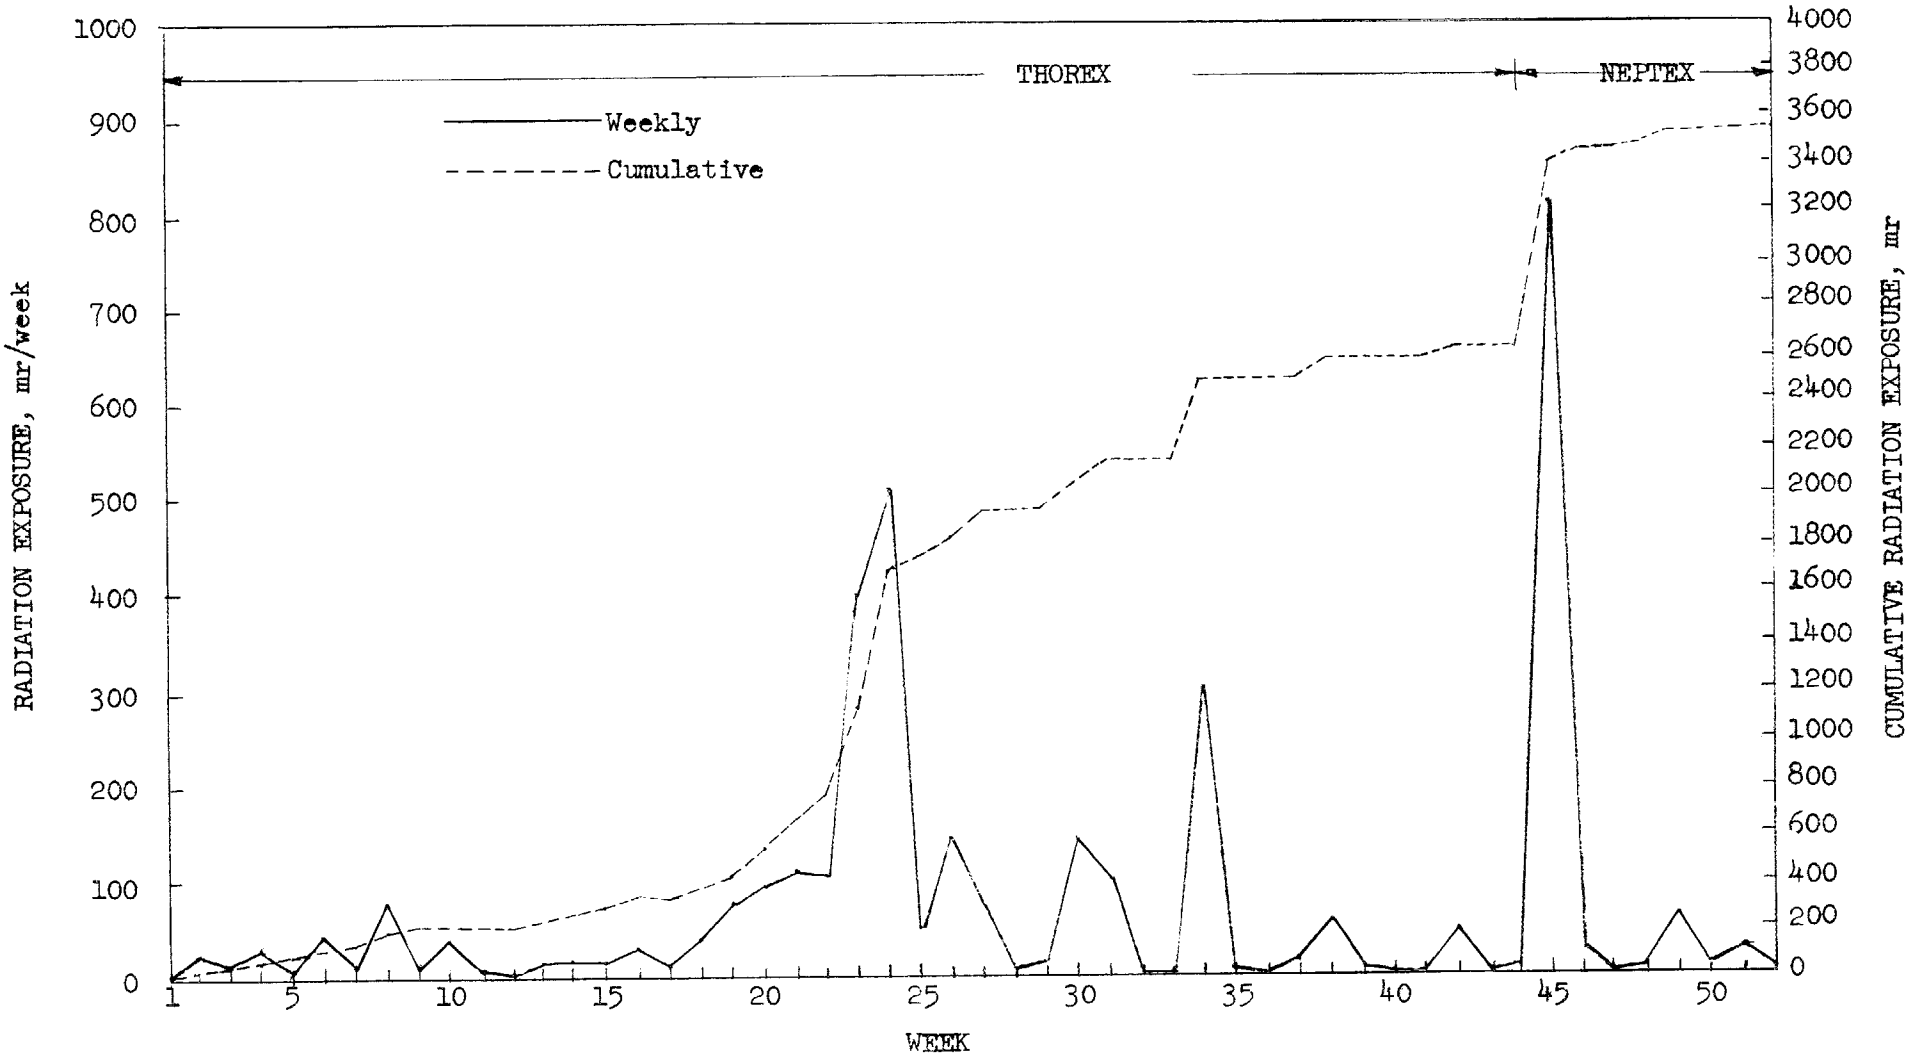
Fig. 6.4 Radiation Exposure Received by Operating Personnel in Cell 5.

The weekly variation of radiation received in cell 5 during 1955 is shown in Fig. 6.4. The accumulation of exposure increased slowly during the first 18 weeks of the year, although radiation levels in the cells were occasionally 2-6 r/hr. The radiation received during this period occurred during routine inspection of equipment and decontamination operations. During week 19, a leak developed in the feed pump (S-4-P) Cuno filter, which contaminated the cell 5 floor and S-4-P cubicle, and inspection and repair of the feed pump filter caused the rapid accumulation of exposure during weeks 20 through 24. Radiation exposure was received on 62 occasions in this period, and three persons became overexposed. The peaks in the curve of Fig. 6.4 occurring during weeks 26 and 34 resulted from testing and servicing the feed pumps. Column operation during run SC-1 was frequently interrupted because of malfunctions of the extraction column feed head pot

and phase separator. This situation was corrected by removing the phase separator from the system. Decontaminating operations and maintenance work associated with the removal of this phase separator resulted in the increased radiation exposure during weeks 30 and 31. In preparation for the Neptex program, it was necessary to accomplish the following repairs in cell 5: replace the agitator in the feed adjustment tank (S-2), unplug the jet suction line on the S-2 outer jacket, and unplug the vapor line from S-2 to the acid fractionator (S-9). This maintenance work, together with the necessary decontamination and equipment inspection, accounted for the highest weekly exposure (dosimeter readings of 810 mr) in cell 5 during the year. The radiation exposure received in cell 5 accounted for 14.4% of the total exposure received by Thorex operating personnel during 1955. Operations performed, which resulted in this exposure, were equipment inspection, decontamination, and equipment operation and service.

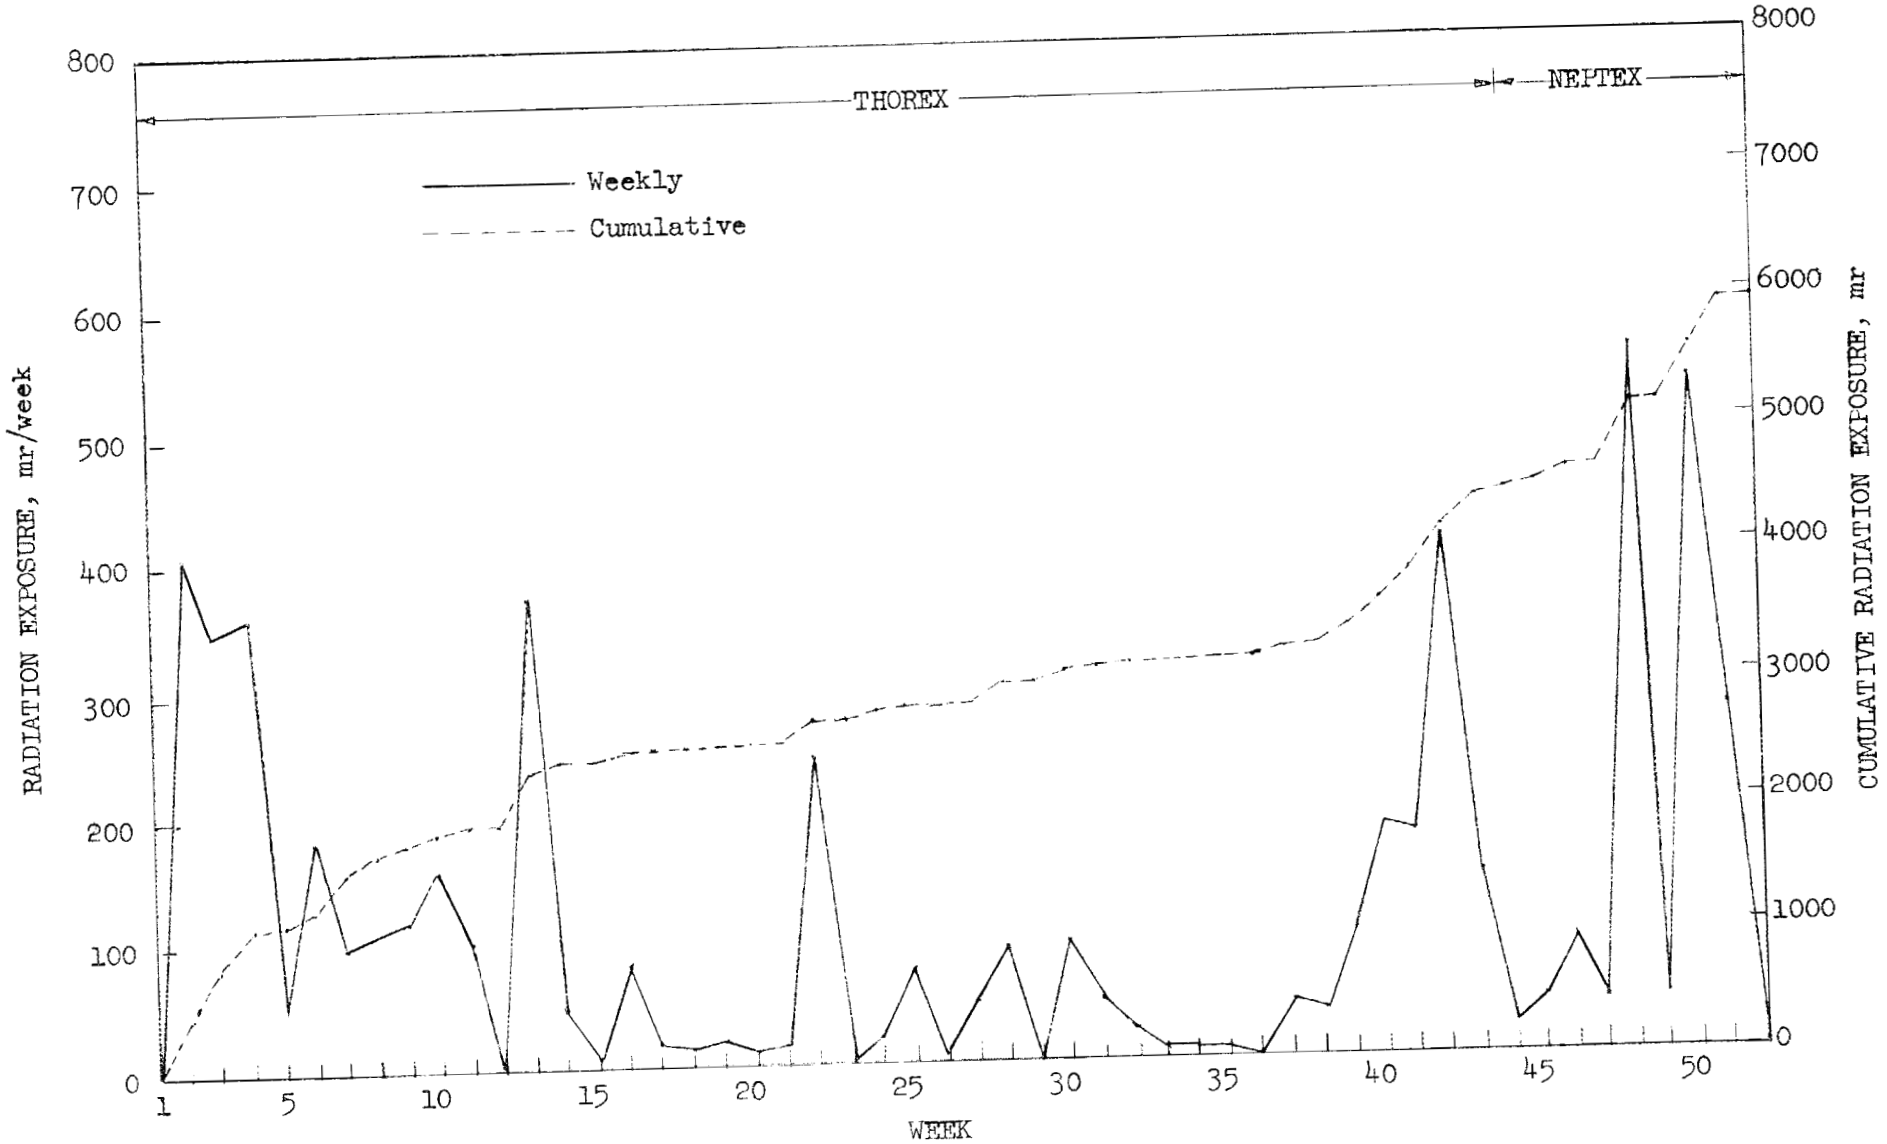
Fig. 6.5 Radiation Exposure Received by Operating Personnel in Cells 6 and 7.

The weekly variation of radiation exposure received in cells 6 and 7 during 1955 is shown in Fig. 6.5. Activity carryover from the extraction column to the partitioning column and BT evaporator increased the radiation in cell 6 to relatively high levels (the BT evaporator averaged greater than 5 r/hr one week) during the first four weeks of the year. As a result, routine inspection of equipment in cell 6 exposed operating personnel to considerable radiation; an average of 133 mr was received per exposure during this period. Subsequent decontamination reduced the radiation levels in cell 6; however, radiation levels of the solvent recovery system in cell 7 increased rapidly during week 5, again exposing personnel to considerable radiation while doing routine inspection and operation of equipment. Decontamination, together with the installation of lead shielding around individual pieces of equipment such as the centrifuge and the bottom of the solvent recovery column, reduced the radiation levels during week 10, and exposure of personnel during normal routine equipment inspection and operation in cell 7 was relatively low for the remainder of the year. A sharp peak in the radiation exposure curve occurred during week 13 when decontamination and maintenance work was required to repair weld leaks in the base of the partitioning column and in a transfer line connecting the

CW catch tank (T-4) and the rework tank (N-8). There was another peak in the curve during week 22 when extensive decontamination was carried out in cells 6 and 7 prior to the installation of second cycle equipment. Personnel exposure received in cells 6 and 7 increased rapidly in the five-week period from week 39 through 43. During this period, the alternate solvent recovery system, consisting primarily of two glass spray columns, was installed in the stripping column cubicle and was operated during runs HD-13 and -14. This system was not designed for remote operation, and frequent inspections were necessary to ensure that the columns were operating properly. Radiation exposure was received on 56 occasions in the five weeks by personnel inspecting the system, with an average of 38 mr/exposure.

During the Neptex program (weeks 44 through 52), two sharp peaks appear in the curve representing exposure received in cells 6 and 7. This exposure was for the most part received while handling Neptex product. The recovered U^{235}-Np^{237} product was concentrated in the BT evaporator and drained into a stainless steel drum, which gave a reading of 13 r/hr on a cutie-pie. It was necessary for operating personnel to handle this drum on several occasions, and the average amounts of radiation received were 357 and 191 mr/exposure for weeks 48 and 50, respectively. These averages are considerably above the yearly average of 38 mr/exposure in the processing cells. Radiation received in cells 6 and 7 amounted to 25% of the total exposure accumulated by Thorex operating personnel in 1955. Operations that resulted in this exposure were equipment inspection, equipment operation and service, decontamination, and product handling. All radiation received while handling product occurred during the Neptex program.

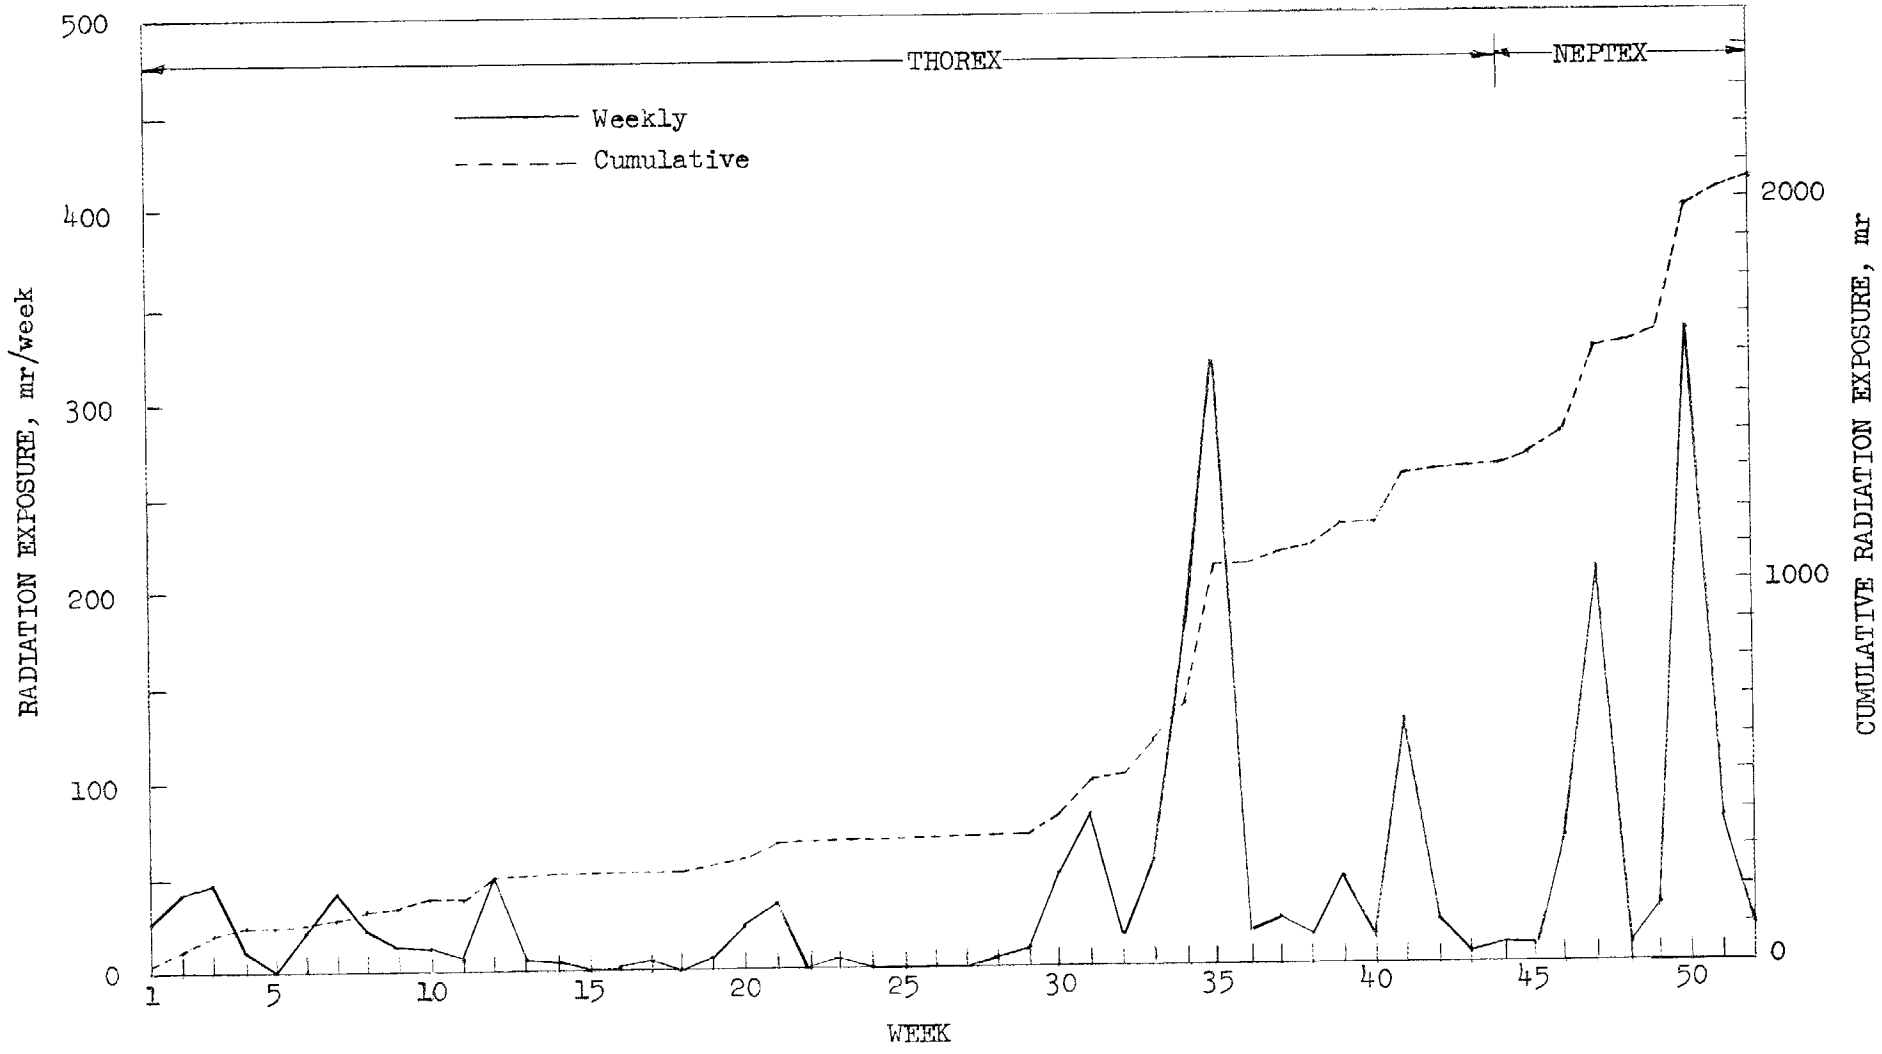
Fig. 6.6 Radiation Exposure Received by Operating Personnel in Roof Area.

Roof Area. Curves representing the radiation exposure received in the roof area are shown in Fig. 6.6. During the first 30 weeks of 1955 personnel exposures were accumulated at a low rate (approximately 2 mr/man-week), while during the last 22 weeks exposures were accumulated more rapidly (9 mr/man-week). This rapid accumulation during the latter part

of the year was due primarily to four periods of relatively high exposure. During weeks 34 and 35, the quick-disconnect panel drain pad became contaminated, 10 r/hr, because of drainage from the off-gas condensate trap tank, and the radiation level of the dissolver condenser (S-3) rose to 375 mr/hr. Decontamination of the drain pad and miscellaneous work in the vicinity of the S-3 condenser accounted for 76% of the radiation received in the roof area during weeks 34 and 35. The peak in the curve at week 41 resulted from solution makeup and equipment servicing necessary for the operation of the alternate solvent recovery system. The loading and charging of the MTR assemblies during the Neptex program accounted for the high exposure in week 47. On one occasion an MTR assembly would not drop through the slug loading chute, and it was necessary to raise the slug charger approximately 2 in. and push the assembly with a long rod before it would drop into the dissolver. Neptex product, which was concentrated in the BT evaporator and drained into a stainless steel drum, was returned to the evaporator for additional concentrating by raising the product drum from cell 6 to the roof area and draining its contents back to the evaporator through a connection on the quick-disconnect panel. This handling of the radioactive product drum (13 r/hr) accounted for 80% of the radiation received in the roof area during week 50. Radiation received in the roof area amounted to 8% of the total exposure accummilated by Thorex operating personnel in 1955. No single operation was primarily responsible for the exposure received in the roof area, and the operations that resulted in exposure were slug loading and charging, miscellaneous operations, equipment inspection, product handling, and decontamination.

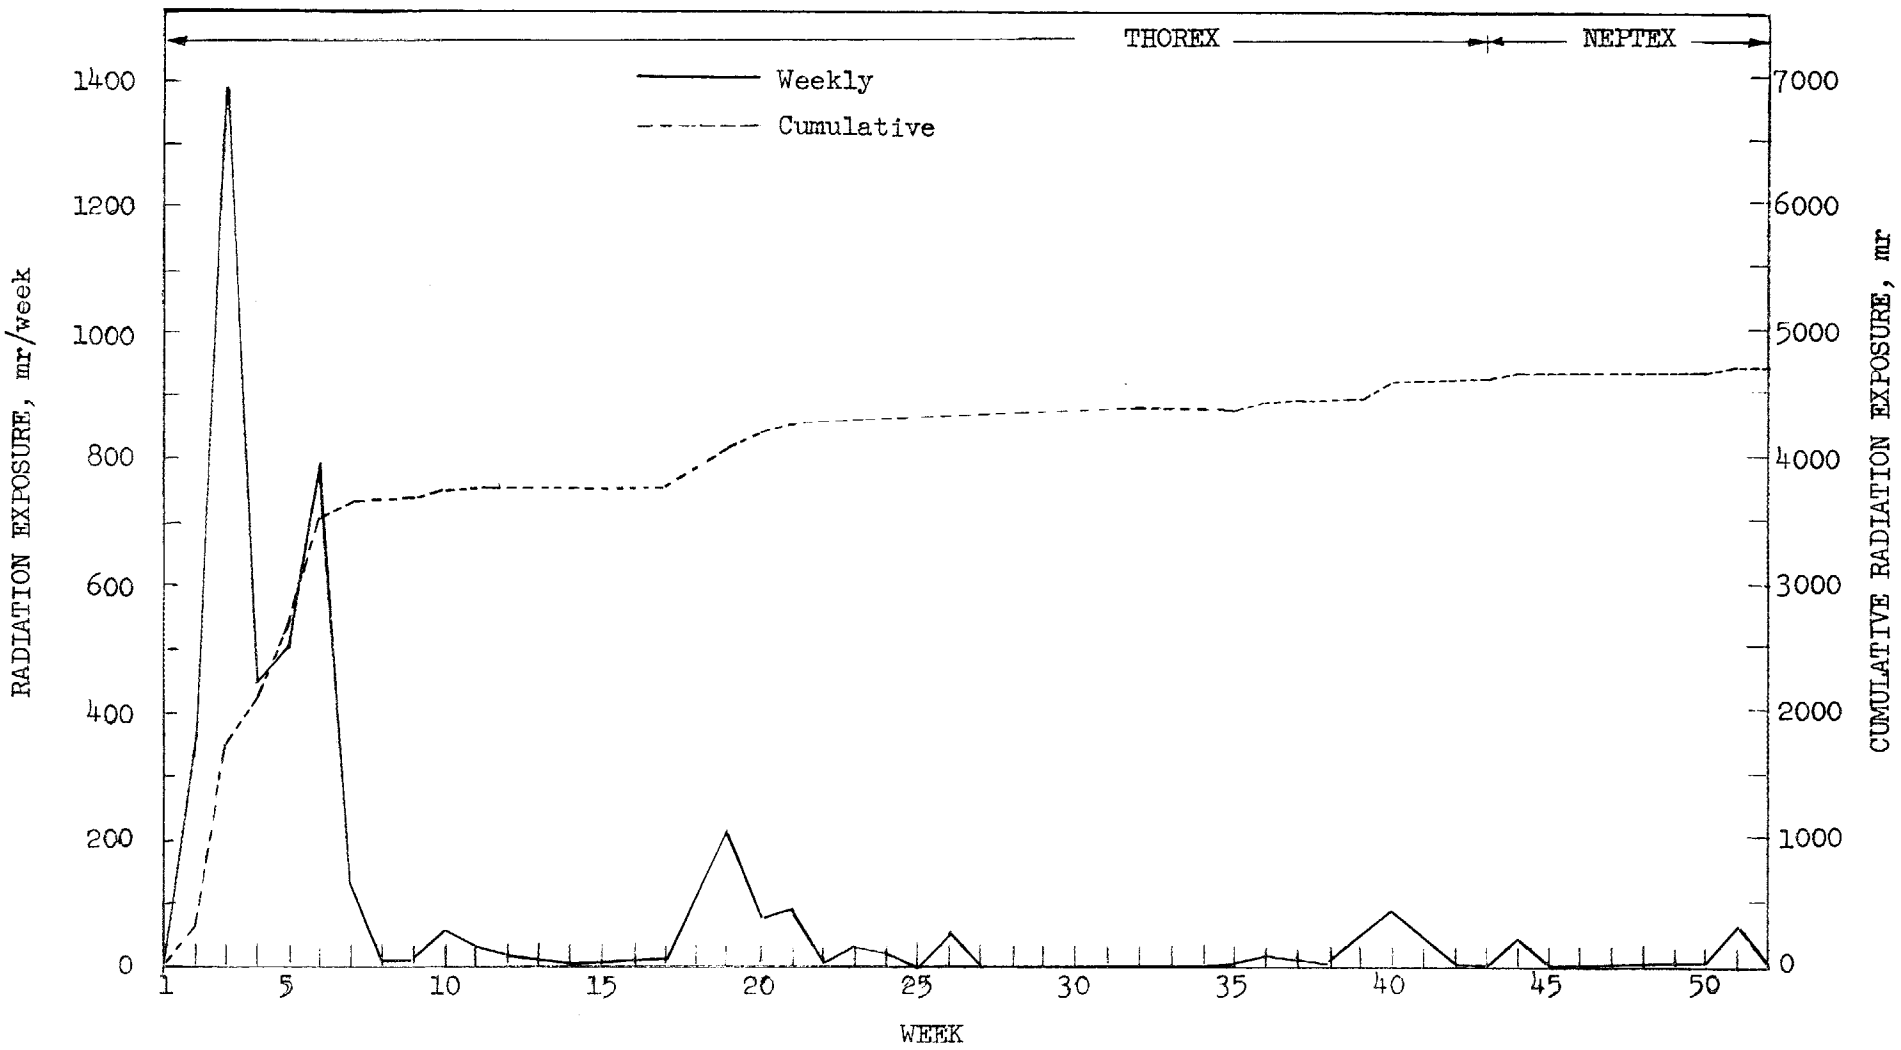
Fig. 6.7 Radiation Exposure Received by Operating Personnel in Isolation Laboratory.

Isolation Laboratory. A significant portion (18%) of the radiation exposure to Thorex operating personnel occurred in the isolation laboratory. Approximately 75% of the total exposure in the isolation laboratory occurred during the first 6 weeks of the year, which represents an average exposure of 73 mr/man-week for this period (Fig. 6.7). The installation of unit shielding around the resin columns and the product receiver greatly
