ORNL-2102
Health and Safety

ANALYSIS OF THOREX PILOT PLANT RADIATION EXPOSURES DURING 1955

W. T. McCarley

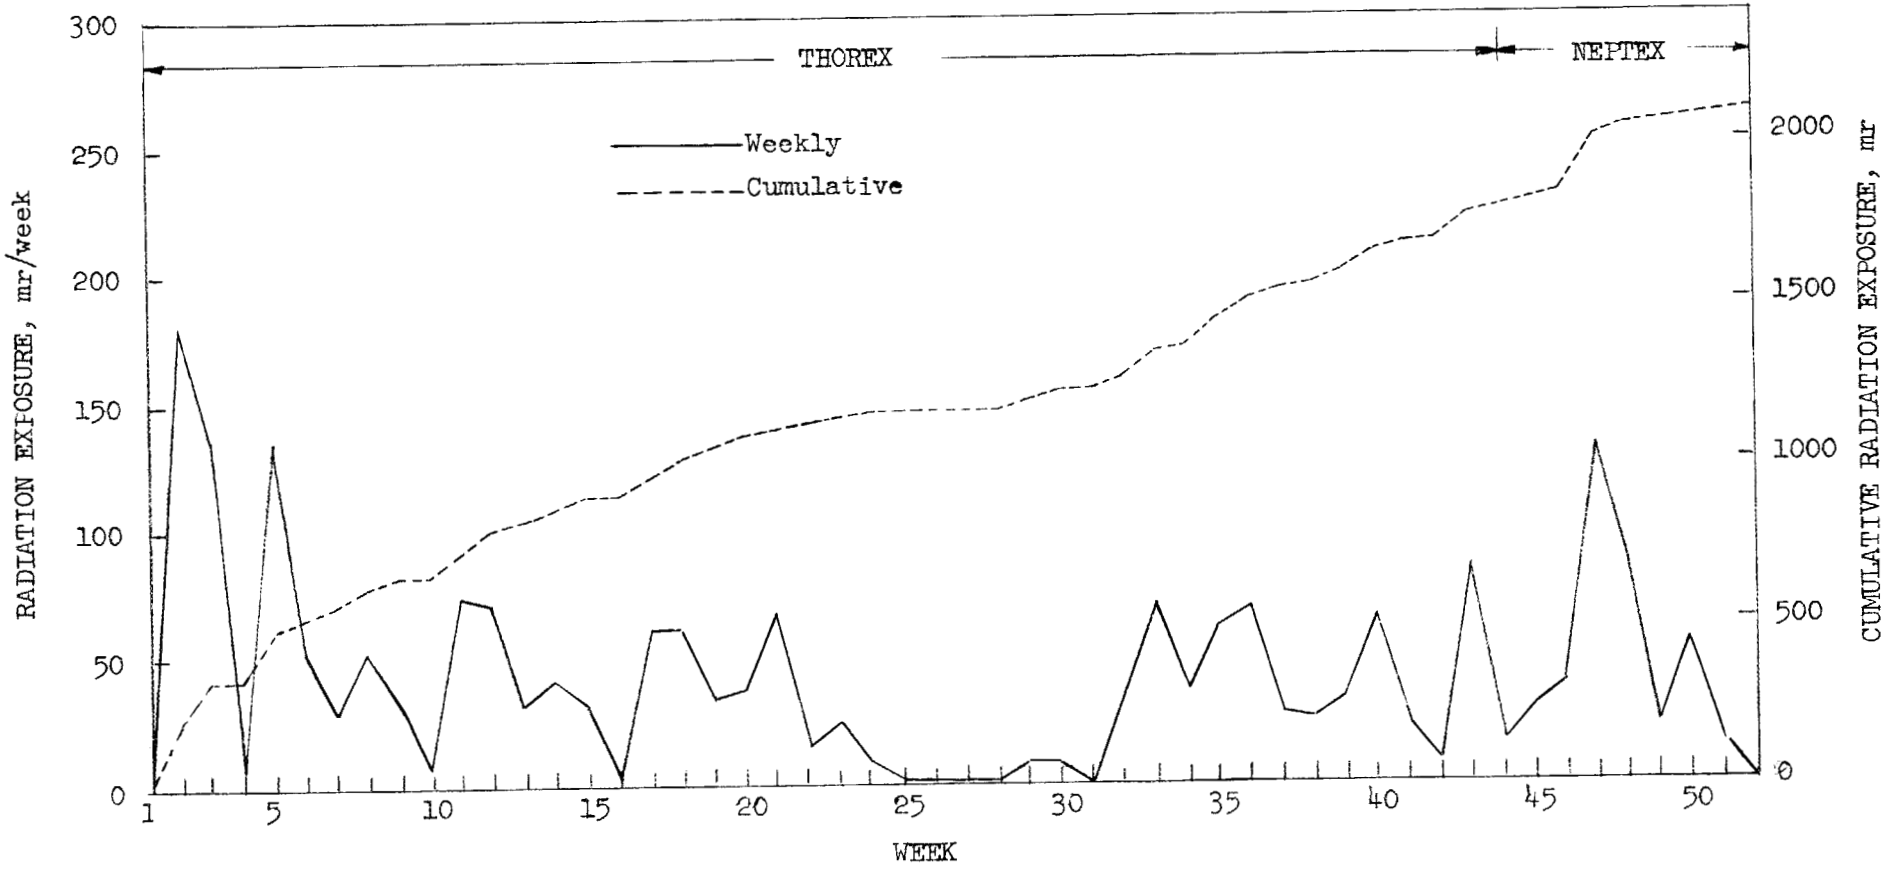
Fig. 6.8 Radiation Exposure Received by Operating Personnel in Isolation Laboratory.

Sampling Gallery. The radiation exposure received in the sampling gallery accounted for 8% of the total exposure received by Thorex operating personnel during 1955. The cumulative exposure curve of Fig. 6.8 shows a relatively constant rate of exposure for 1955 except for a rapid buildup during the first 5 weeks of operation and a period of low exposure during operation with recycled thorium feed (weeks 24 through 31). The average exposure rate for the year in the sampling gallery was 5 mr/man-week. Weekly exposures in excess of 100 mr (dosimeter reading), which occurred four times, resulted when the sample gallery floor was contaminated during blowing down of sampling lines. This contamination was difficult to remove from the concrete floor, and it was necessary to cover one spot under the cell 5 sampling blister with a 0.5-in.-thick lead sheet.

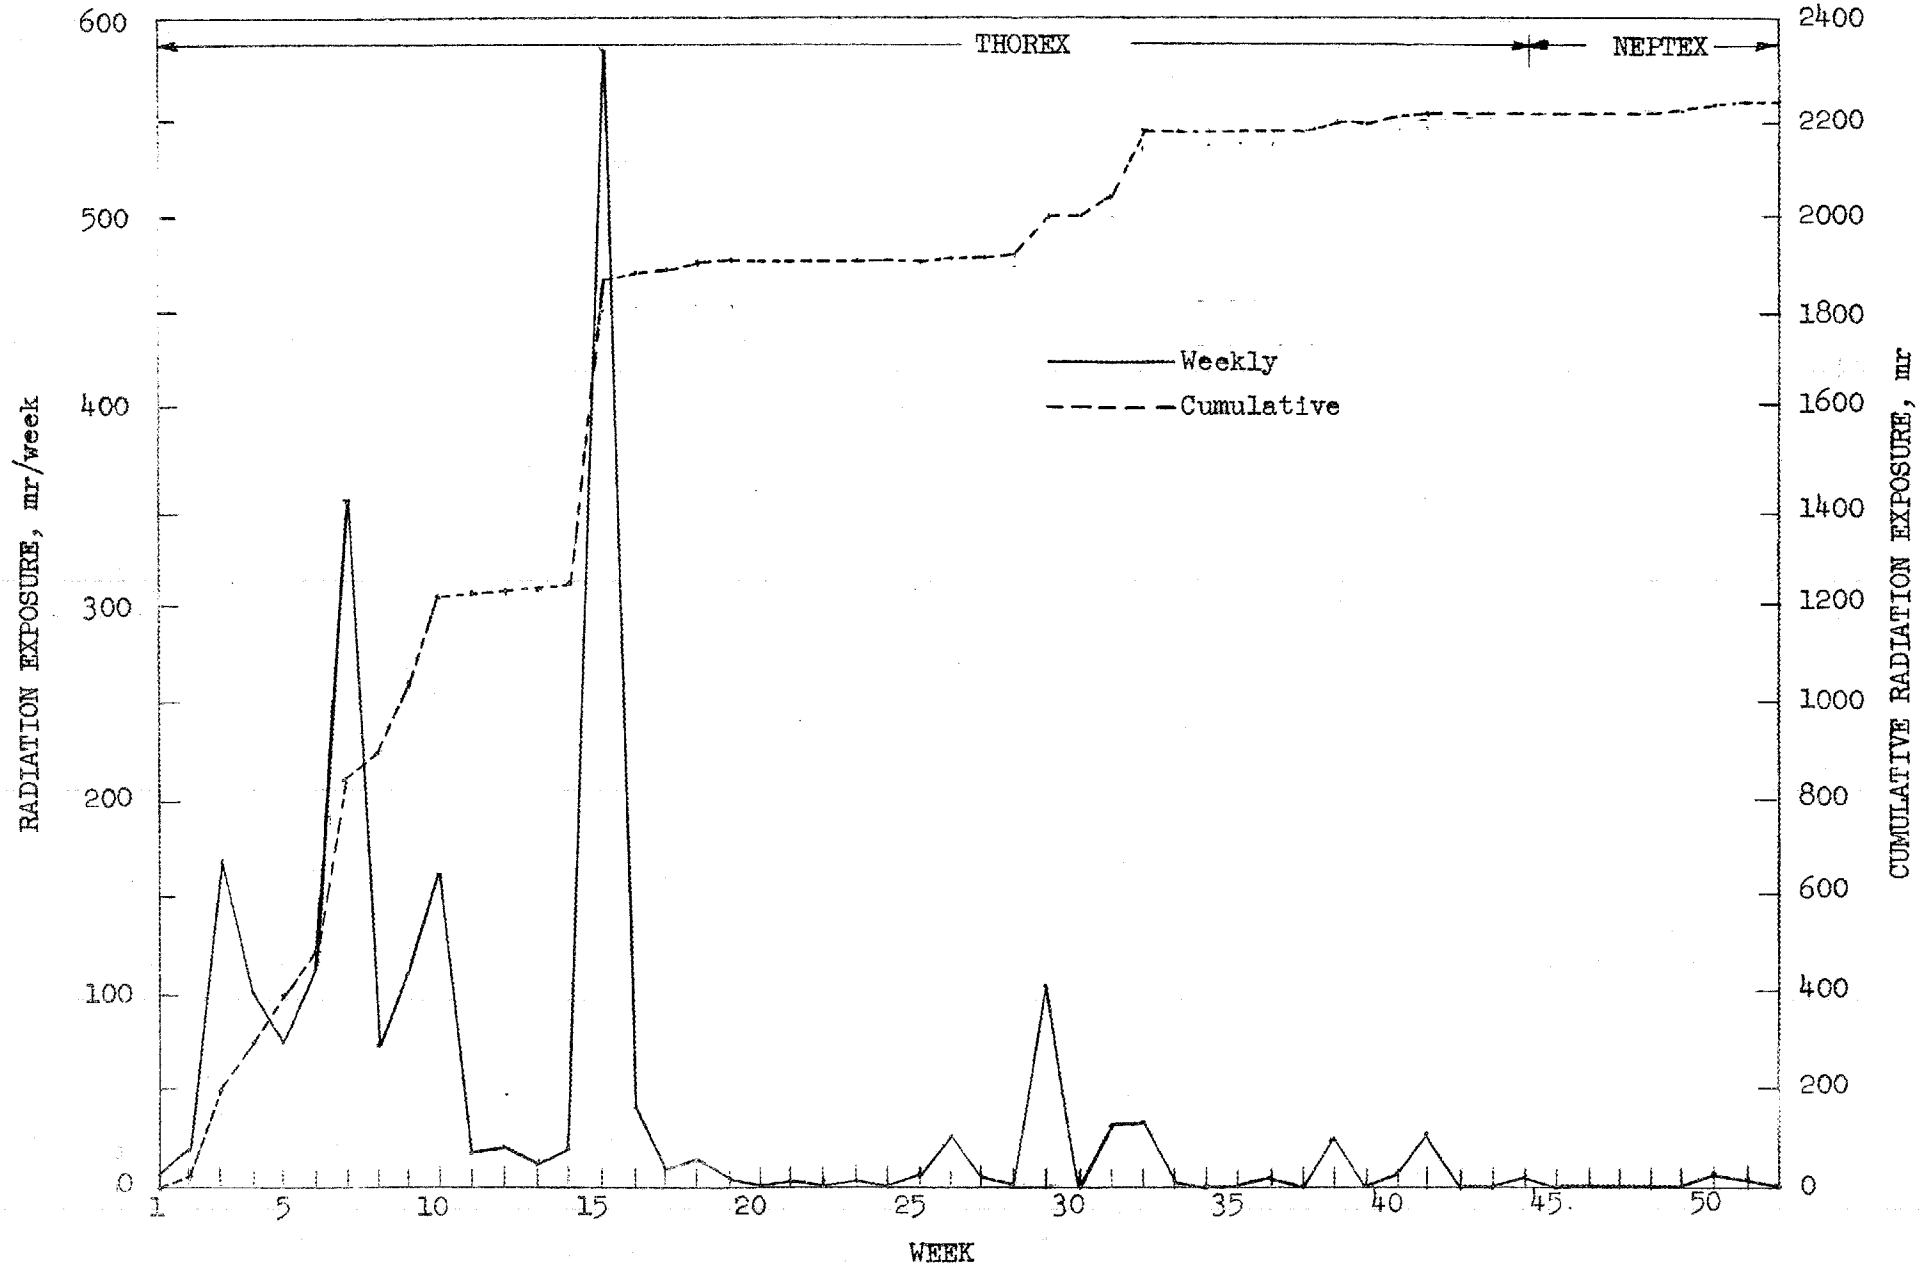
Fig. 6.9 Radiation Exposure Received by Operating Personnel in BT Decay Area

BT Decay Area. The radiation exposure received in the BT decay area accounted for 11% of the total exposure received by Thorex operating personnel during 1955. Operations that resulted in this exposure were chiefly equipment operation, product handling, equipment inspection, sampling, and miscellaneous operations. The cumulative exposure curve of Fig. 6.9 shows that approximately 80% of the total exposure in the BT decay area occurred during the first 15 weeks of the year, which represents an average exposure of 15 mr/man-week for this period. The doorway to the BT decay area was shielded with 6-in. barytes blocks during week 16, and the average exposure decreased to 1.5 mr/man-week for the remainder of the year. Leakage from the BT transfer pump (P-19-P) contaminated the BT decay area to 1350 mr/hr during week 15, and operation (product handling and equipment modification) in the vicinity of this contamination produced the highest weekly exposure, 580 mr (dosimeter reading), for 1955 in this area.

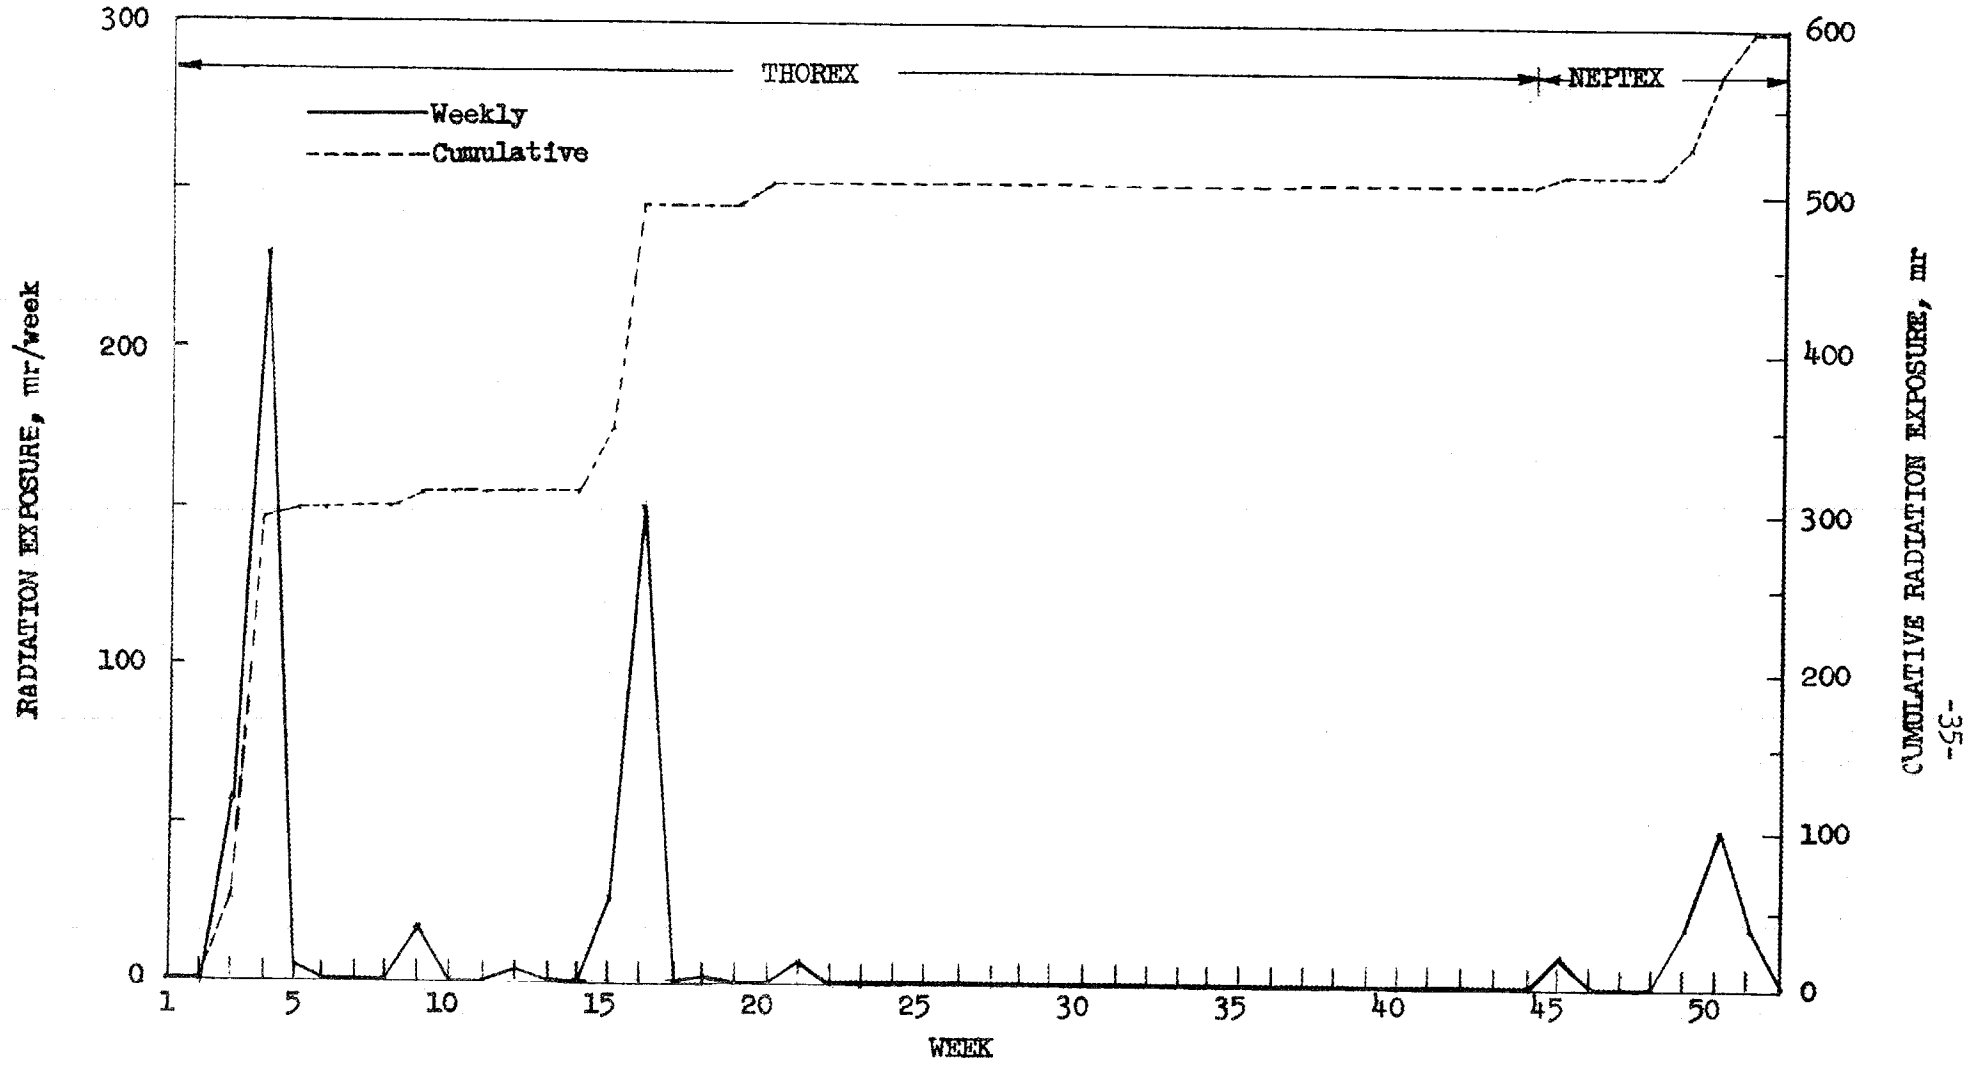
Fig. 6.10 Radiation Exposure Received by Operating Personnel in the Basement.

Basement. Radiation exposure received in the basement area was only a small portion (2.5%) of the total exposure received by Thorex operating personnel. The major portion of this exposure was received when thorium product was drummed and sampled in the basement with background radiation levels as high as 260 mr/hr (Fig. 6.10, weeks 4 and 16). The handling of thorium product in this area was discontinued, and radiation exposure was negligible for the remainder of the year except for the last month. To make room for second cycle equipment, the clean solvent catch tank (T-5) was moved from cell 7 to a cubicle in the basement. During the Neptex program, this tank became contaminated, producing a reading of 1200 mr/hr through the cubicle door on one occasion, and radiation was received by personnel while servicing equipment in this area.

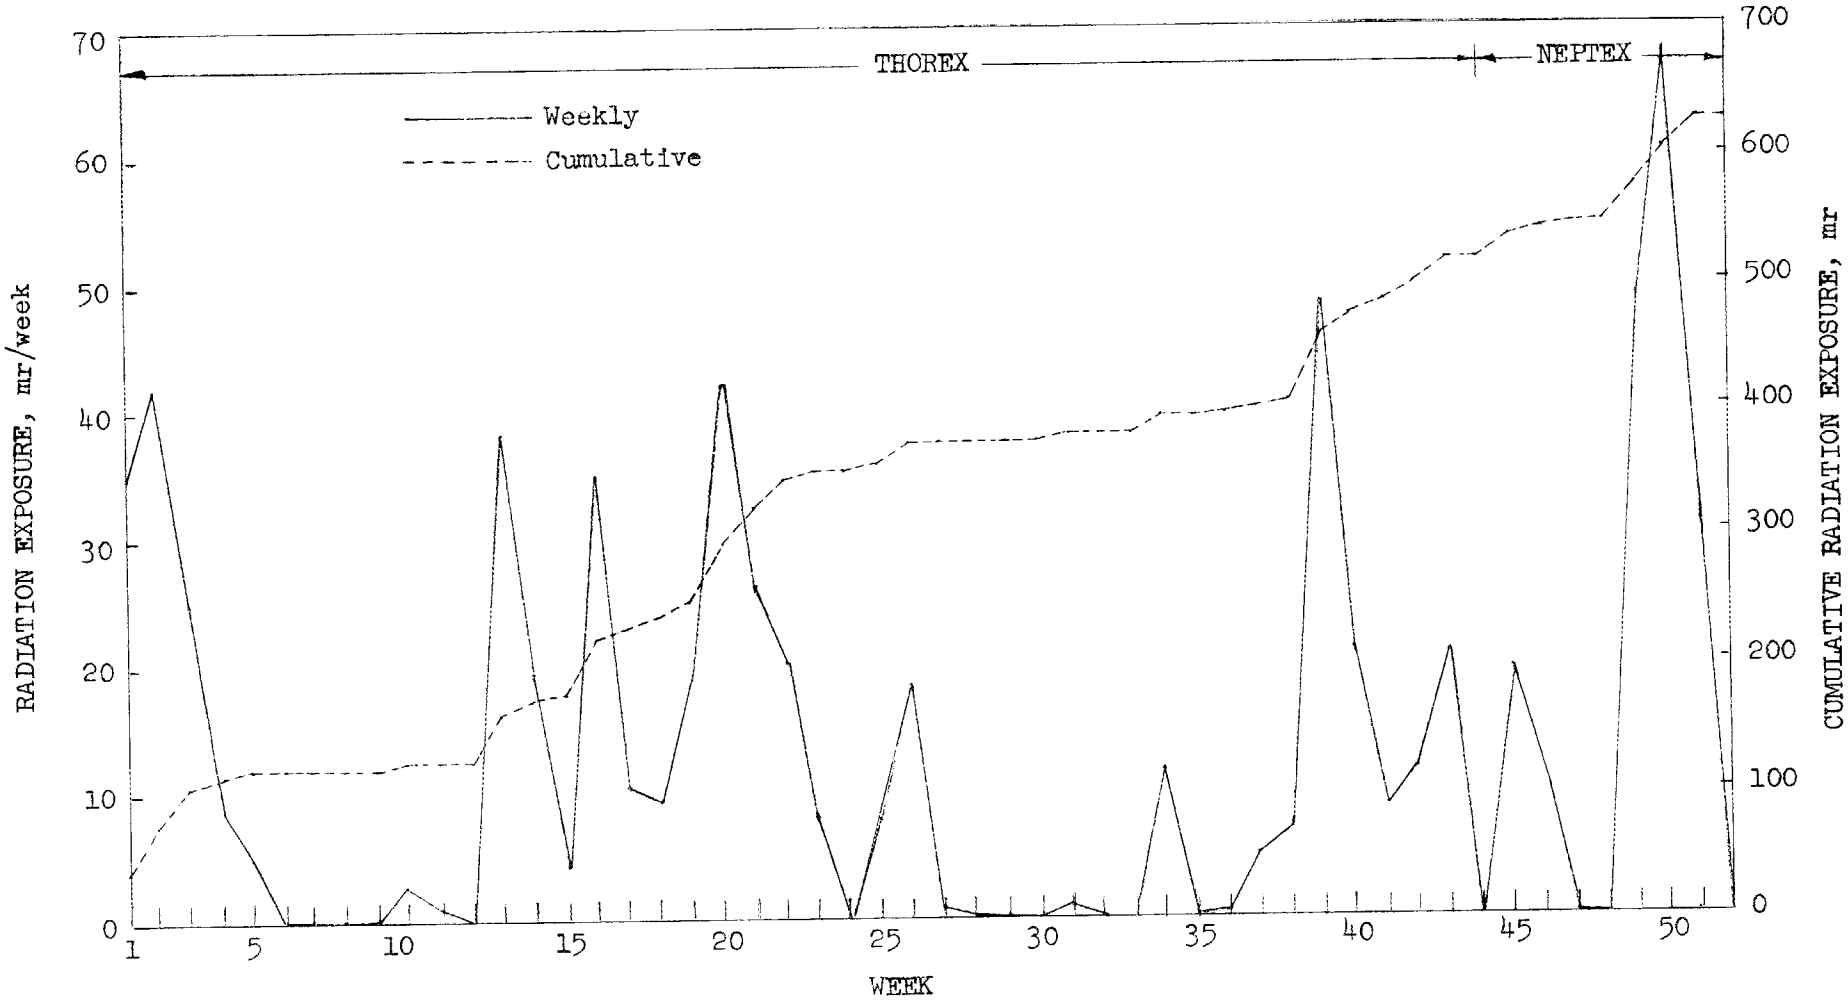
Fig. 6.11 Radiation Exposure Received by Operating Personnel in Pipe Tunnel, Control Room, and Makeup Area.

Pipe Tunnel, Control Room, and Makeup Area. Radiation received in these three areas amounted to only 3% of the total exposure to Thorex personnel for 1955. The cumulative exposure curve of Fig. 6.11 indicates that the rate of exposure accumulation corresponded approximately with the processing of radioactive material in the plant, and the average exposure rate for the year was 1.5 mr/man-week. Operations resulting in exposure were equipment inspection and decontamination.

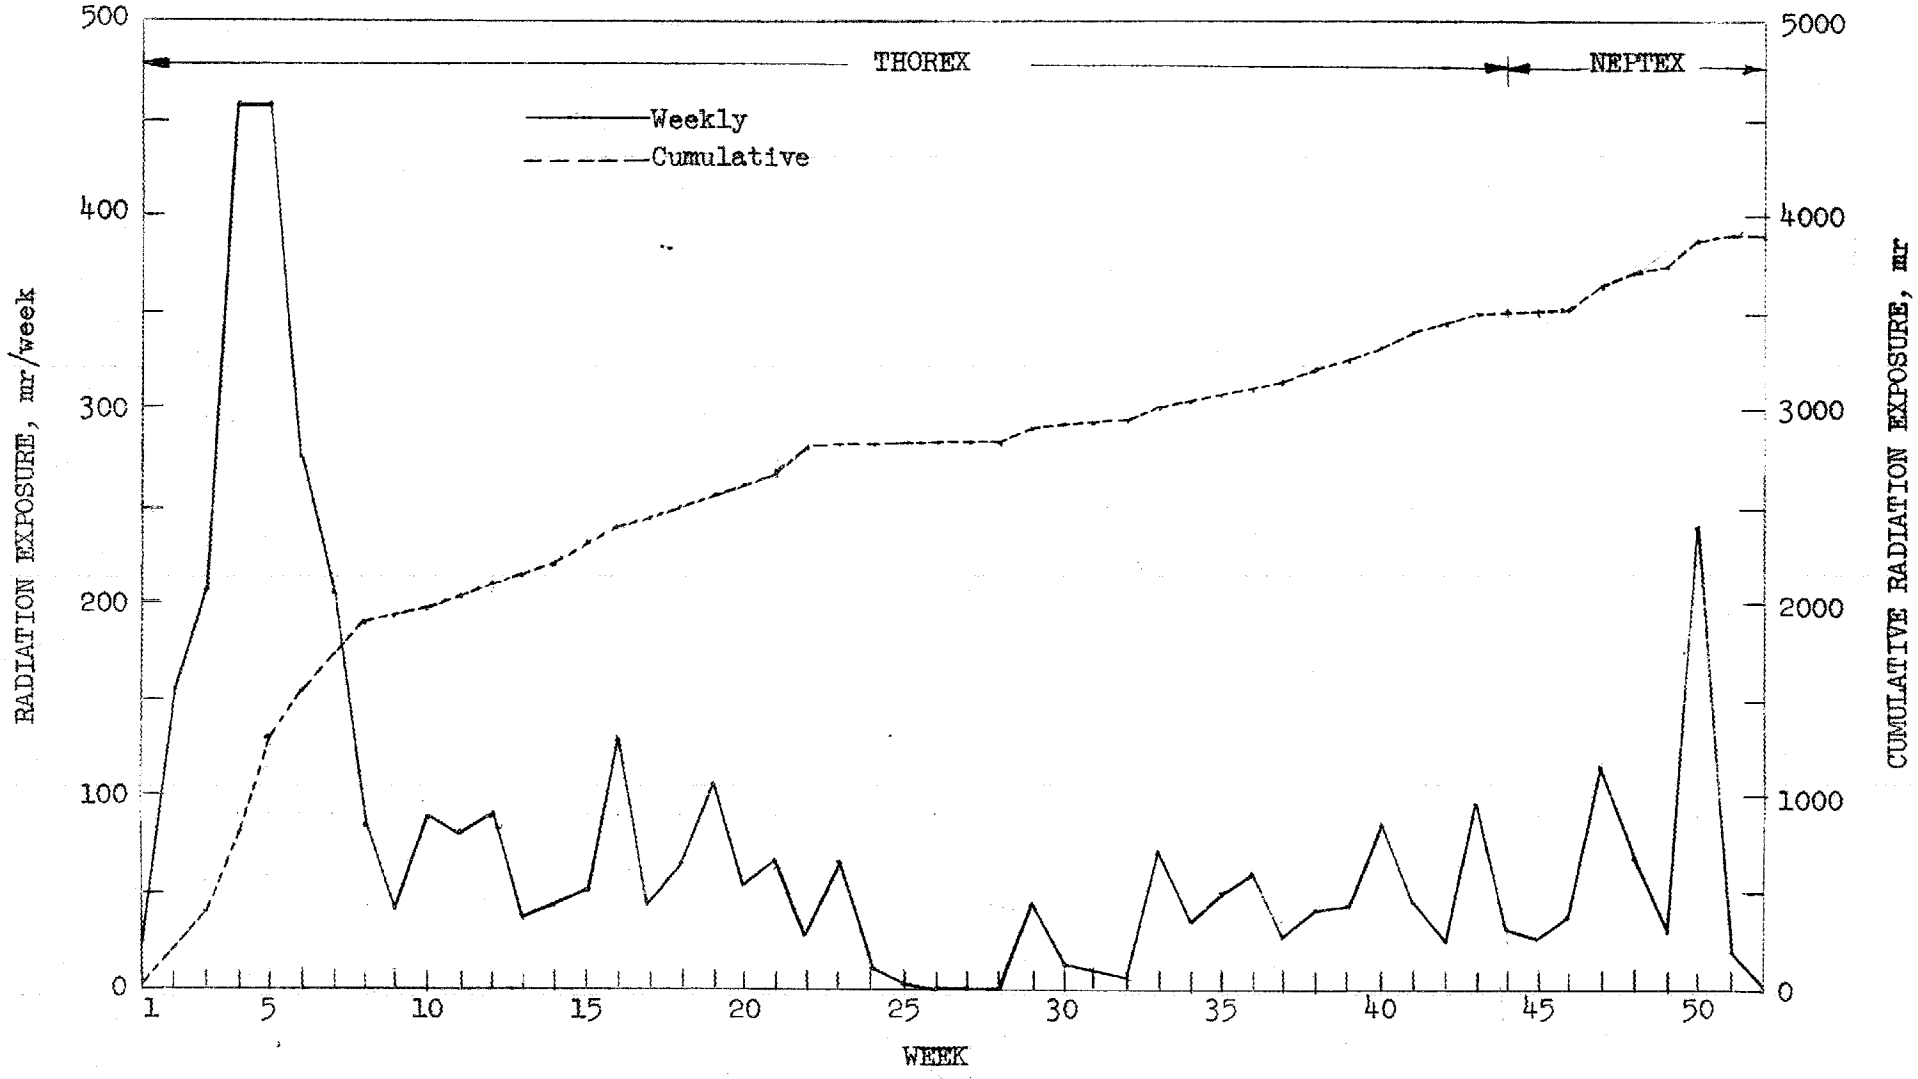
Fig. 6.12 Radiation Exposure Received by Operating Personnel During Sampling.

Sampling. Sampling operations accounted for 16% of the total radiation exposure to operating personnel during 1955. This total was accumulated mainly while sampling in the gallery (46%) and in the isolation laboratory (31%). Approximately 45% of the total exposure due to sampling was accumulated during the first 7 weeks of the year (Fig. 6.12), and the average exposure rate was 31 mr/man-week for this period. Over half the exposure due to sampling in this 7-week period occurred in the isolation laboratory. After several units of equipment had been shielded, radiation exposure, including that due to sampling, was reduced in the isolation laboratory, and the average exposure rate for sampling decreased to 6 mr/man-week for the remainder of the year.

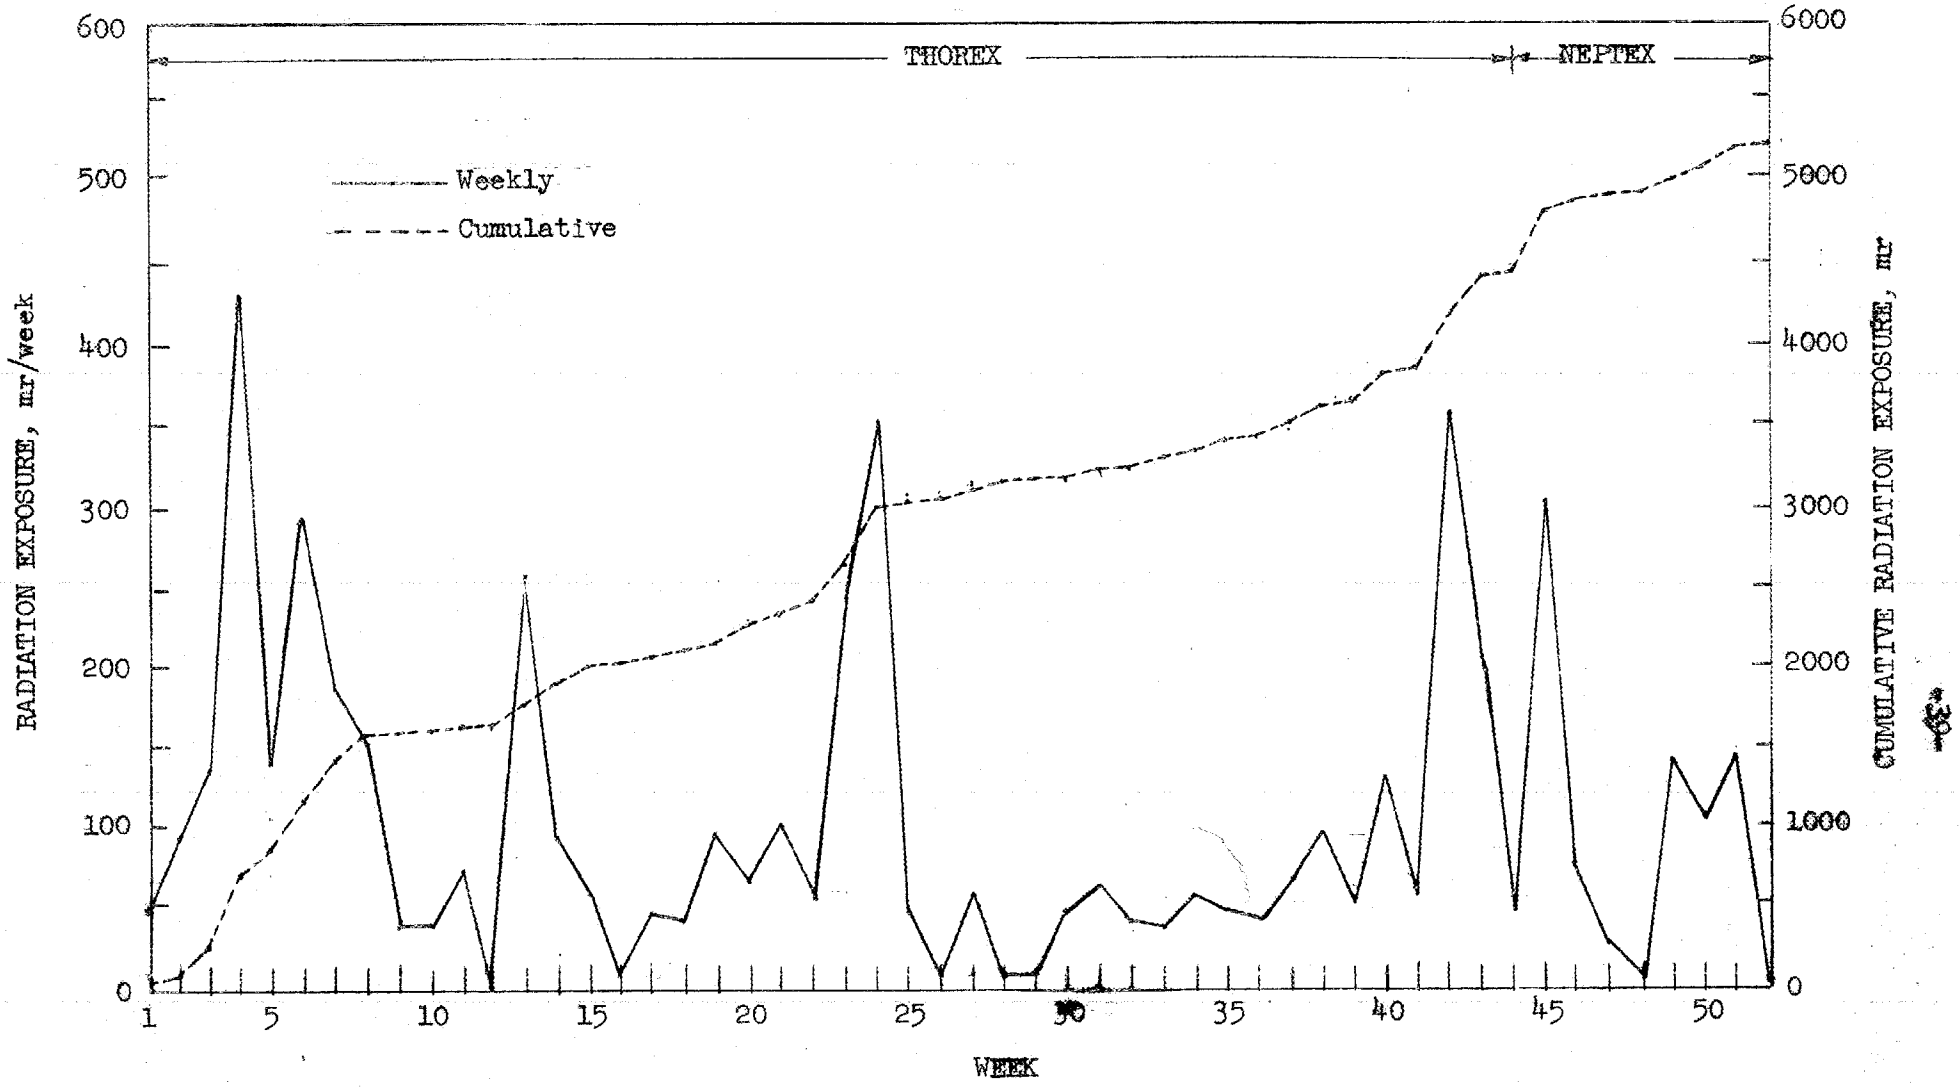
Fig. 6.13 Radiation Exposure Received by Operating Personnel During Equipment Inspection.

Equipment Inspection. The operation resulting in the greatest proportion (21%) of radiation exposure to operating personnel was equipment inspection, and of this amount, 28% was received in cell 5 and 46% in cells 6 and 7. The accumulation of exposure during the year (Fig. 6.13) was maintained at an average rate of 12.5 mr/man-week, and 8 weeks of high exposure (dosimeter readings greater than 200 mr) were primarily responsible for this exposure rate. The highest weekly exposure (dosimeter readings 430 mr) for the year occurred in week 4 during routine equipment inspection in cell 6. At this time the radiation levels of cell 6 equipment were at their highest peak of the year (the BT evaporator read 6.1 r/hr). Routine equipment inspection also accounted for the high exposures during weeks 6 and 7. These exposures were received primarily in three areas (cell 6, BT decay area, and isolation laboratory), where radiation levels ranged from 400 to 2000 mr/hr. The sharp peak in the radiation exposure curve in week 13 was caused by nonroutine equipment inspection of welds in the bottom of the partitioning column and in a transfer line connecting the CW catch tank (T-4) and the rework tank (N-8) which had leaked and were repaired during this week. The accumulation of exposure while inspecting equipment increased rapidly during weeks 23 and 24. All this exposure was received in cell 5 while repairs were being made on the feed pumps and filters. The operation of the alternate solvent recovery system required frequent routine inspection of the two glass spray columns in cell 7. This accounted for the high exposure during week 42. The high peak in the exposure curve of Fig. 6.13 in week 45 resulted from radiation received during inspection of the maintenance work performed on equipment in cell 5 prior to the startup of the Neptex runs.

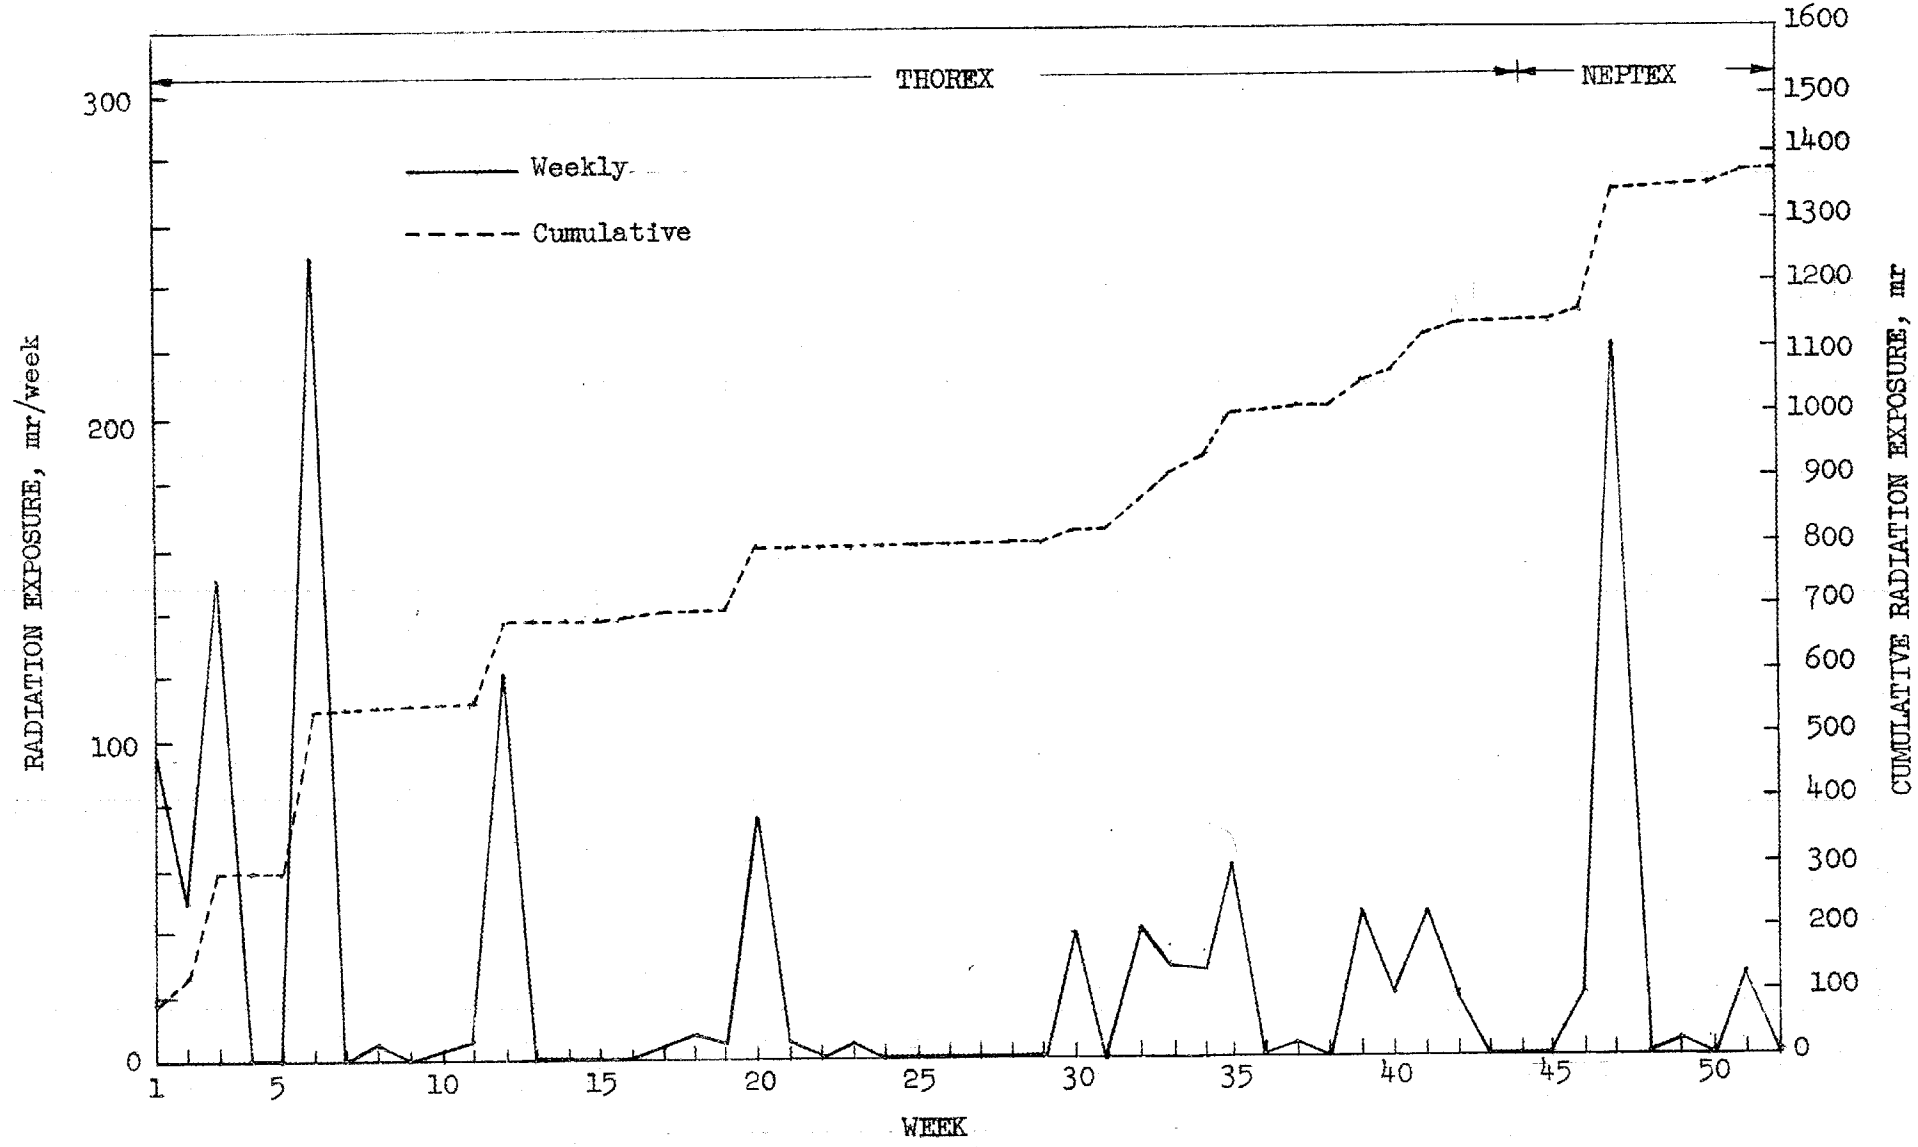
Fig. 6.14 Radiation Exposure Received by Operating Personnel During Slug Loading, Slug Charging, and Solution Makeup

Slug Loading and Charging and Solution Makeup. The radiation received while performing these operations amounted to 6% of the total exposure to operating personnel for 1955. Fifty-eight per cent of this amount was attributed to slug loading and charging and the remainder to solution makeup. Exposure during solution makeup was received primarily (62%) in the isolation laboratory, and most of this occurred within the first 7

weeks of the year. The highest weekly exposure, which occurred during week 6, was accumulated entirely in the isolation laboratory while making up solutions. The intermittent nature of slug loading and charging is responsible for the steplike appearance of the cumulative exposure curve of Fig. 6.14. Each peak in the weekly exposure curve, except for week 6, coincides with slug loading and charging operations. Approximately 49 mr was received for each loading and charging of thorium slugs, and approximately 51 mr was received for each of the 12 MTR elements that were loaded and charged during the Neptex program.

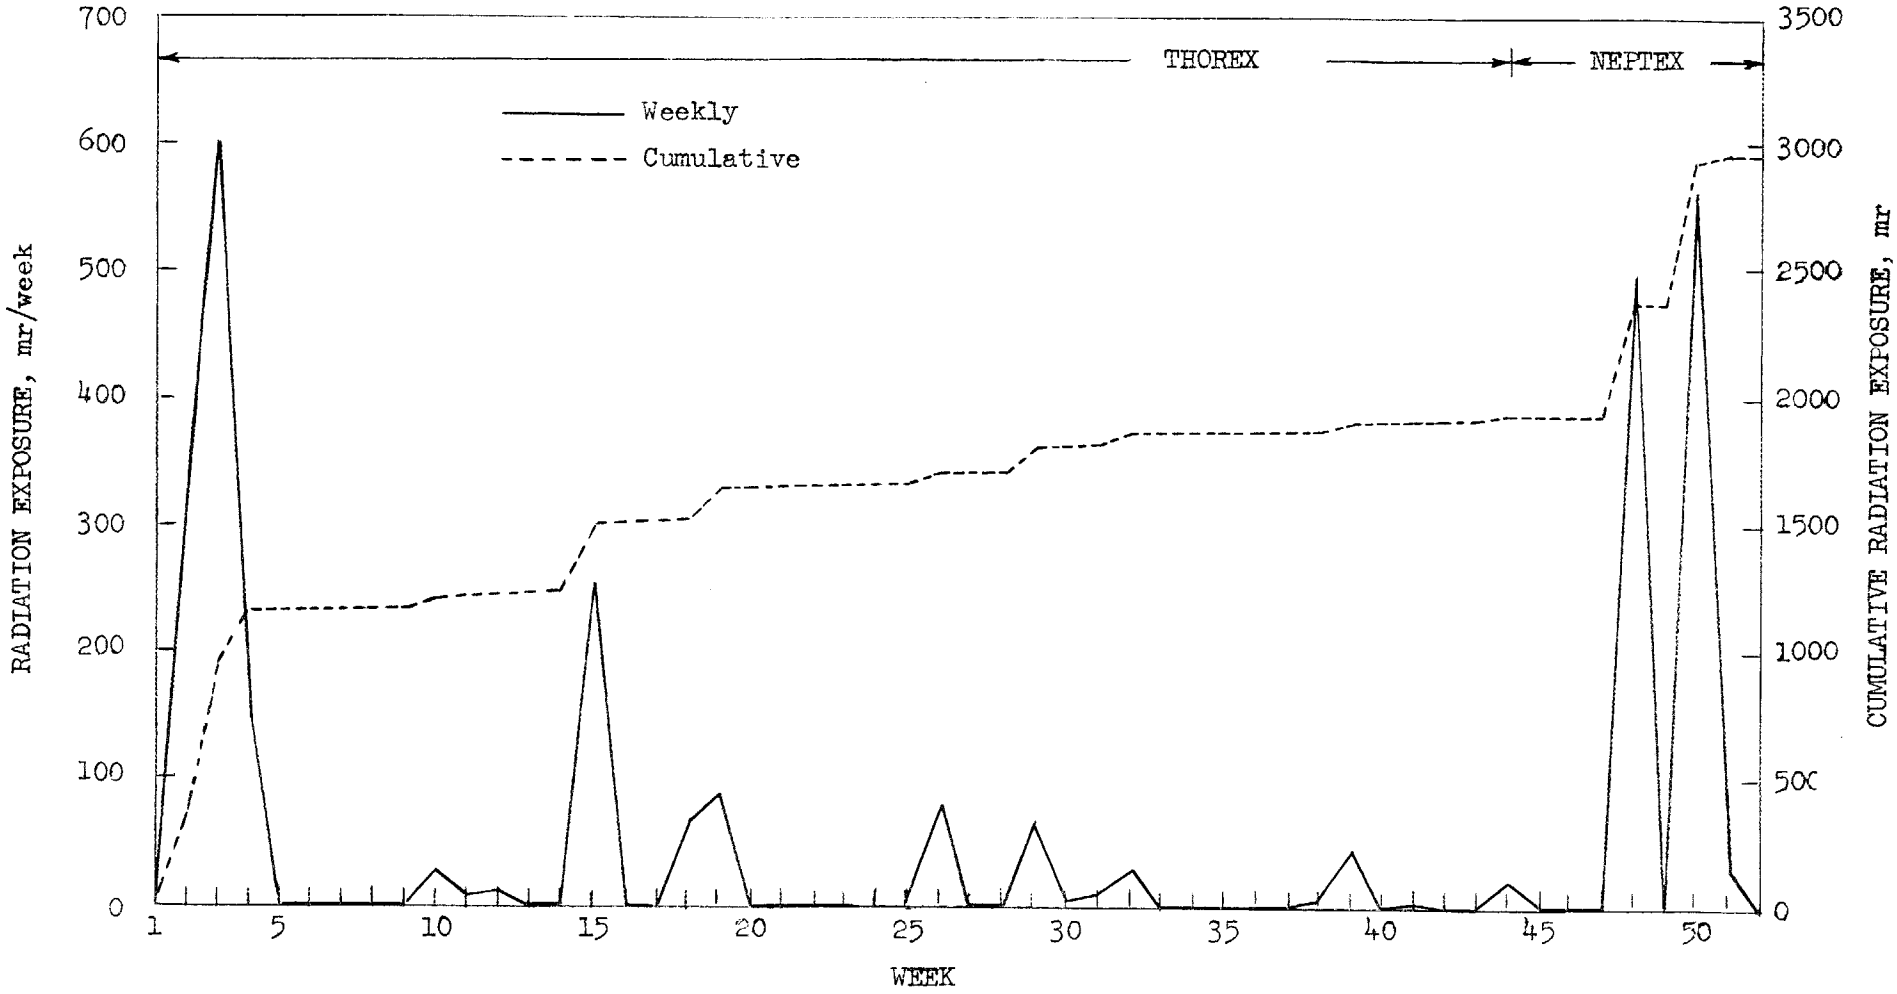
Fig. 6.15 Radiation Exposure Received by Operating Personnel During Product Handling.

Product Handling. The handling of product---thorium, U^{233}, U^{235}, or Np^{237}---accounted for 12% of the total radiation exposure to operating personnel. This exposure was accumulated mainly in the isolation laboratory, cells 6 and 7, and the BT decay area. Most of the exposure due to product handling was received in the first and last portions of the year. Forty per cent of the exposure was received while handling U^{233} product in the isolation laboratory in weeks 2 through 4. The handling of Neptex product in the roof area and in cells 6 and 7 accounted for 37% of the total. The peak in the weekly exposure curve of Fig. 6.15 for week 15 resulted from handling thorium product in the BT decay area where P-19-P leakage had contaminated the area to 10 r/hr. Personnel exposure rates while handling product were 37 mr/man-week (weeks 1-4), 2 mr/man-week (week 5-47), and 26 mr/man-week (week 48-52).

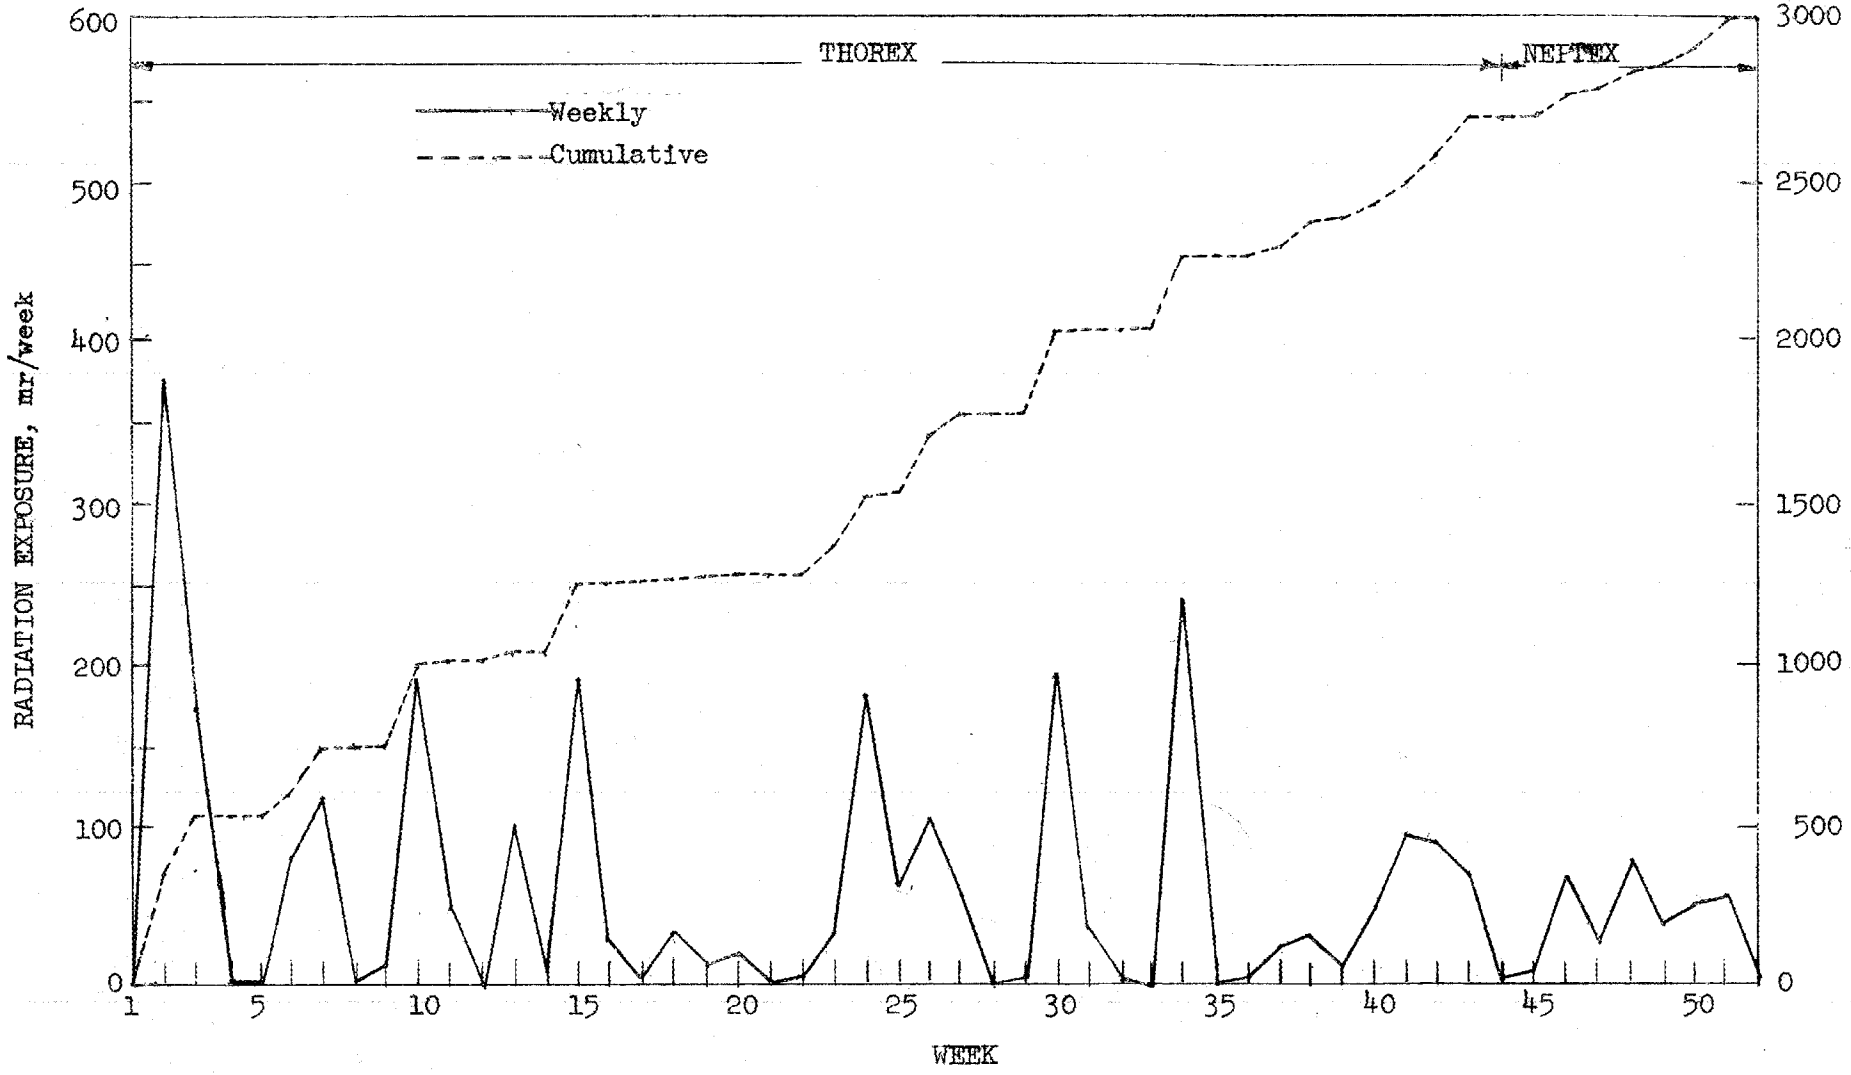
Fig. 6.16 Radiation Exposure Received by Operating Personnel During Equipment Operations

Equipment Operation. The operation of equipment accounted for 12% of the total radiation exposure to operating personnel. This total was accumulated mainly in cells 6 and 7, BT decay area, and cell 5. Except for the first three weeks of the year, the accumulation of exposure was relatively constant, with an average for the year of 7 mr/man-week (Fig. 6.16).
