ORNL-2102
Health and Safety

ANALYSIS OF THOREX PILOT PLANT RADIATION EXPOSURES DURING 1955

W. T. McCarley

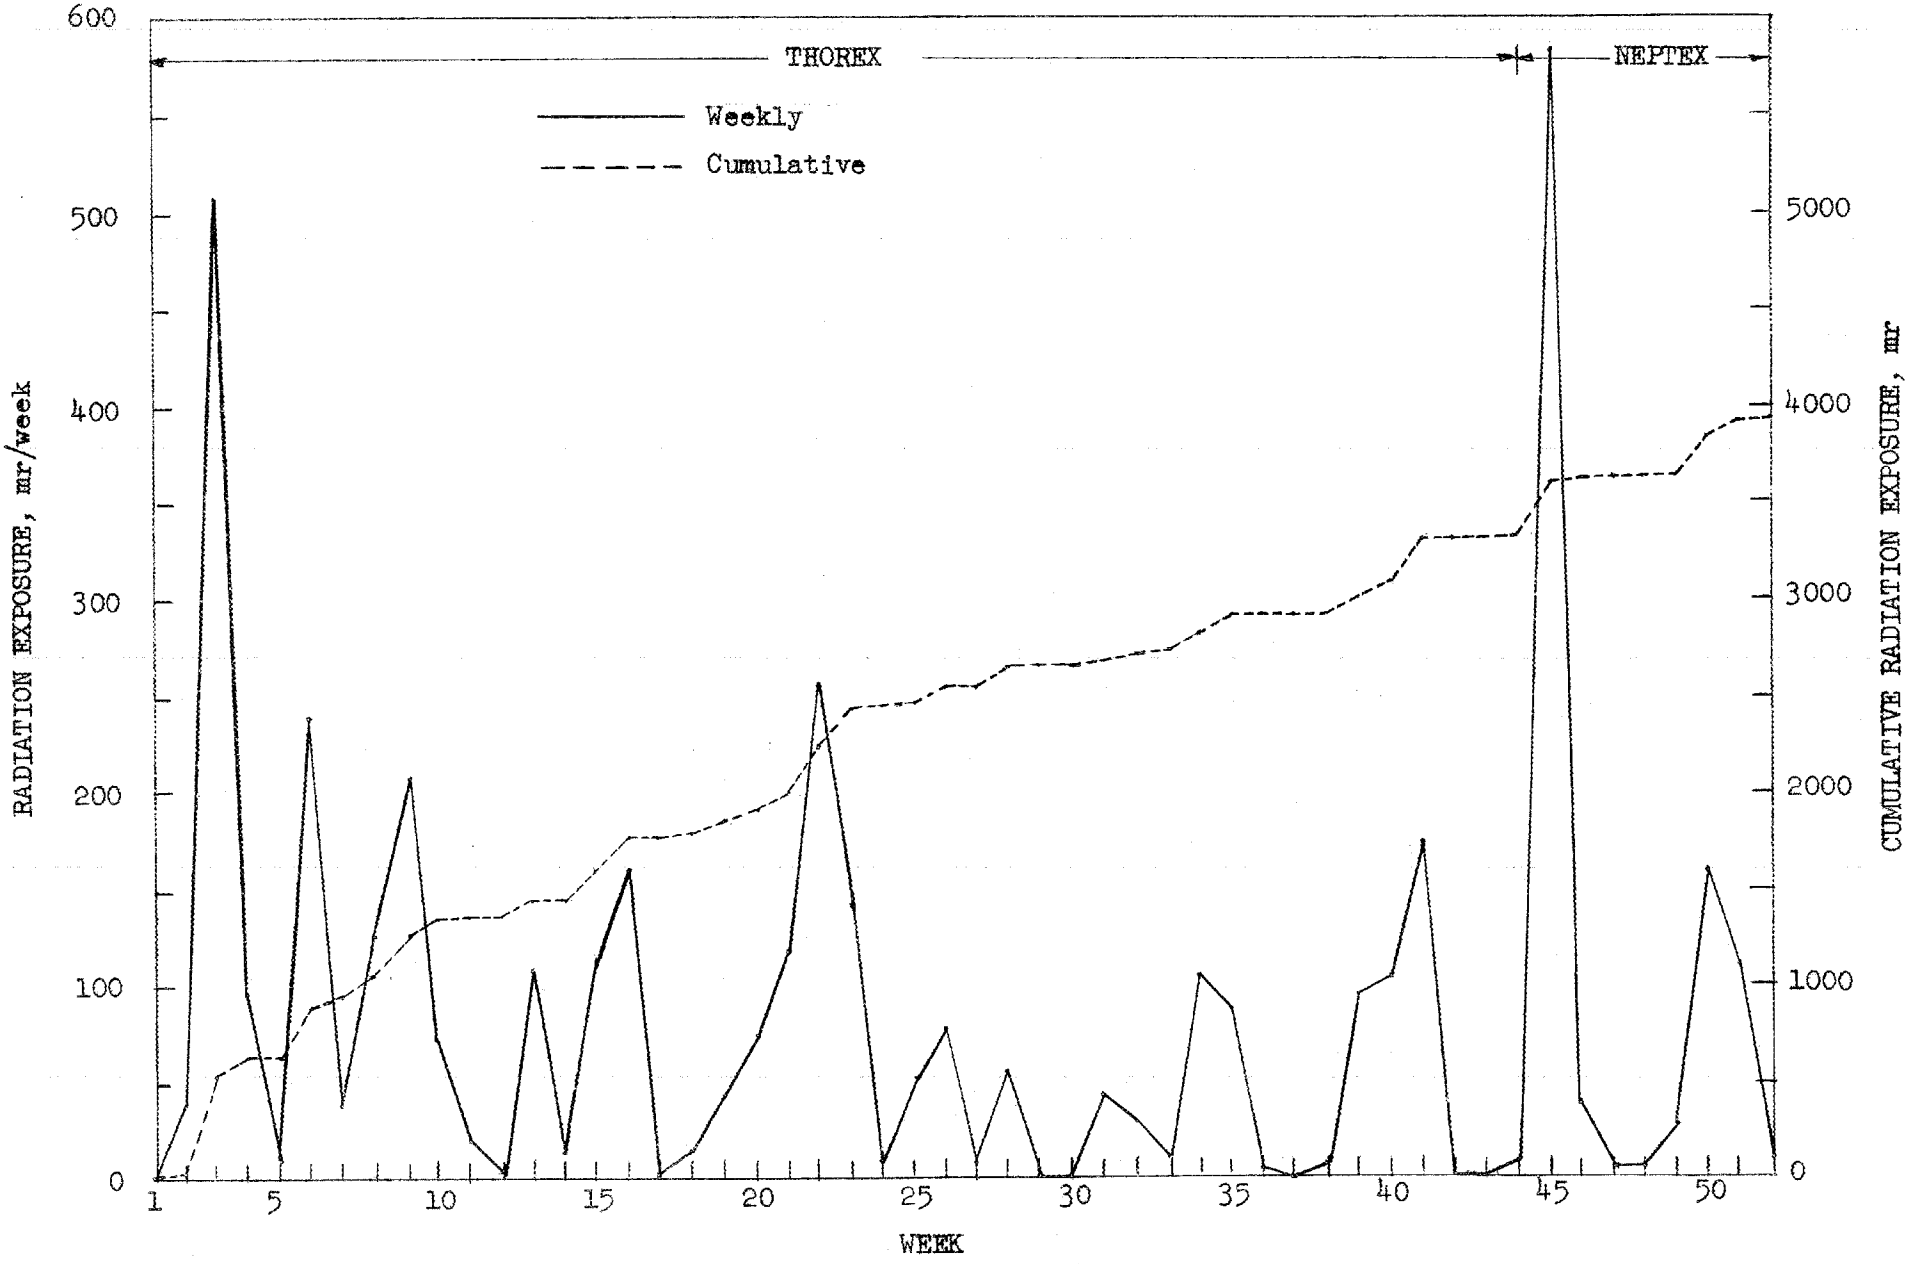
Fig. 6.17 Radiation Exposure Received by Operating Personnel During Decontamination.

Decontamination. In order to decrease the exposure of operating and maintenance personnel, it was necessary to keep the Thorex Pilot Plant as free of contamination as possible by prompt and thorough decontaminating procedures. These operations accounted for the second highest proportion

(16%) of exposure to personnel; however, if these operations had not been carried out, the accumulation and spread of contamination would have soon forced a plant shutdown to avoid excessive personnel exposure. Exposure due to decontaminating operations was received mainly in cells 6 and 7 (30%), cell 5 (29%), and the isolation laboratory (20%), and the exposure rate varied from an average of 12 mr/man-week during the first half of the year to 7 mr/man-week during the last half. The weekly accumulation of exposure received during decontamination is presented in Fig. 6.17. The high exposure received in week 3 resulted from intensive decontamination of the isolation laboratory and cells 6 and 7. Radioactive solution from a faulty check valve was tracked throughout the isolation laboratory, and this area remained contaminated for several weeks. Activity carryover from the extraction column to the other equipment accumulated rapidly during the production run in January, and this necessitated a complete plant decontamination prior to maintenance and construction. This was accomplished in weeks 7 through 11. Similarly, an intensive decontamination program was carried out in cells 6 and 7 during week 22 in preparation for the installation of second cycle equipment. The highest weekly exposure (dosimeter readings of 580 mr) resulting from decontamination occurred during week 45. Again, extensive decontamination prior to equipment maintenance and modification resulted in this high exposure. In this latter instance, it was necessary to accomplish the following repairs in cell 5 prior to the Neptex program: replacement of the agitator in the feed adjustment tank (S-2), unplugging of the jet suction line on the S-2 outer jacket, and unplugging of the vapor line from S-2 to the acid fractionator (S-9).
