Removal Action Report for the Core Hole 8 Plume Source (Tank W-1A) at Oak Ridge National Laboratory Oak Ridge, Tennessee

Date Issued – January 2002

Prepared for the
U.S. Department of Energy
Office of Environmental Management

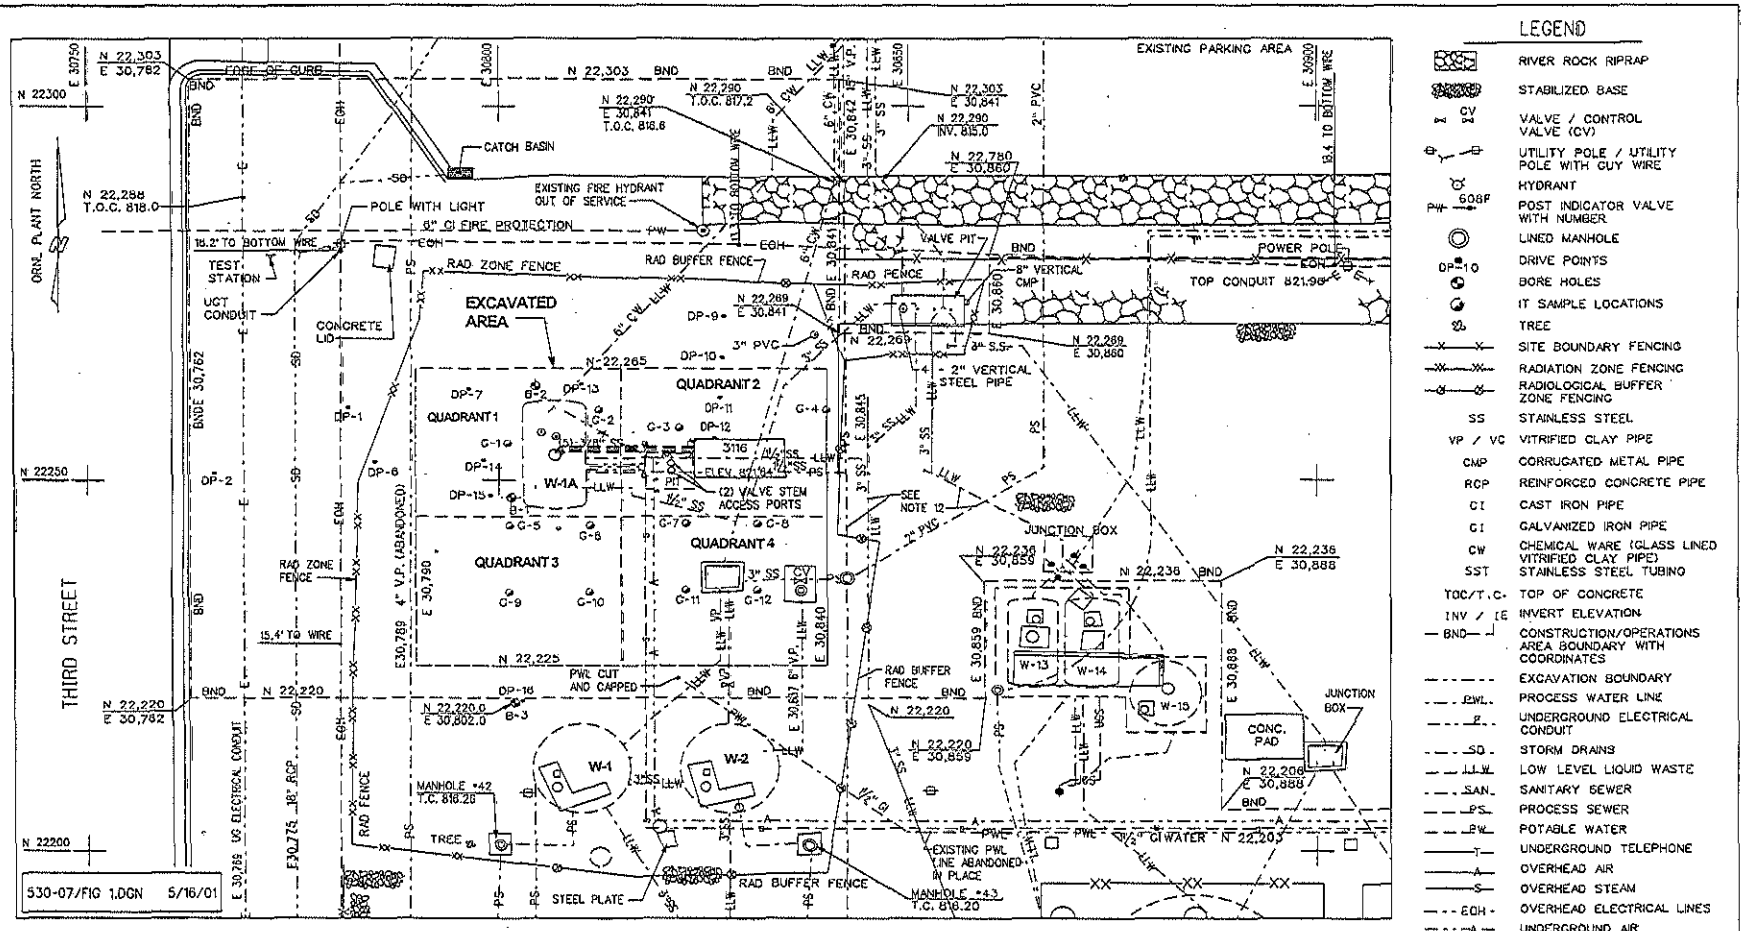
Fig. 1. Tank W-1A removal action excavated area.

The excavation area was approximately 12 by 15 m (40 by 50 ft) and is shown on Fig. 1. The average depth to bedrock was approximately 15 ft below surface. The area containing the high-concentration transuranic soil is shown in Figs. 2 and 3.

The Removal Action was accomplished by dividing the 40- by 50-ft area of excavation into four equally sized quadrants. The quadrants were identified by numbers beginning with the northwest quadrant as 1 and numbered clockwise 1 through 4 (see Fig. 1). Photographs of the excavation of each quadrant are provided in Appendix A.

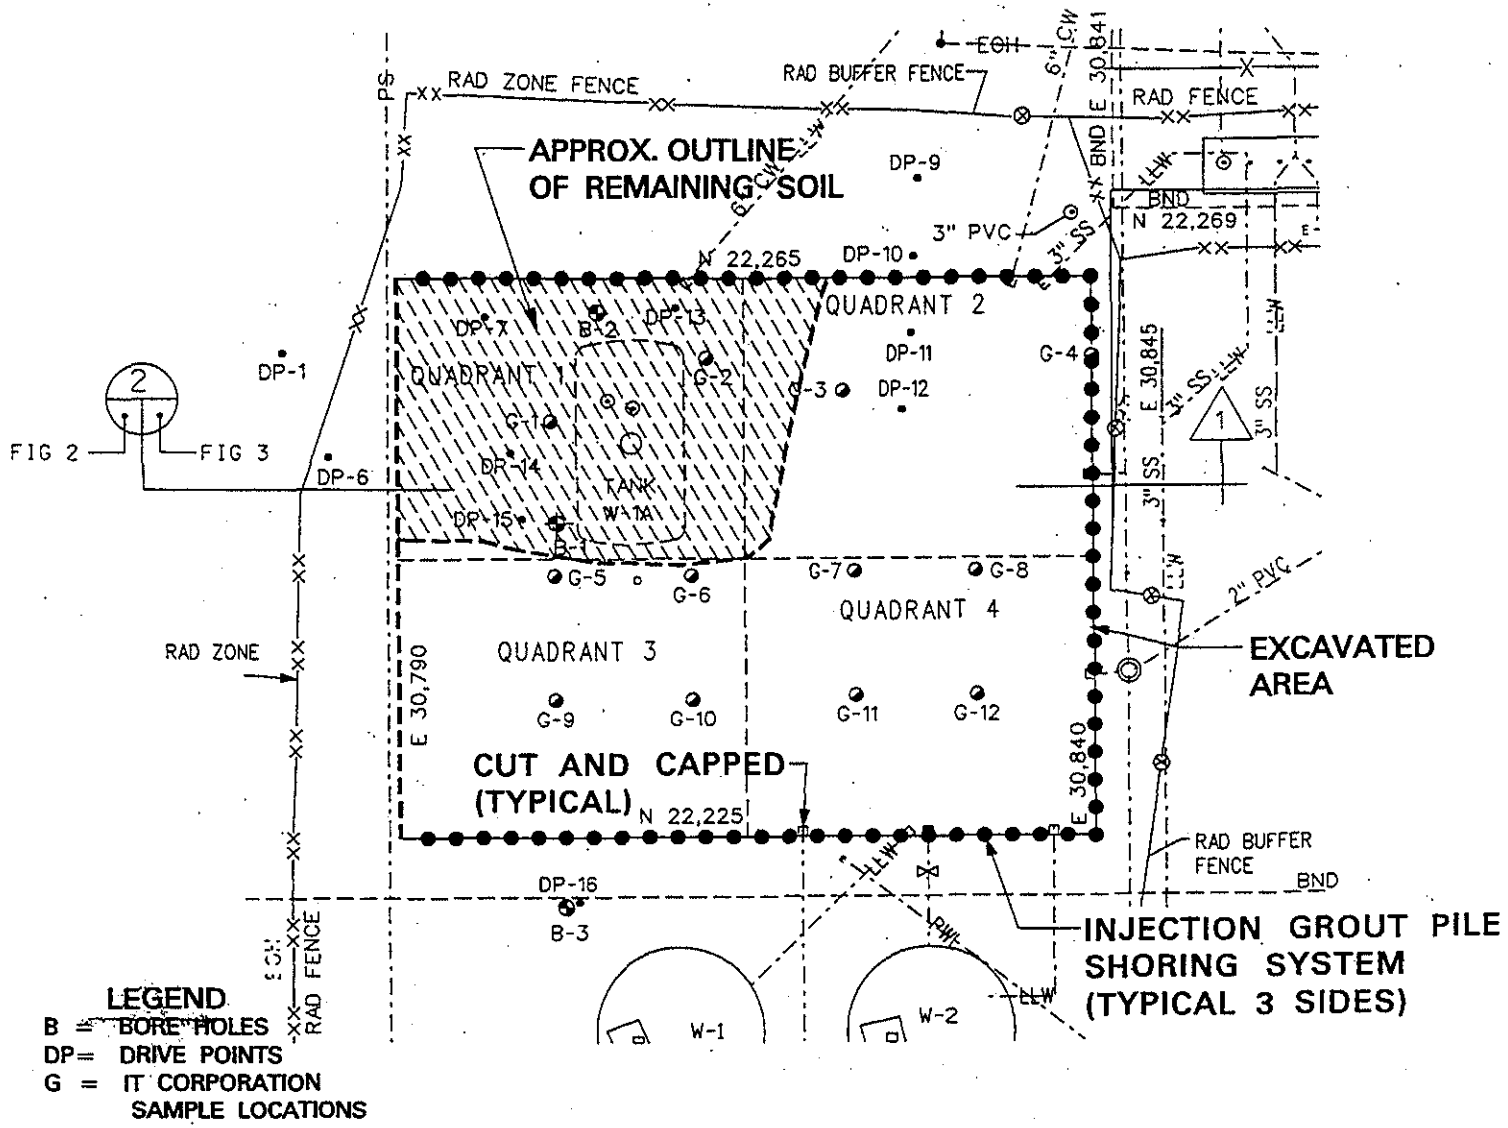
Fig. 2. Plan view of the approximate area of soil remaining after excavation.

4. During excavation of soil from around the tank in quadrant 1, approximately 100 yards^3 of soil containing high concentrations of transuranic isotopes was encountered. These soils and the tank were left in place as a result of the presence of TRU waste, the removal of which was not contemplated by either the EE/CA or the Action Memorandum. Accordingly, these remaining soils were beyond the scope of the action authorized under the Action Memorandum. Figure 2 provides a plan view of the approximate area of the remaining soil and Fig. 3 provides a cross section through the remaining soil and tank.
