CORROSION OF THE VOLATILITY PILOT PLANT
INOR-8 HYDROFLUORINATOR AND NICKEL 201
FLUORINATOR DURING FORTY FUEL-PROCESSING
RUNS WITH ZIRCONIUM-URANIUM ALLOY

ORNL-3623

Chemical Technology Division

MARCH 1965

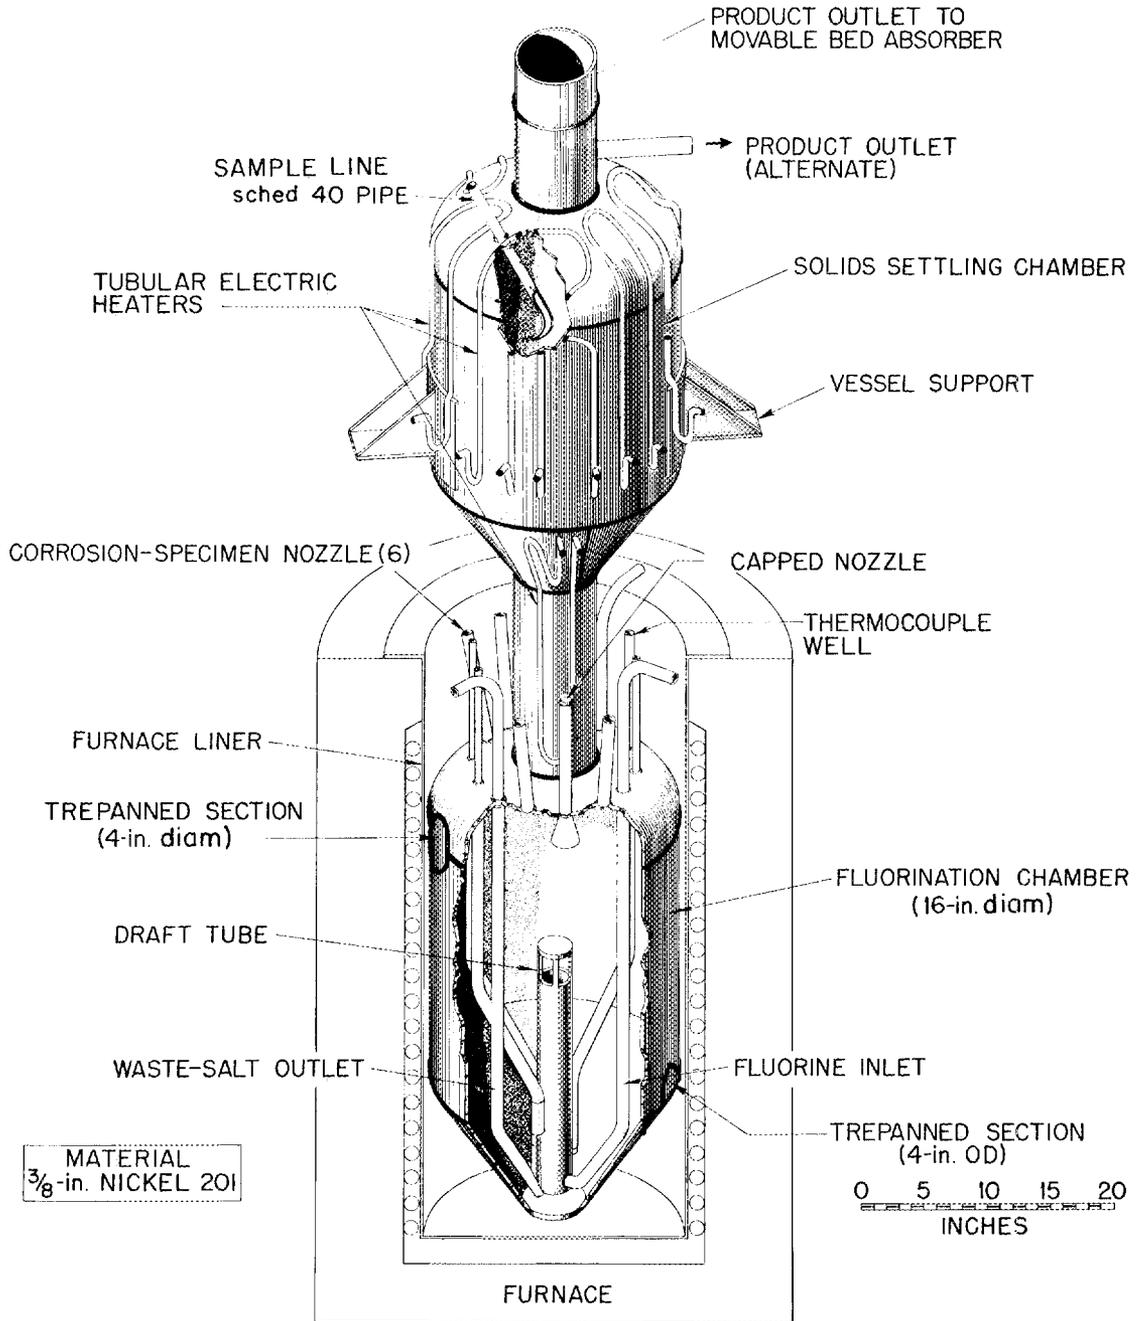
Fig. 10. Volatility Pilot Plant Fluorinator, Mark III.

Two 4-in.-diam disks were trepanned from the lower section of the fluorinator after T-11 (29 runs) for metallurgical analysis. They were removed from the intersection of girth and seam welds (Fig. 10) after radiography revealed that the weld had been selectively attacked. New plugs were welded into the holes from which the disks were removed.

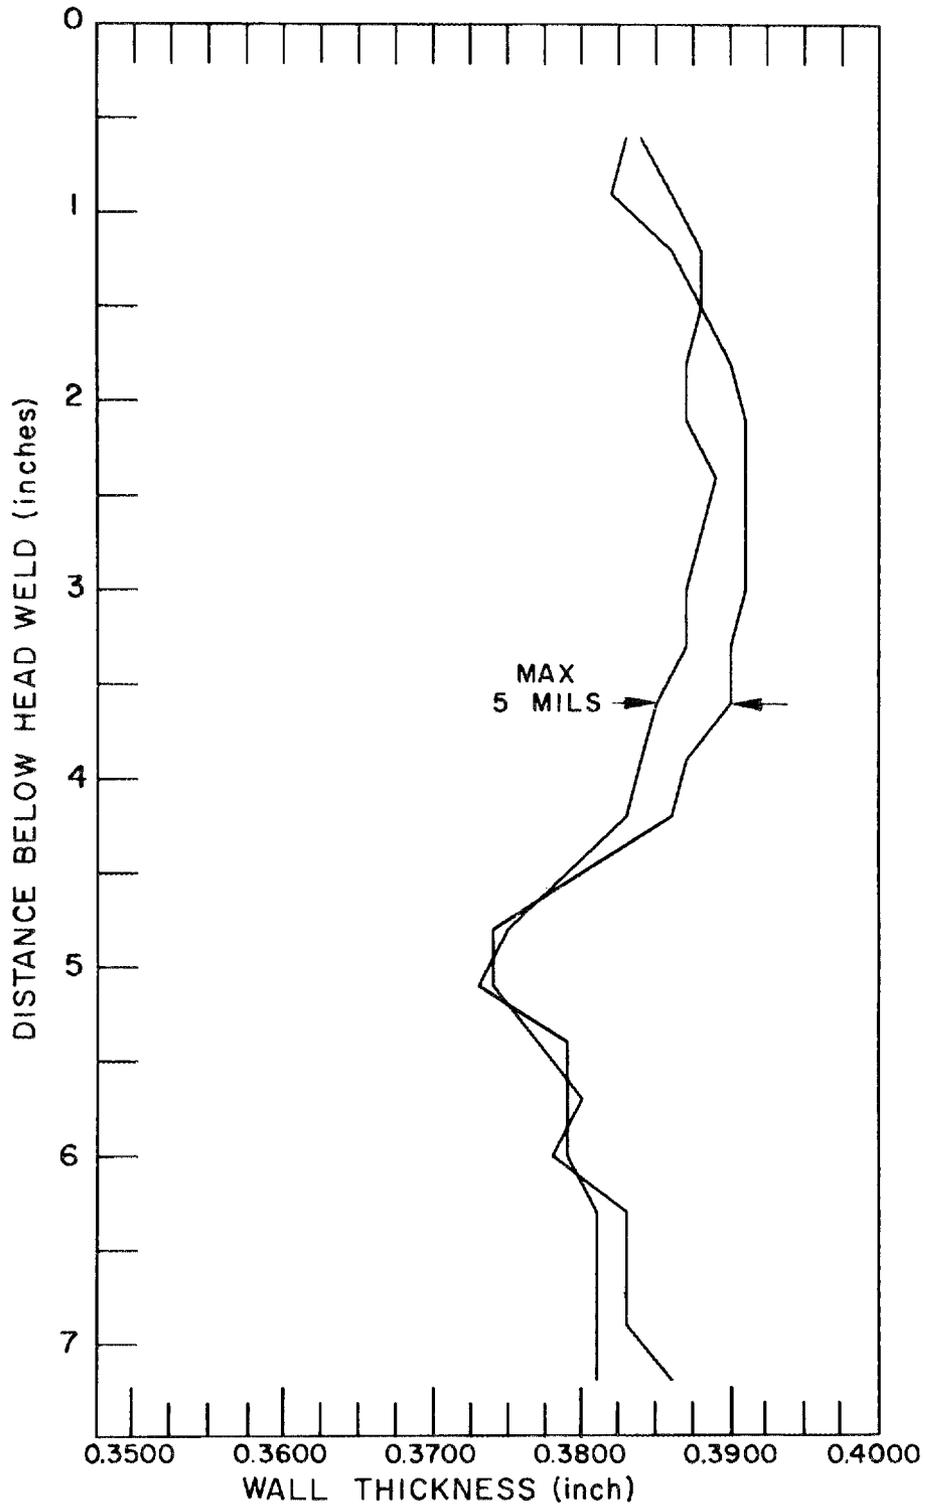
Fig. 1A. Duplicate Measurements Made in the Hydrofluorinator to Indicate the Precision of the Pulse-Echo Technique.

After 40 runs, the hydrofluorinator was only partially decontaminated, and wall-thickness measurements were made with the ultrasonic pulse-echo procedure originally developed for the Homogeneous Reactor Test.¹ With this method, a crystal transducer was placed inside the hydrofluorinator, which was filled with water to couple the transducer to the wall. The transducer emitted ultrasonic pulses that produced reverberation in the vessel wall at a point opposite the transducer. The time between pulses from these reverberations was measured by an electronic gating circuit and counter and was converted directly into wall thickness. This method also indicated predominant wall thickness. An estimate of the error of the pulse-echo system, based on time constants in the electronic circuitry, is $\pm 3.3\%$ for 1/4-in. material and $\pm 2.5\%$ for 1/2-in. material; however, the error could be as high as $\pm 10\%$.⁵ The variation of duplicate measurements taken in the 3/8-in. large-cylinder section of the hydrofluorinator is shown in Fig. 1A in the Appendix. These measurements have a maximum variation of 5 mils or 1.3% of the wall thickness.
