ORNL-4714 *107*
UC-25 - Metals, Ceramics, and Materials

POSTIRRADIATION EXAMINATION AND
EVALUATION OF THE PERFORMANCE
OF HFIR FUEL ELEMENTS

A. E. Richt
R. W. Knight
G. M. Adamson, Jr.

DECEMBER 1971

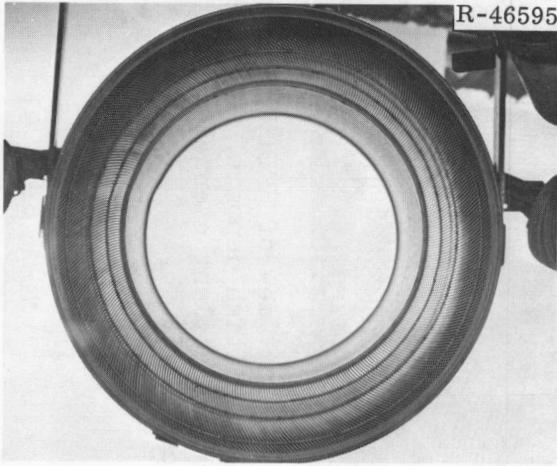
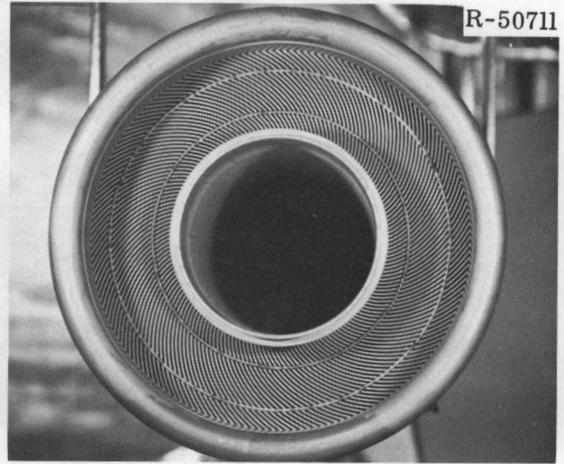
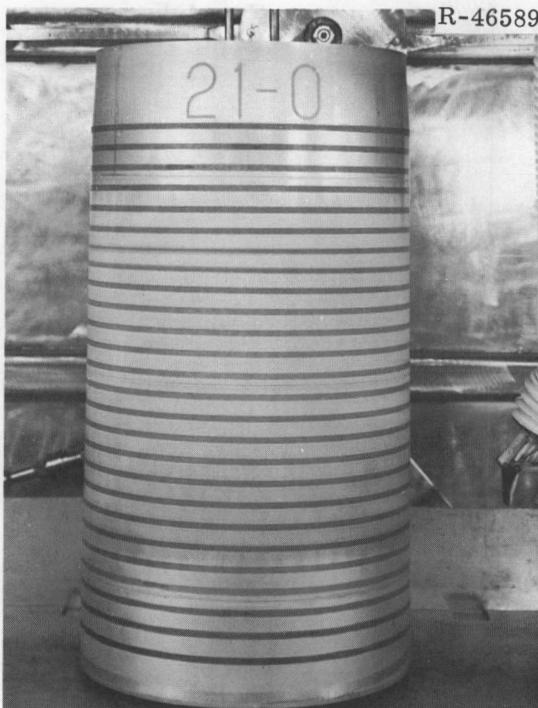
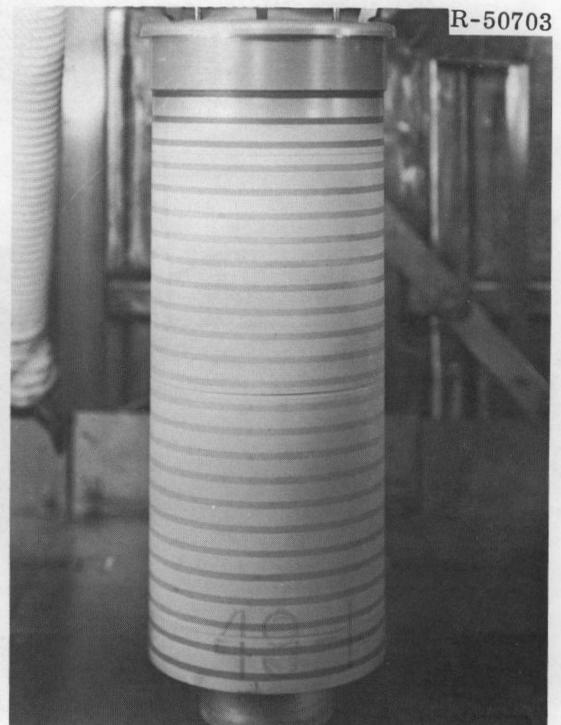
Shortly after unloading the irradiated fuel elements from the shipping cask, we examined the spent fuel assemblies visually through the hot cell windows and with the in-cell periscope system at magnifications up to 4X for evidence of damage. The overall appearance of the four fuel elements is shown in Figs. 9 and 10. In general, all appeared to be in excellent physical condition; no indications of gross warpage or distortion was apparent, and careful inspection of the surfaces revealed no evidence of any type of mechanical or structural damage. The only noticeable effect of irradiation upon the appearance of the elements was a difference in the overall coloration of the fuel assemblies; the as-fabricated HFIR fuel elements normally are bright and shiny, whereas all the irradiated elements were a dull light gray. This coloration appears to be a result of the formation of a thin oxide film on the element surfaces during irradiation or during storage in the HFIR pool. Elements 5-I and 5-0 were slightly darker than elements 49-I and 21-0. This indicates that the oxide film on elements 5-I and 5-0 was slightly thicker. All four elements were slightly darker at the bottom (i.e., the coolant outlet end). This also appears to be a result of slight variation in the thickness of the oxide film along the elements.

Fig. 10. Fuel Elements 21-0 and 49-I. Reduced 13%.

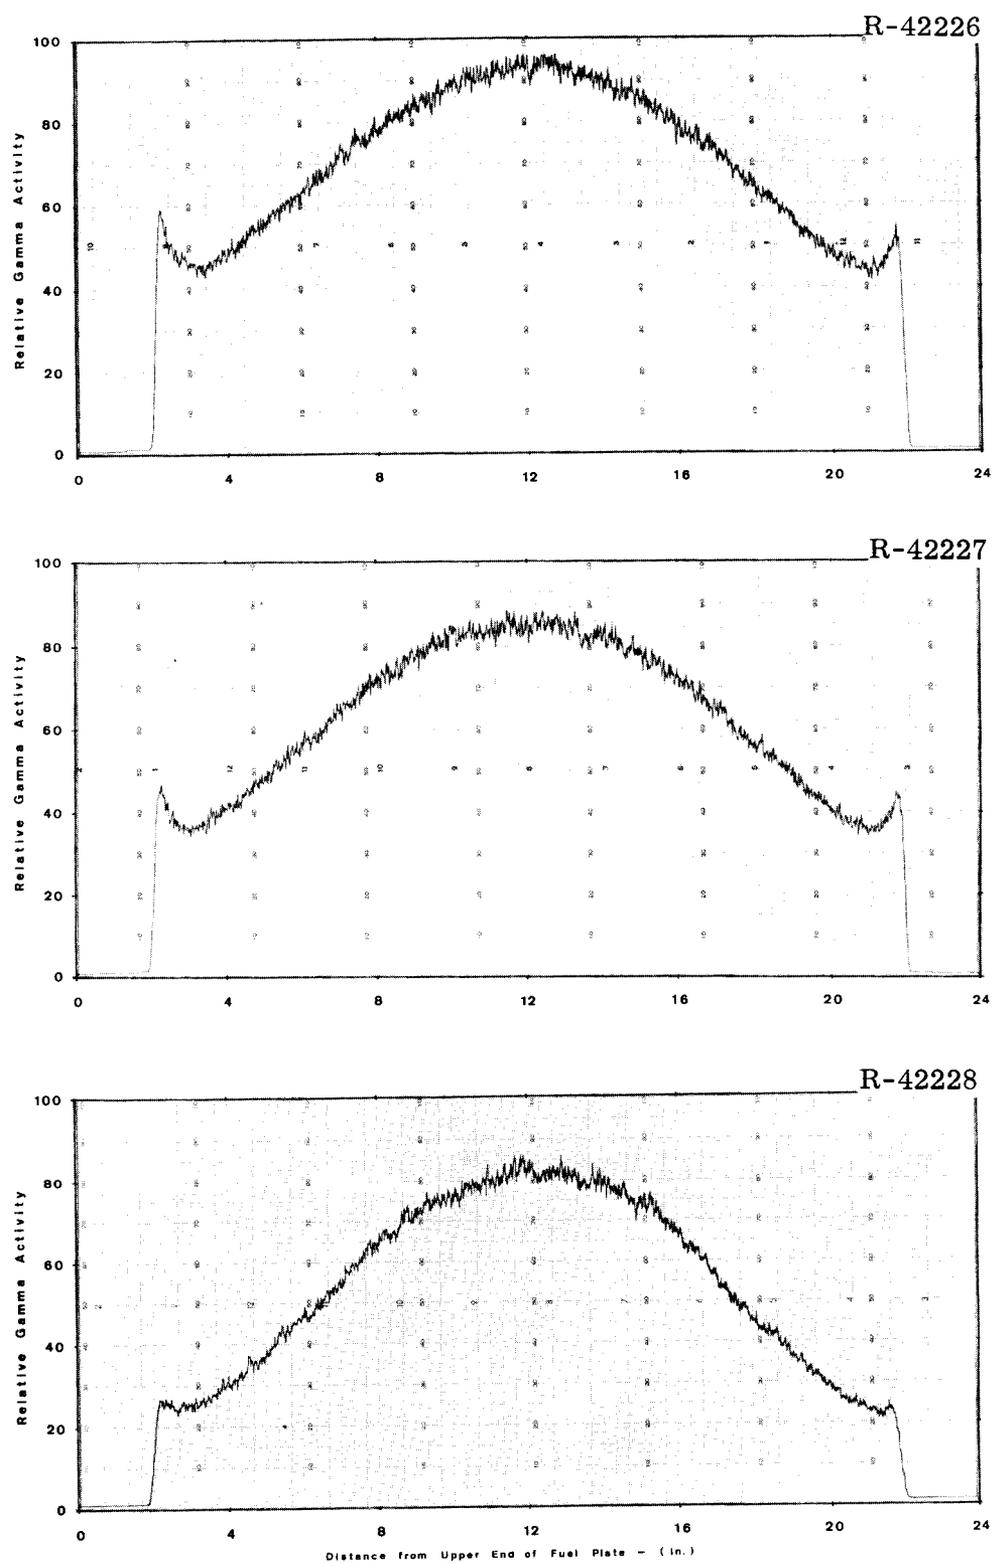
Typical examples of the axial scans of a fuel plate from each element are shown in Fig. 19 and Appendix B. In general, the scanning results appear to be consistent with the expected axial power distribution. Note, for example, that these activity scans are essentially symmetrical about the axial center line of the fuel plates (i.e., 12 in. from the upper end). The small deviations from a smooth, cosine curve (i.e., the small peaks and valleys) were reproducible and probably indicative of small variations in the fuel loading. Note, however, that in no instance did the variations result in more than about a 10% change in the local gamma activity level. Consequently, these small variations in the fuel loading resulted in less than a 10% deviation in the expected local power distribution over an area approximately 3/16 in. in diameter (i.e., the diameter of the collimator).

Fig. 19. Typical Axial Gamma Activity Scans of a Fuel Plate from HFIR Fuel Element 5-0. Scans were made at radial positions 16 cm (top), 18.5 cm (center), and 20 cm (bottom) from the core center line.

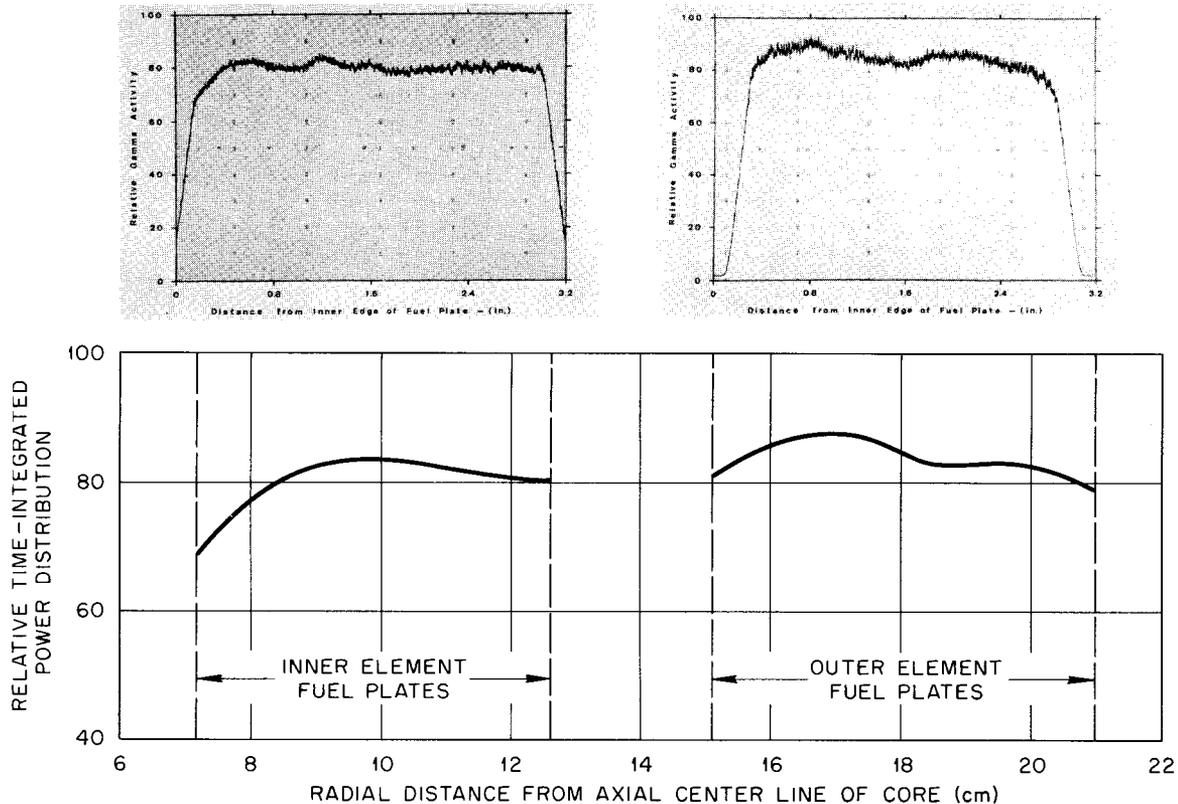
Typical examples of the scans across an inner and outer fuel plate at the axial midplane are compared with the predicted radial power distribution in Fig. 20. The agreement between the gamma scanning results and the predicted time-integrated power distribution appears to be excellent and shows that the reactor designers successfully flattened the power distribution across the fuel plates.

Fig. 20. Comparison Between Transverse Gamma Scanning Results and the Predicted Radial Time-Integrated Power Distribution for the HFIR Fuel Plates. Top-left, transverse gamma scan across axial center line of a fuel plate from element 49-I; top-right, gamma scan across axial center line of a fuel plate from element 21-0; bottom, predicted radial power distribution across both inner and outer fuel plates.

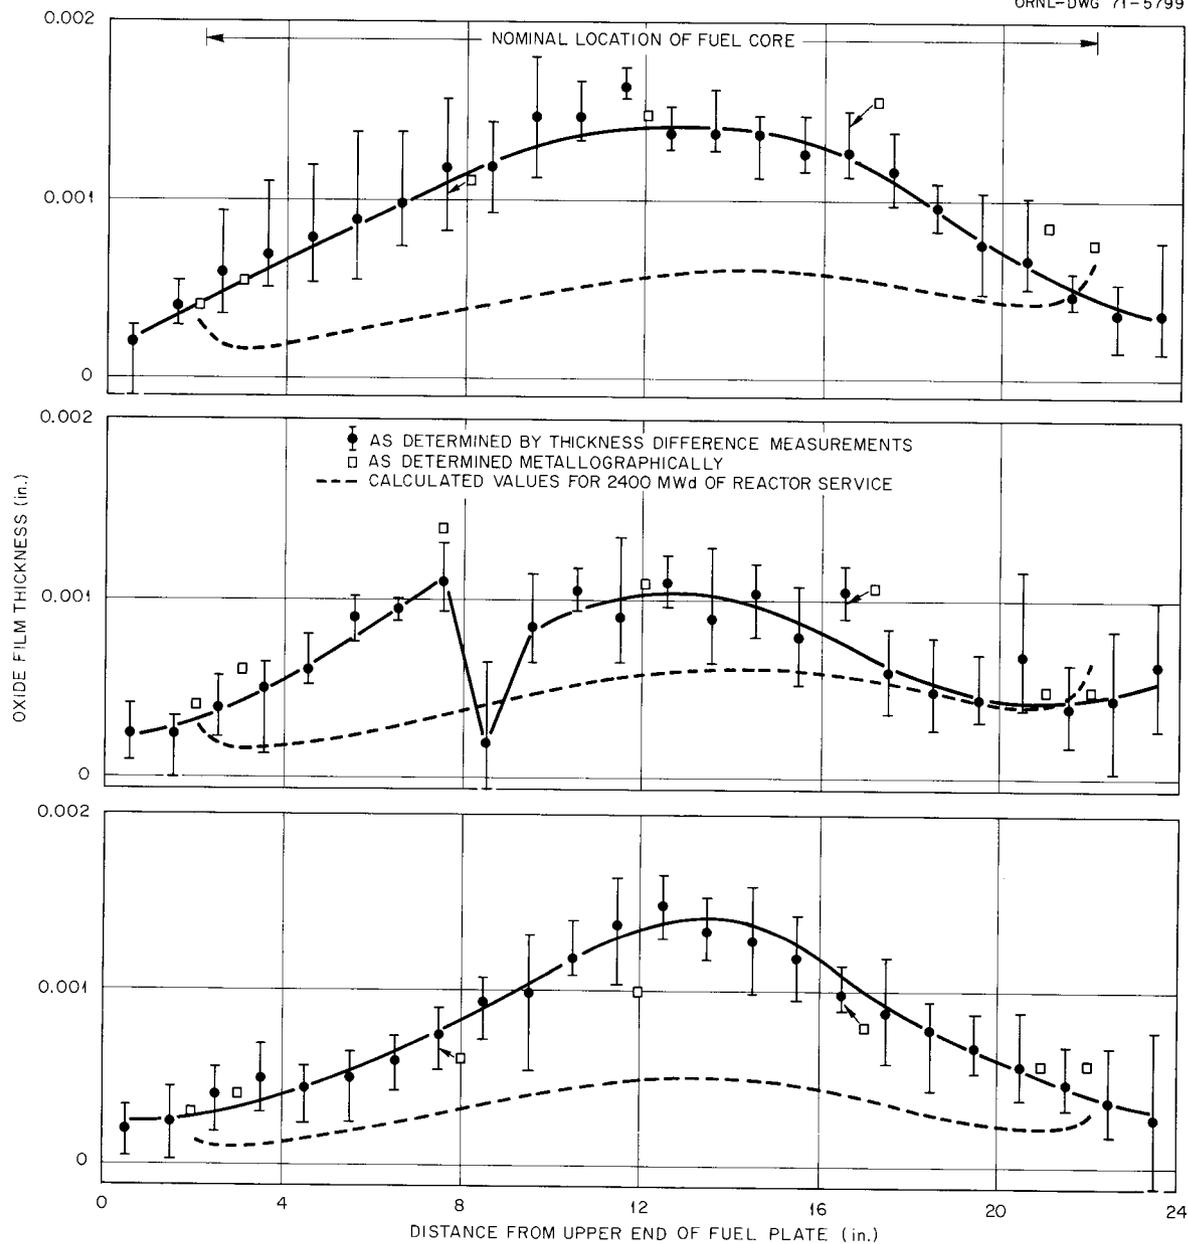
Results of measurements of the oxide film thickness on the surfaces of fuel plates from the three irradiated HFIR fuel elements are summarized in Figs. 21 through 23. As indicated, metallographic measurements of the film thickness agreed quite well with that indicated from differences in the thickness of the stripped and unstripped fuel plates. In general, the oxide film on the surfaces of the fuel plates from all three elements was thicker than that predicted from calculations based upon Griess' correlation⁸ for the rate of oxide buildup upon aluminum surfaces in out-of-reactor corrosion tests. Note that the oxide thickness on fuel plates from element 5-0 (i.e., one of the pretreated fuel elements) is considerably thicker than that on plates from elements 21-0 and 49-I, even though the later elements were irradiated longer. This suggests that oxide built up more rapidly on the surfaces of the pretreated fuel plates. The actual oxide thickness profiles generally appear to have the same shape as that predicted by these calculations, differing only in absolute magnitude. However, it should be noted that the oxide film may have increased in thickness as a result of additional corrosion or transformation in the oxide after reactor operation. The storage period was much longer than the irradiation period, and since

Fig. 21. Axial Film Thickness Profiles on Fuel Plates from HFIR Fuel Element 5-0. Near inner edge (top), over core hump (center), and near outer edge (bottom).

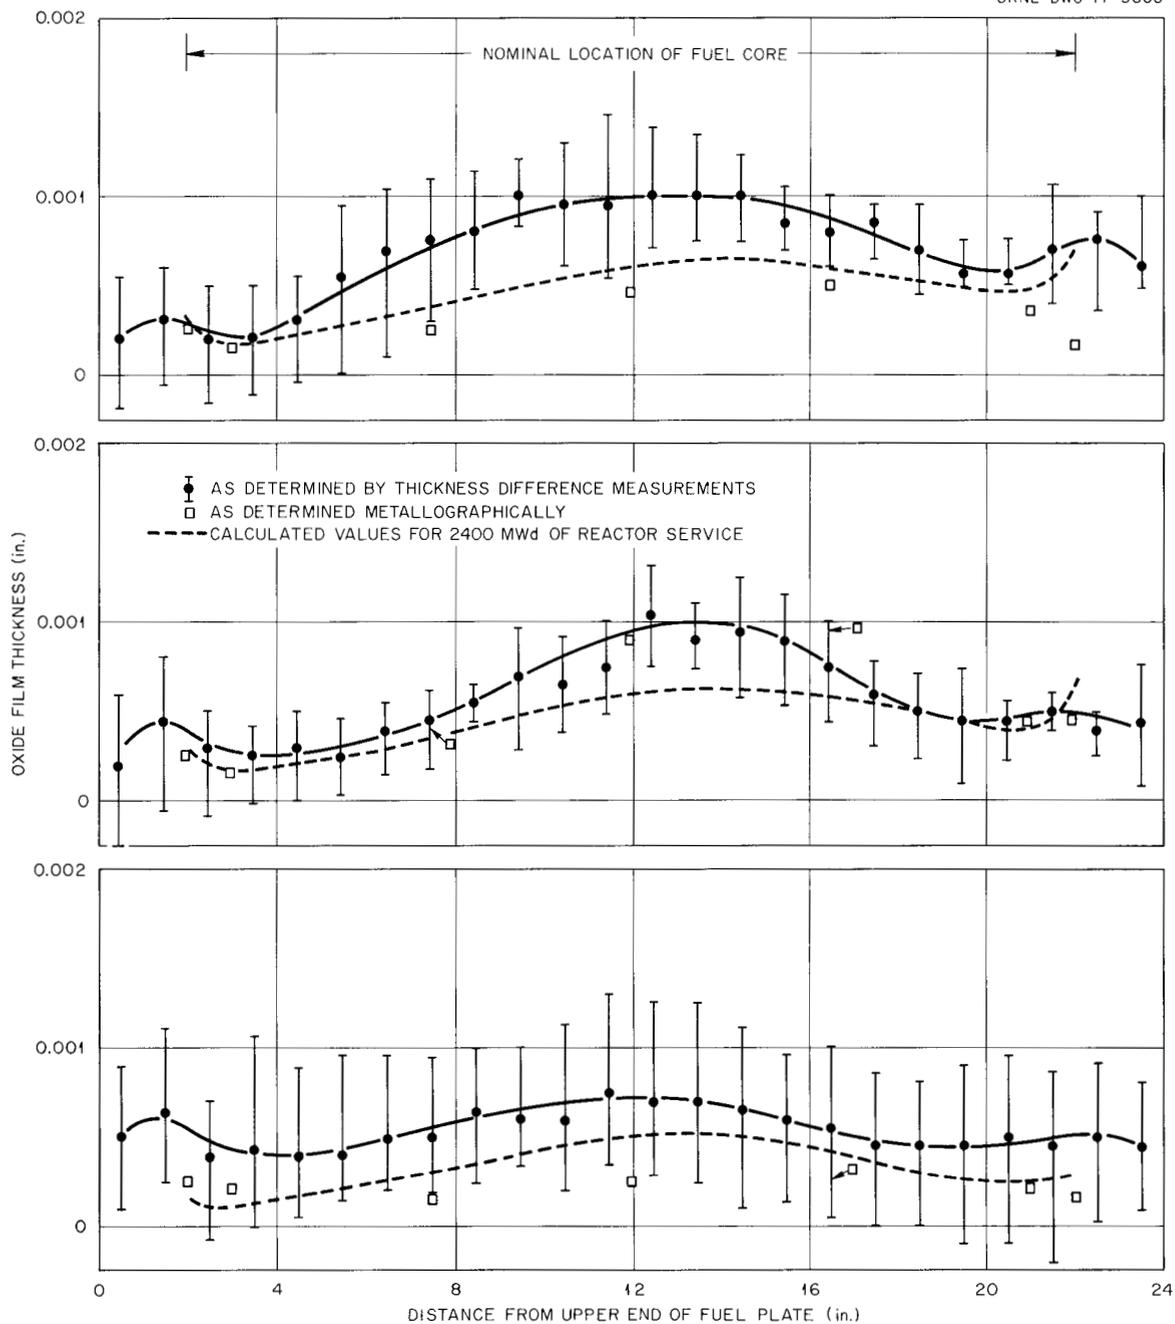
Fig. 22. Axial Film Thickness Profiles on Fuel Plates from HFIR Fuel Element 21-0. Near inner edge of plate (top), over core hump (center), and near outer edge (bottom).

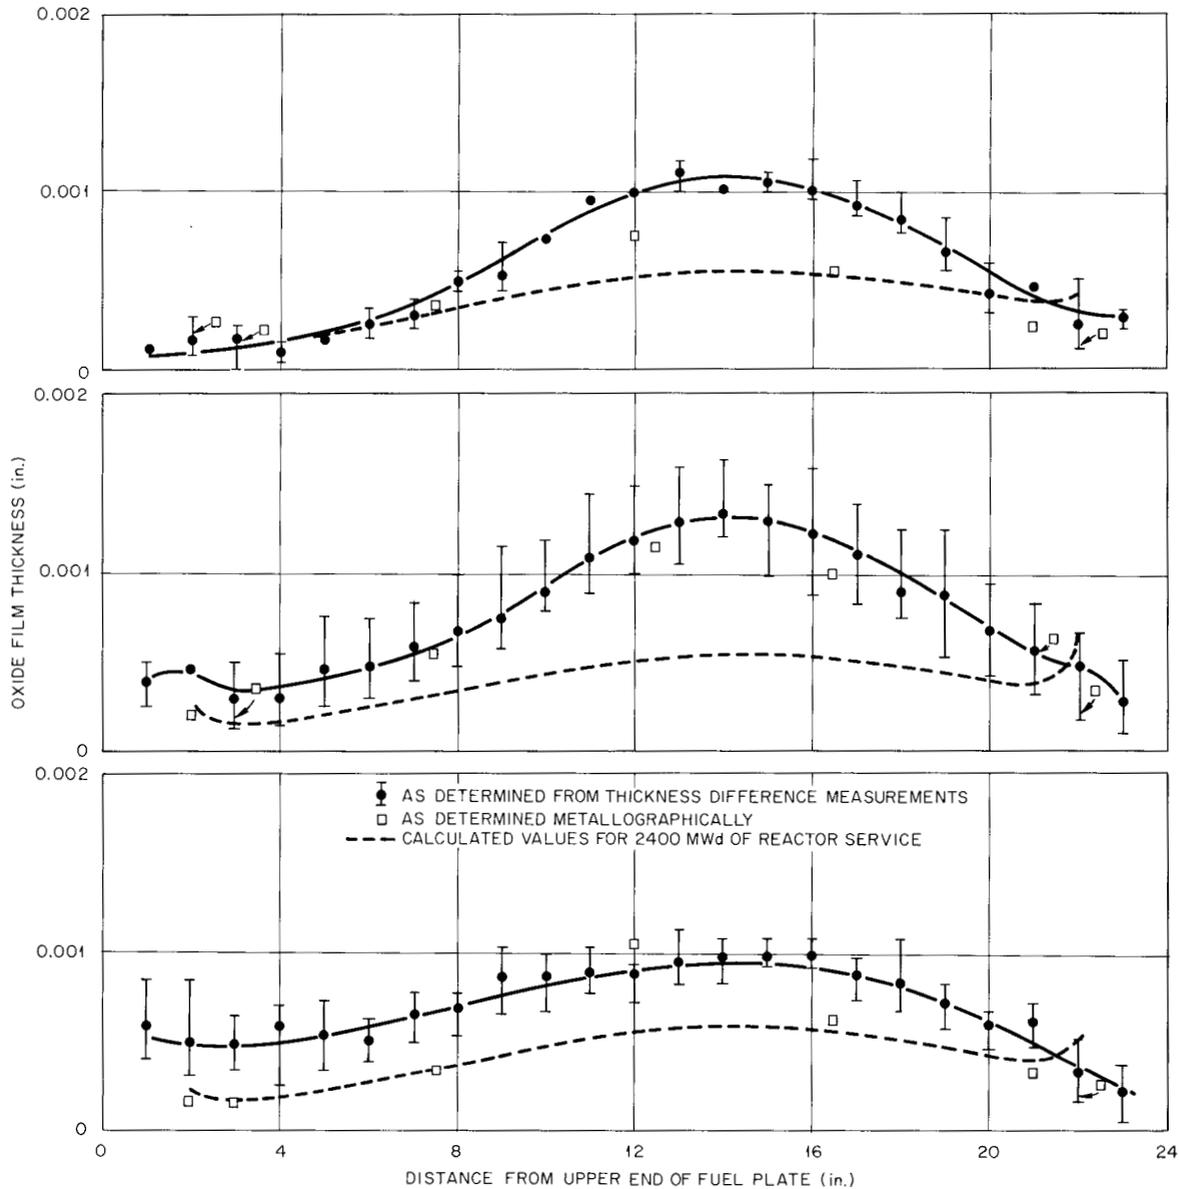
Fig. 23. Axial Film Thickness Profiles on Fuel Plates from HFIR Fuel Element 49-I. Near inner edge of plate (top), over core hump (center), and near outer edge of plate (bottom).

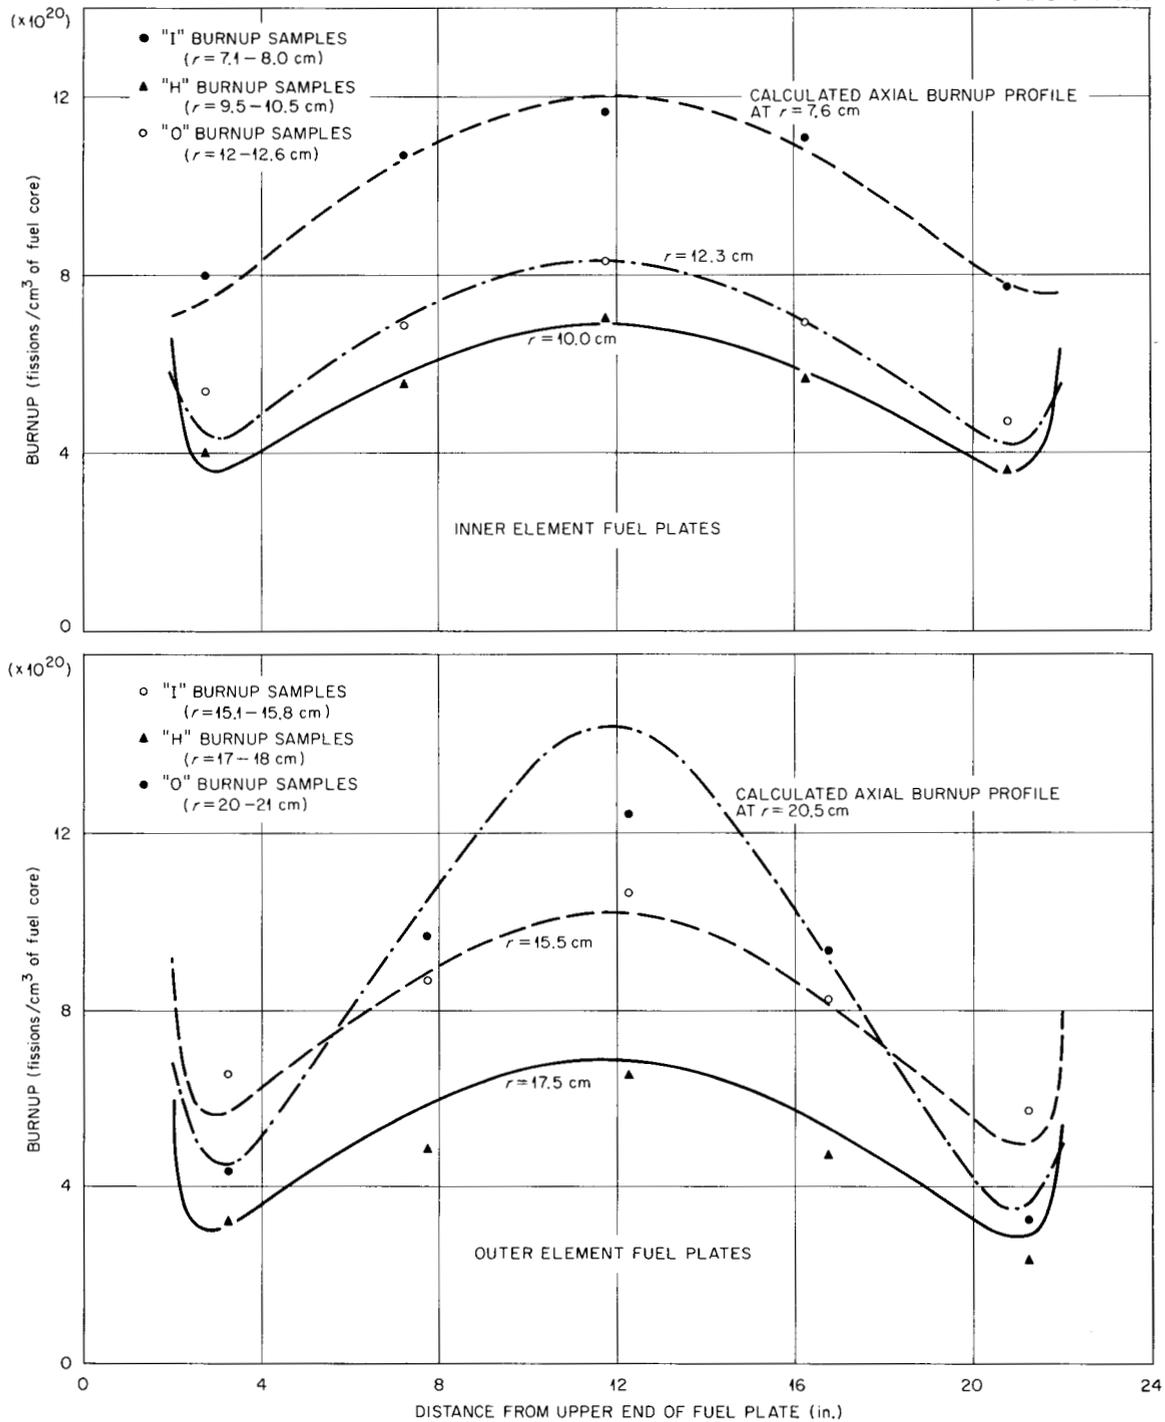
Results of the isotopic analyses and the calculated burnup values for the individual specimens are tabulated in Appendix D. As shown in Figs. 26 and 27, results of the burnup determinations on sections from elements 49-I and 21-0 were in excellent agreement with those predicted. The burnup of sections from the fuel plate from element 5-0 (not shown) was generally about 10% lower than those from element 21-0, as expected from the lower exposure (2046 compared with 2309 Mwd).

Fig. 26. Comparison of Predicted and Measured Burnup Values Along an Inner and an Outer Fuel Plate. Curves represent the predicted burnup profiles at indicated radial positions; data points represent analytical burnup values obtained on sections of a fuel plate from elements 49-I (top) and 21-0 (bottom).

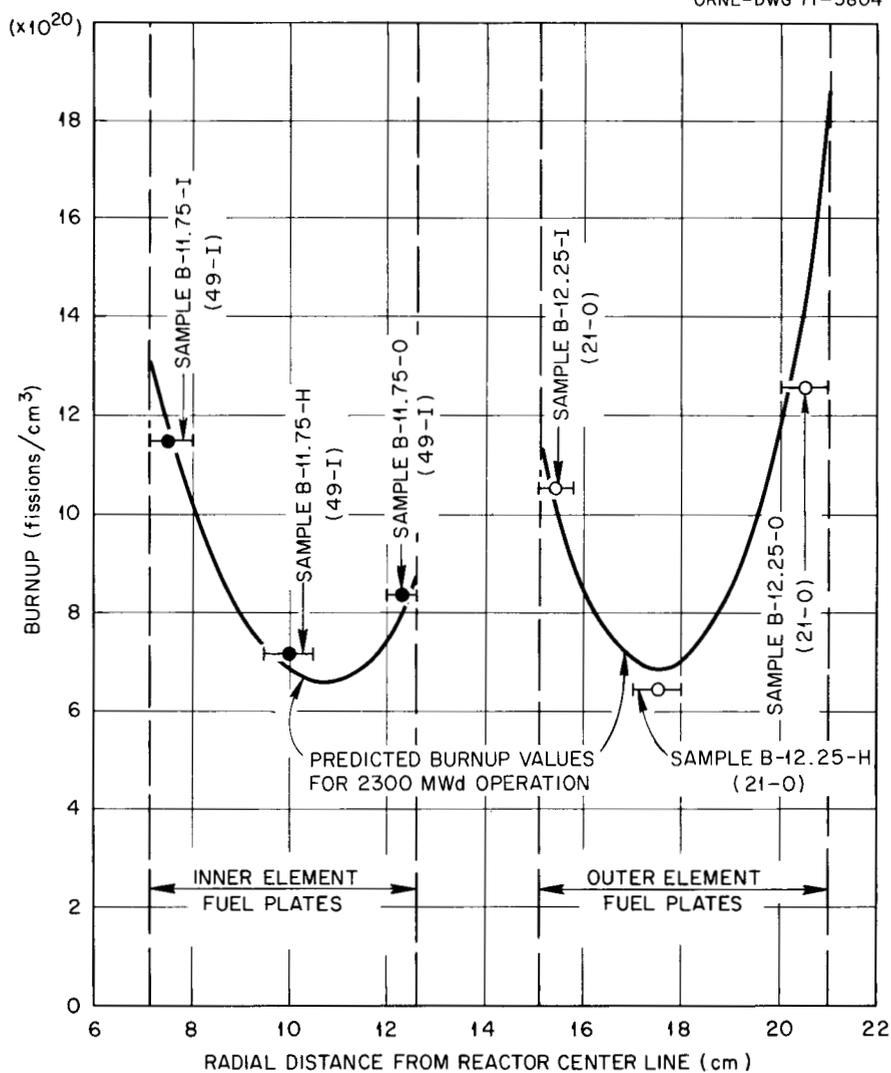
Fig. 27. Comparison of Predicted and Measured Burnup Profiles Across the Horizontal Midplane of the HFIR Fuel Plates.

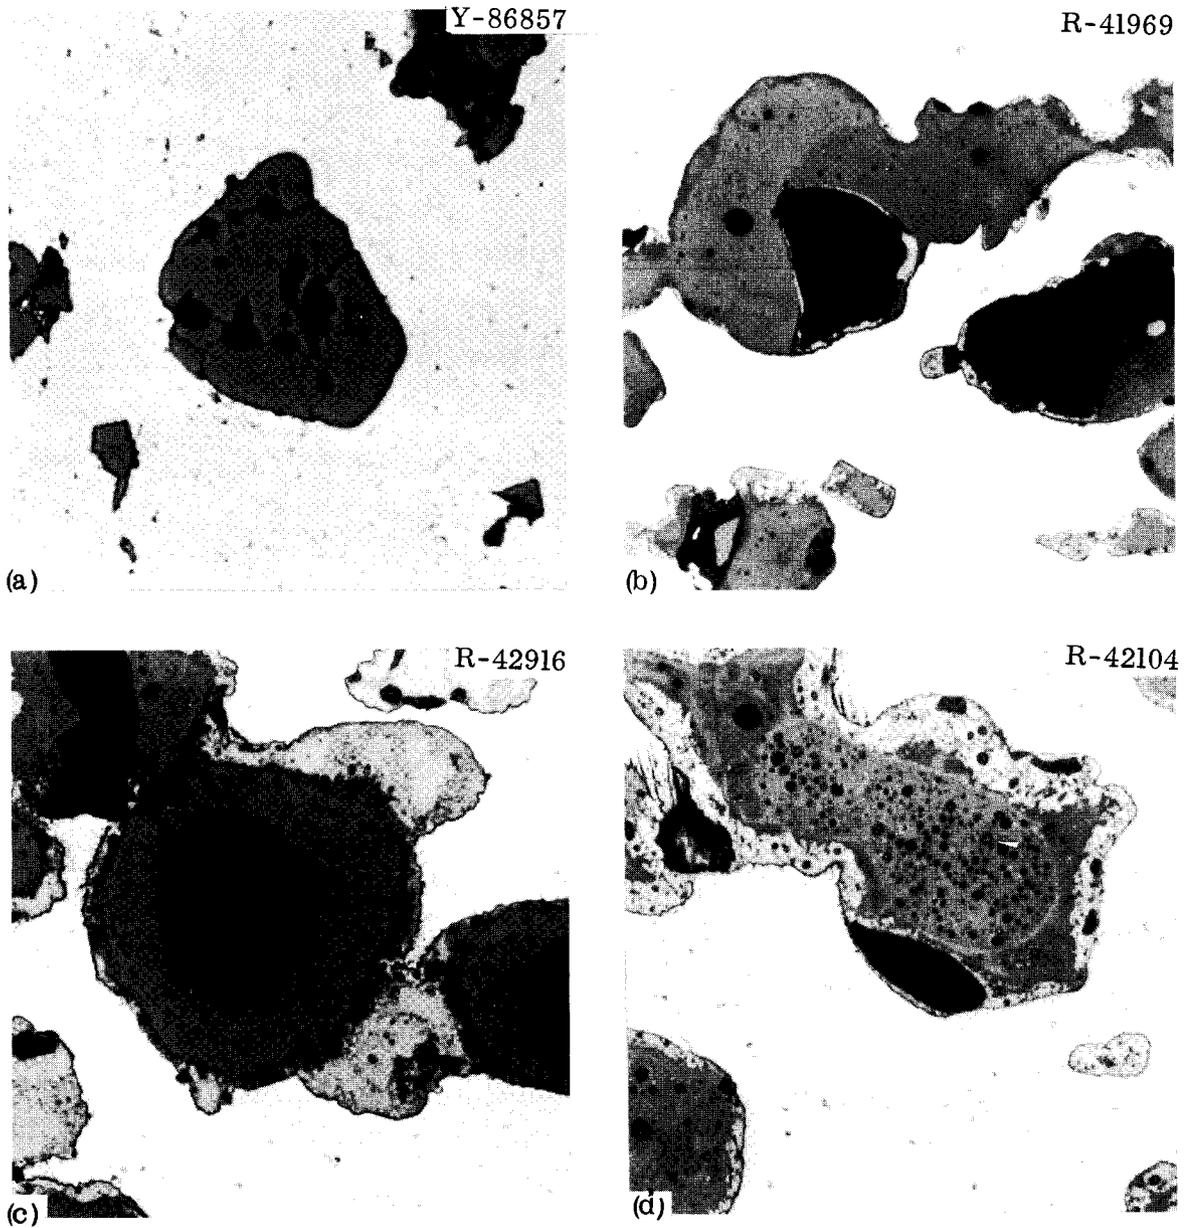
Although not readily apparent at lower magnifications shown in Appendix E, the microstructure of the U_3O_8 -aluminum fuel dispersion varied considerably along and across each of the three irradiated fuel plates. These differences are perhaps more clearly shown in Fig. 31, which compares the microstructure of the fuel dispersion of an unirradiated HFIR fuel plate with that from the low-burnup, low-temperature and high-burnup, high-temperature regions. These changes in the microstructure of the fuel dispersion appear to result from at least two distinctly different mechanisms: (1) an irradiation-induced change in the microstructure of the U_3O_8 fuel particles proper, and (2) chemical reaction between the U_3O_8 fuel particles and the aluminum matrix material. Note, for example, that the cracks and fractures initially present in the U_3O_8 particles of the as-fabricated dispersion appear to have

Fig. 31. Typical Microstructures of Fuel Cores of the HFIR Fuel Plates. As polished. 500X. (a) Unirradiated, (b) from a low-burnup, low-irradiation temperature region, (c) from an intermediate-burnup, high-irradiation temperature region, and (d) from a high-burnup, intermediate-irradiation temperature region.

healed or sintered even at the lowest burnup. Also, the numerous small voids and cracks have agglomerated to form rather large voids or pores. At higher burnup levels, these large voids generally appear to decrease somewhat in size; however, an increasing number of small, spherical voids (or perhaps fission-gas bubbles) begin to appear. In many respects, these changes appear to be somewhat analogous to the fuel restructuring often observed in bulk-oxide fuel pins for power reactors.

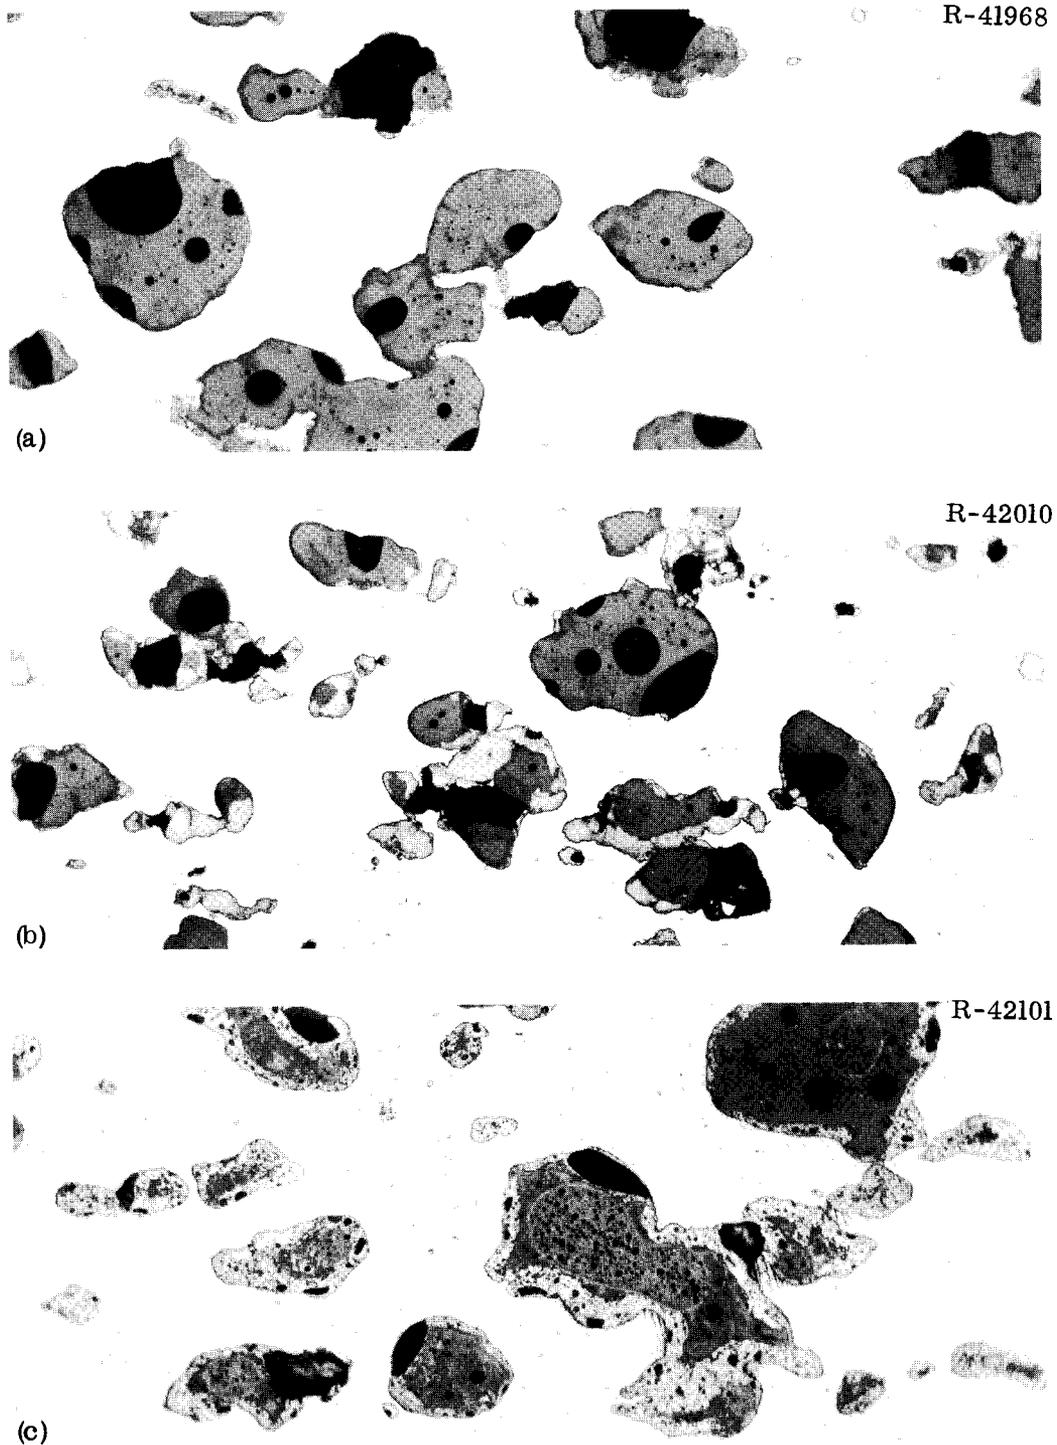
Since it has been known for some time that U_3O_8 is thermodynamically unstable in contact with aluminum, we were not surprised to find evidence of reaction between the fuel particles and the matrix. Although reaction between these two materials is generally quite sluggish even at 500 to 600°C in the absence of irradiation,⁹ extensive reaction has been observed¹⁰ in such dispersions after irradiation at temperatures as low as 100°C. On the basis of some early irradiation testing results of U_3O_8 -aluminum dispersions, Graber et al.¹¹ concluded that the extent of reaction was a function of both the fuel burnup and the irradiation temperature. As indicated in Fig. 31, the extent of reaction at higher burnup and higher irradiation temperature was significantly greater than at lower burnup and temperature. However, comparing the microstructure of the dispersion at other locations within the three fuel plates indicated that the extent of reaction might be a function of only the irradiation temperature and relatively independent of the fuel burnup in the range experienced by the fuel elements. For example, in regions of the fuel plates irradiated to the same burnup level but at different temperatures, as seen in Fig. 32(a) and (b), the reaction is greater in the region irradiated at the higher temperature. However, regions irradiated at the same temperature but to different burnup levels - compare Fig. 32(b) and (c) - show little difference in the extent of reaction.

Fig. 32. Comparison of the Extent of Reaction in Regions of a Fuel Plate from Element 5-0 to the Same Burnup at Different Temperatures or Different Burnups at the Same Temperature. (a) 3×10^{20} fissions/cm³ at 80°C; (b) 3×10^{20} fissions/cm³ at 115°C; (c) 16×10^{20} fissions/cm³ at 115°C. As polished. White, aluminum matrix; black, voids; dark gray, U₃O₈; light gray, reaction products. Reduced 6%.

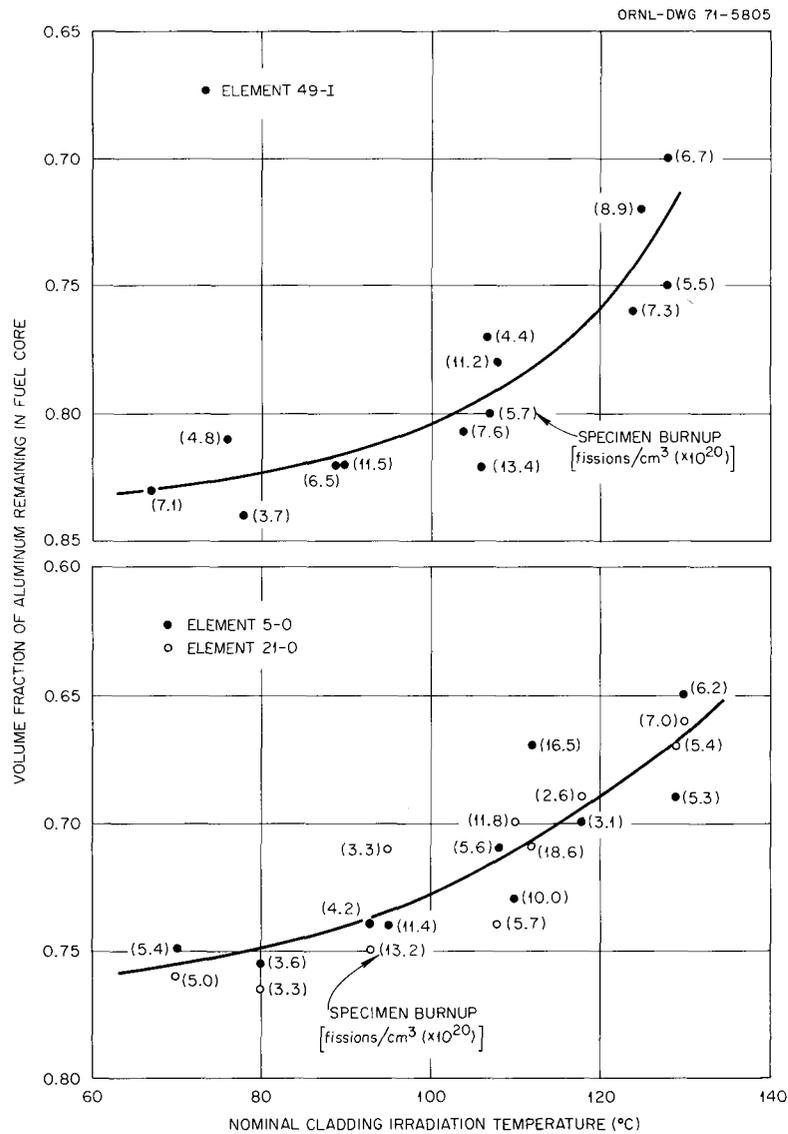
To check on this hypothesis, we attempted to estimate the extent of reaction in various regions of the three irradiated fuel plates by determining the volume fraction of aluminum remaining within the dispersion by areal analysis of the photomicrographs. Since aluminum is consumed during reaction with the U_3O_8 , the volume fraction of aluminum within the fuel dispersion should decrease with increasing amounts of reaction. The results of these measurements were then plotted as a function of the estimated fuel-core irradiation temperature. As shown in Fig. 33, the results clearly show that the extent of reaction between U_3O_8 and aluminum is primarily a function of the irradiation temperature and relatively insensitive to the fuel burnup, which is shown in parentheses by each point.

Fig. 33. Effect of Irradiation Temperature upon the Extent of Reaction in the Cores of the Inner (Top) and Outer (Bottom) Annulus HFIR Fuel Plates.

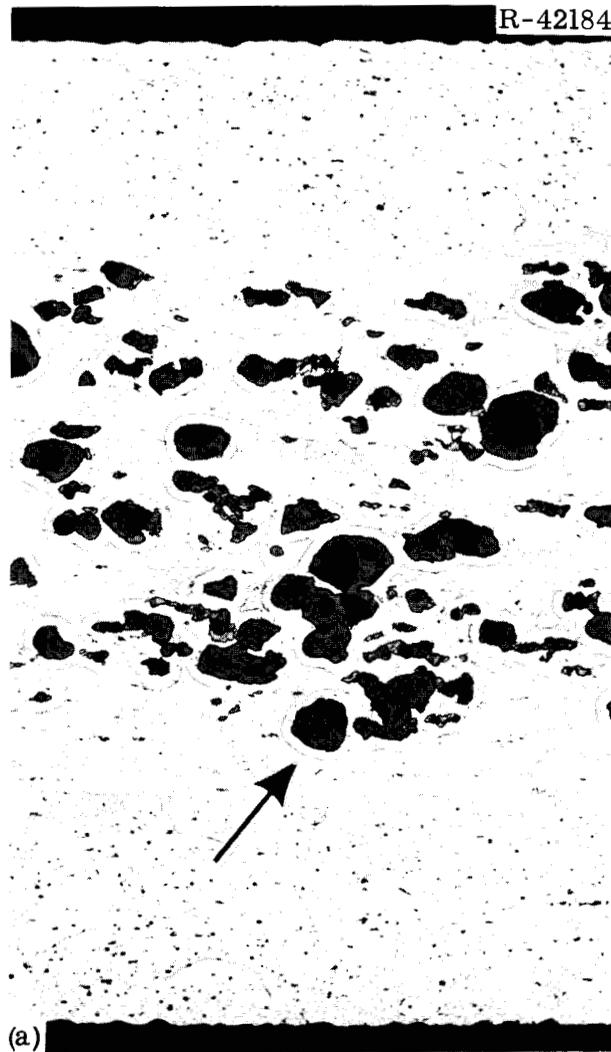
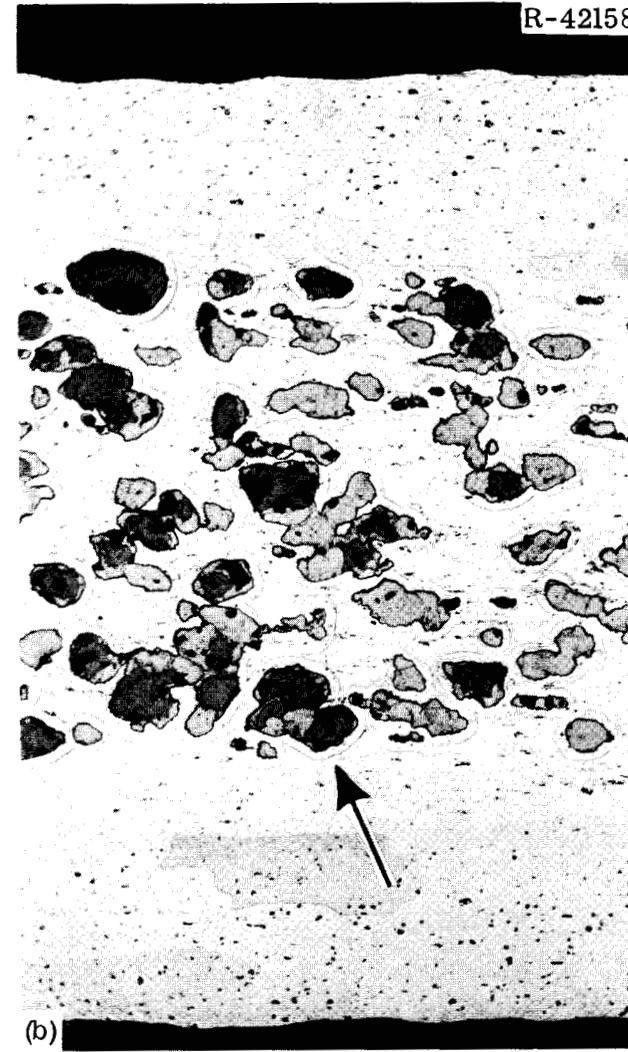
One other interesting aspect of the metallographic examination was the observation of zones showing fission-product-recoil damage around the individual fuel particles (Fig. 34). Although recoil-damaged zones have been previously observed around the fuel particles of irradiated dispersions of UO_2 in stainless steel,¹² to our knowledge these are the first photomicrographs to clearly show the recoil-damaged zones in an aluminum-base fuel dispersion. In these fuel plates, the width of the damaged zone appeared to be about 15 μm , which is in excellent agreement with the average accepted range of 13.8 μm for fission fragments in aluminum.

Fig. 34. Zones of Fission-Product Recoil Damage Surrounding Fuel Particles in the Irradiated HFIR Fuel Plates. 100X. Etched with 30% KOH. (a) Typical low-burnup, low-temperature region. (b) Typical high-burnup, high-temperature region.

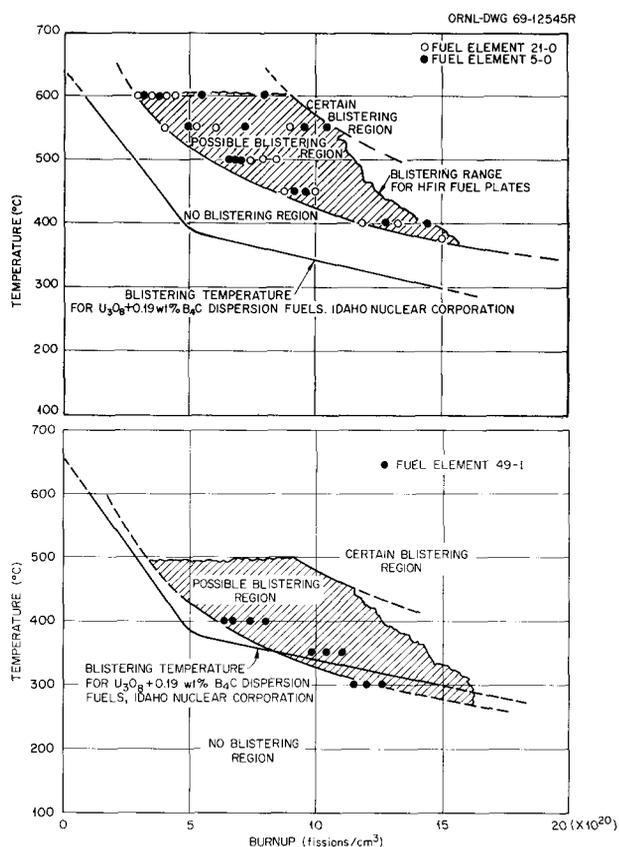
As shown in Fig. 35, the postirradiation blistering temperature of the outer fuel plates was significantly higher than that of the inner plate. The blistering temperature of the inner plate appears to agree reasonably well with that reported¹³ for other U_3O_8 -aluminum dispersions, but that of the outer plates appears to be about 100°C higher.

Fig. 35. Postirradiation Blistering Temperatures of Outer (Top) and Inner (Bottom) HFIR Fuel Plates. Idaho Nuclear Corporation results are from Marchbanks et al.¹³

At present, we have no completely satisfactory explanation for these differences in the postirradiation blistering of these fuel plates. However, the postirradiation blistering temperature of the U_3O_8 -aluminum fuel dispersions is apparently not strictly a function of the fuel core fission density. Differences in the blistering behavior of the inner and outer HFIR fuel plates might be attributed to the differences in the fuel loading of these plates (the cores of the inner plates contain a 30 wt % U_3O_8 dispersion and those of the outer plates contain a 40 wt % U_3O_8 dispersion). If this is true, one would expect the post-irradiation blistering temperature of the advanced HFIR fuel plates, which would contain approximately 25% higher fuel loadings, to be significantly different from that of the present elements. Consequently,

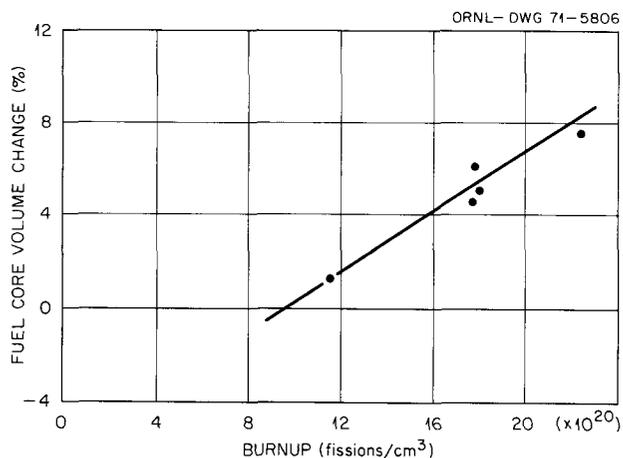
Fig. 37. Experimental Fuel Core Swelling Results for HFIR-Type U₃O₈-Aluminum Dispersions.

Thus, even at the burnup level of 19×10^{20} fissions/cm³, a 6% increase in fuel core thickness should result in only a 0.00054 in. increase in the overall thickness of the fuel plate. Consequently, fuel core swelling does not limit the performance of the current HFIR fuel elements.
