ORNL-4714 *107*
UC-25 - Metals, Ceramics, and Materials

POSTIRRADIATION EXAMINATION AND
EVALUATION OF THE PERFORMANCE
OF HFIR FUEL ELEMENTS

A. E. Richt
R. W. Knight
G. M. Adamson, Jr.

DECEMBER 1971

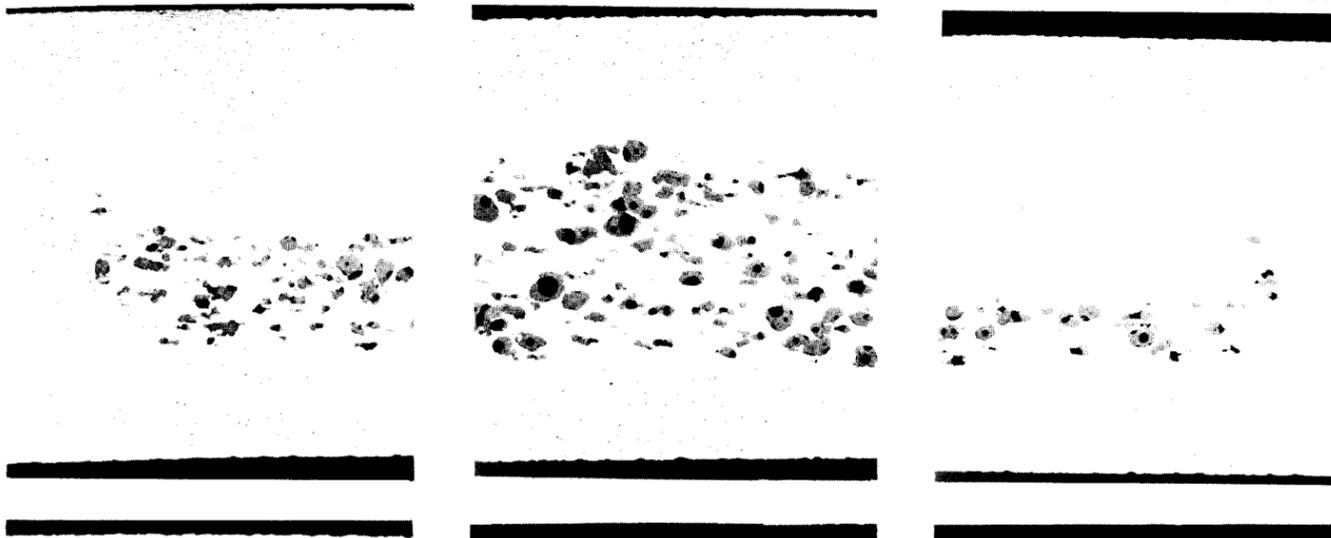
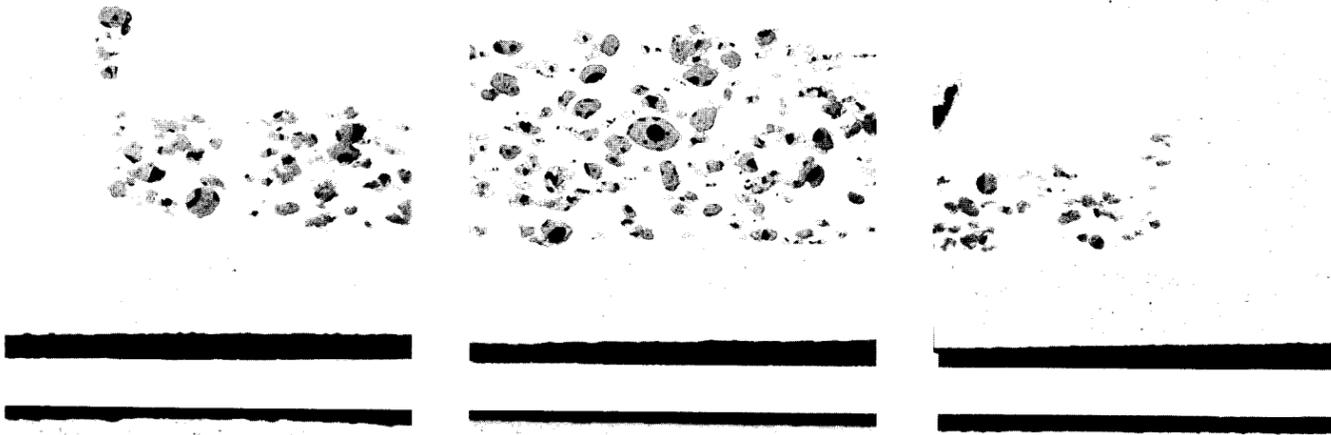
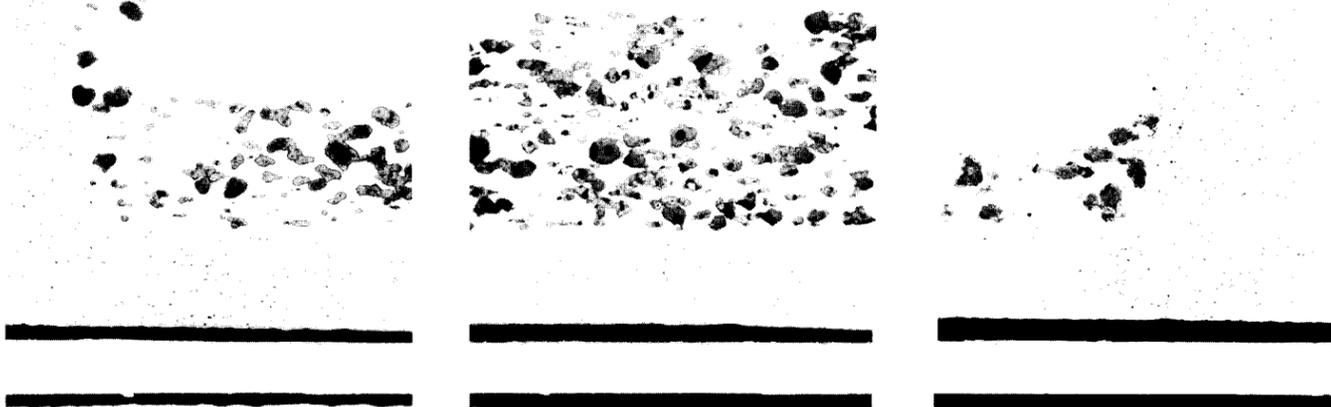
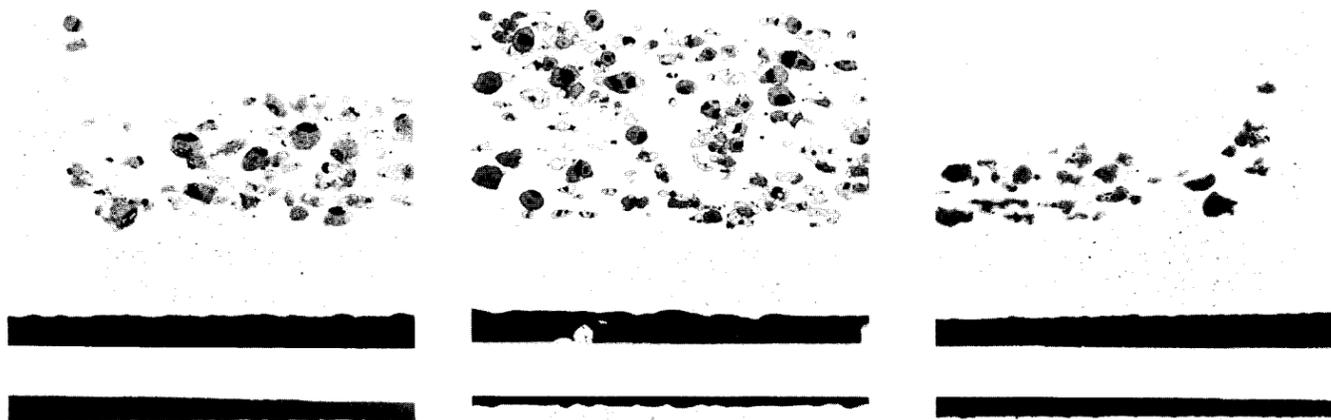
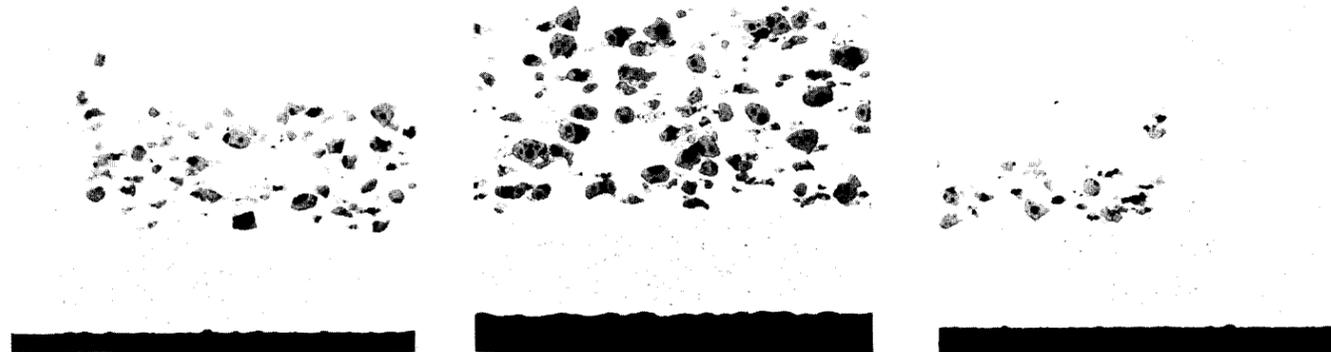
Although not readily apparent at lower magnifications shown in Appendix E, the microstructure of the U_3O_8 -aluminum fuel dispersion varied considerably along and across each of the three irradiated fuel plates. These differences are perhaps more clearly shown in Fig. 31, which compares the microstructure of the fuel dispersion of an unirradiated HFIR fuel plate with that from the low-burnup, low-temperature and high-burnup, high-temperature regions. These changes in the microstructure of the fuel dispersion appear to result from at least two distinctly different mechanisms: (1) an irradiation-induced change in the microstructure of the U_3O_8 fuel particles proper, and (2) chemical reaction between the U_3O_8 fuel particles and the aluminum matrix material. Note, for example, that the cracks and fractures initially present in the U_3O_8 particles of the as-fabricated dispersion appear to have

Fig. E-1. Typical Cross Sections of a Fuel Plate from HFIR Fuel Element 5-0. Concave surface of plate is at the bottom edge of all photomicrographs. 50X. As polished. Reduced 5%.

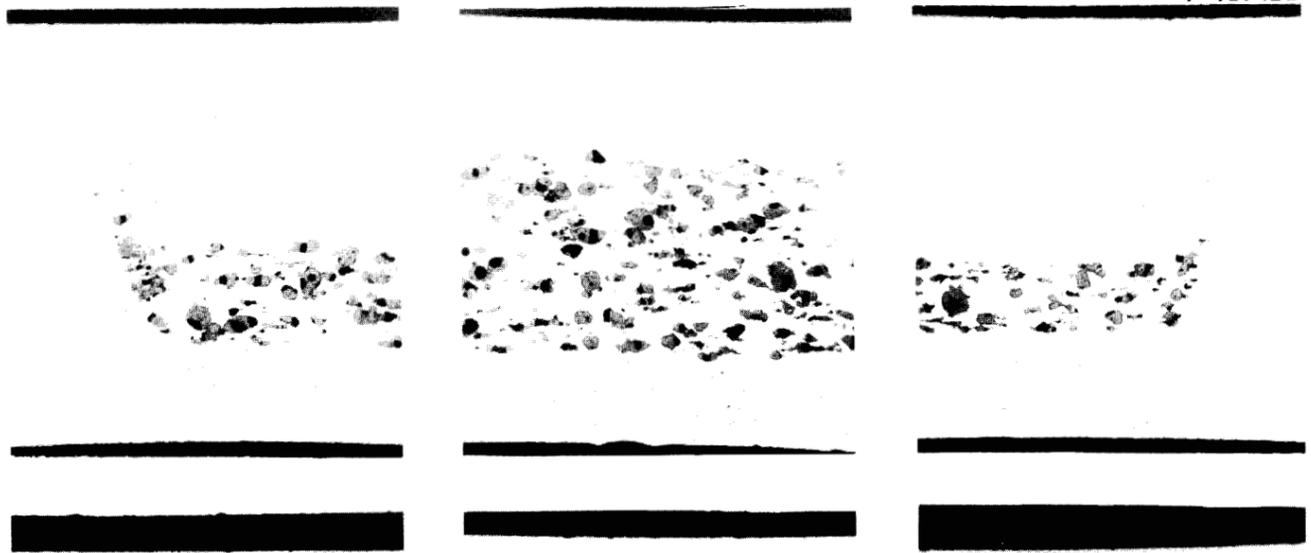
Fig. E-2. Typical Cross Sections of a Fuel Plate from HFIR Fuel Element 21-0. Concave surface of plate is at bottom edge of all photomicrographs. 50X. As polished. Reduced 5%.
