CONDENSATION IN FLAT ROOF SPACES: TWO CASE HISTORIES

J.W. Warren

CASE HISTORY I

CASE HISTORY II

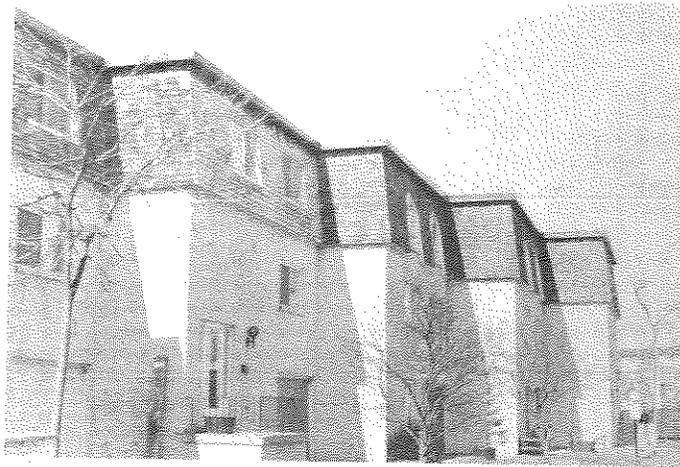
Figure 3. Typical elevation

80% of the total roof structure was decayed to a greater or lesser extent. Further, it was predicted that approximately 16 units had roof structures deteriorated to the point where they were inadequate to support any superimposed load whatsoever and were therefore in imminent danger of collapse. A typical elevation of the townhouses is shown in Figure 3. It was recommended that remedial measures be designed and implemented immediately. Without such measures being taken, the municipal building authority indicated the homes were likely to be condemned.

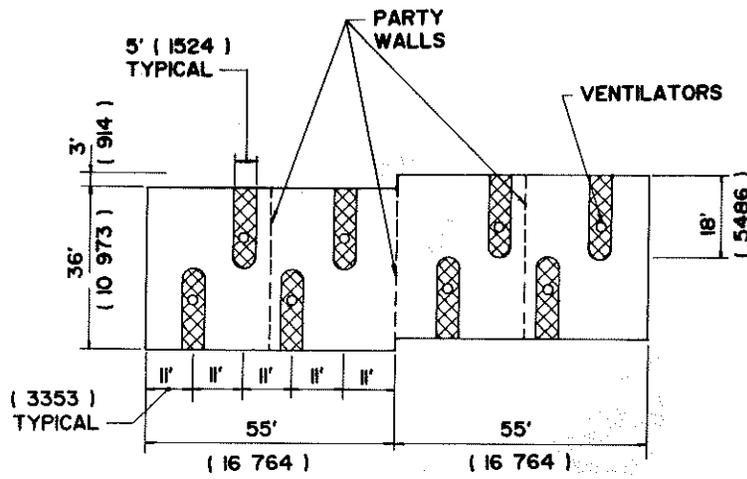
Figure 10. Roof plan

The insulation contractor anticipated, in the absence of drawings to indicate otherwise, that the joists would span in the shorter 36 ft (11.0 m) east-west direction and, therefore, by installing insulation from each side would have a maximum 18 ft (5.5 m) to blow it. When the work began in early September of 1982, the contractor found, however, that the joists spanned in the north-south direction instead, and he could not, therefore, effectively install the insulation through the complete spans from the sides of the roof. The contractor decided to cut out eight sections of the roof on each building to install the insulation from above. These sections, shown on Figure 10, were patched by the insulation contractor after installing the insulation. All work was completed before October at a cost of about \$34,000.
