FAILURE OF THE BUILDING ENVELOPE: TWO CASE STUDIES

ABSTRACT

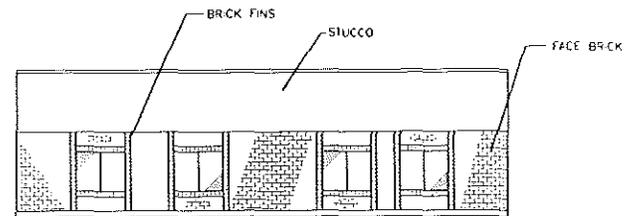
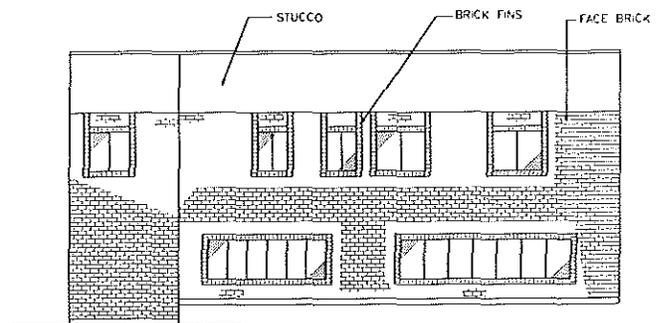
Figure 1 Case study 1, typical elevations.

Figure 1 shows typical wall sections and elevations as shown in the original architectural drawings.

- Large cracks had formed in the brick veneer surrounding many of the windows. The crack formation process appeared to be accelerating.
- There were stains and efflorescence on the brick veneer.
- Portions of the exterior stucco were cracking and delaminating. This had already caused the hospital to replace several stucco panels.

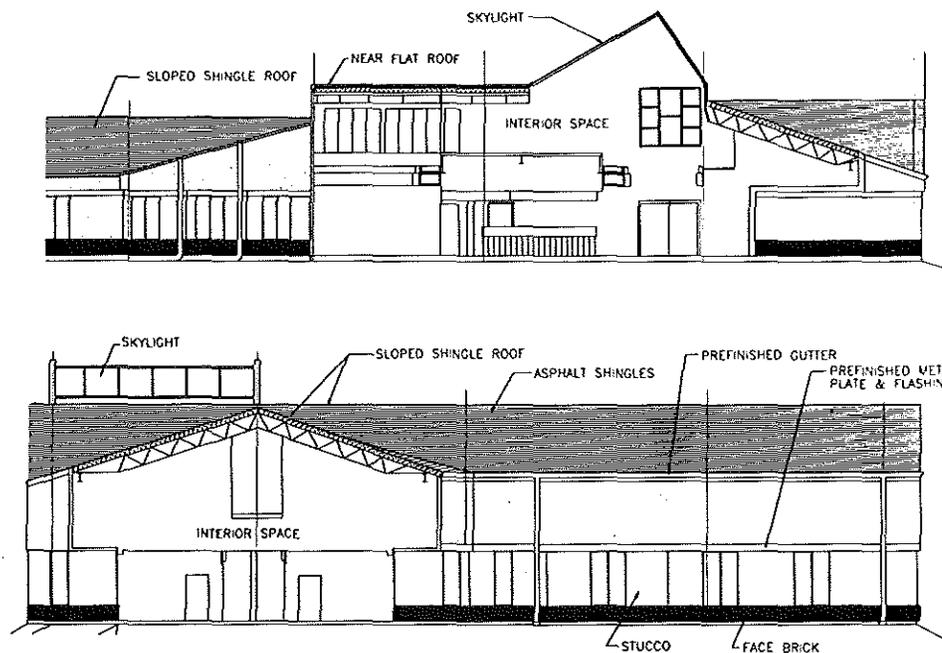
Figure 5 Case study 2, typical original elevations.

Figures 5 and 6 show typical elevations and wall sections from the original architectural drawings.

In 1993, 11 years after construction of the hospital, APW was asked to investigate several ongoing problems with the building envelope:

- Ice damming on the sloped roofs and subsequent water leakage into patient rooms.
- Deterioration of asphalt shingles and apparent “sponginess” of the plywood deck.
- Dark brown stains on stucco fascias and soffits.

- Water leakage and excessive solar heat gain associated with the sloped glazing.
