ENVELOPE DURABILITY PROBLEMS IN HIGH-HUMIDITY BUILDINGS

Mark Lawton, P.Eng.

David Scott

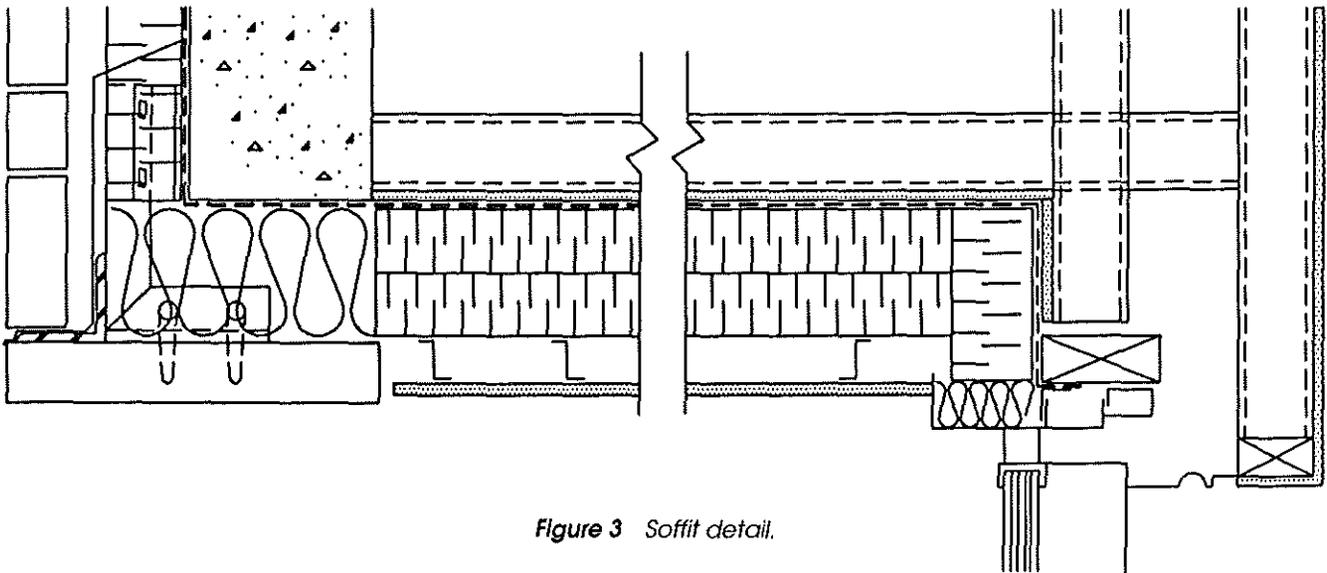
Figure 3 Soffit detail.

The construction of the soffit assembly and housing for the potlights is shown in Figures 3 and 4. In general the torch-on air barrier membrane is adhered to a cement board substrate. A high level of insulation is provided by

Investigation of the problem included removal of several soffit sections to determine the source of moisture to the ice collection points. It was found that the construction was in general conformance with the

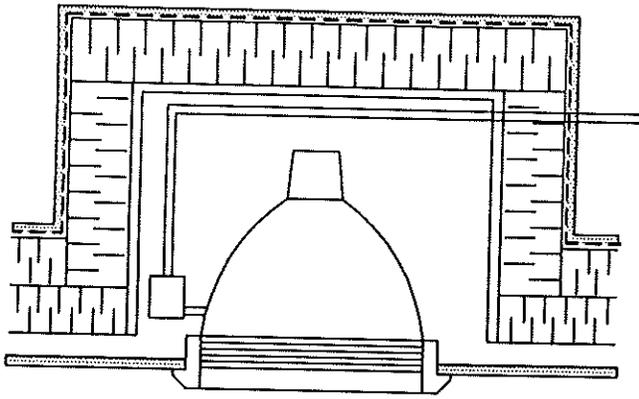
Figure 4 Potlight housing.

- At corners of the potlight housing assemblies (photo 12).
- Through and around the electrical conduit serving the potlights (photo 12).
- At the head end of the split mullions of the strip windows on the inner perimeter of the overhang. It was found that the membrane used to seal between the mullion sections was located on the inside of the mullion and no provision was made to transfer the plane of airtightness to outside the structure, where the wall and soffit air barriers were located.
- At unsealed screw holes, which appeared to have been drilled from above during construction to identify attachment locations for Z-girts supporting the exterior soffit finish (photo 13).
- Some poor seals at laps between adjacent sheets of air-seal membrane. In the test opening areas these did not appear to be major air leakage points but they could have been a problem in other locations.

The general condition of materials in the soffit was good except for the potlights themselves, which showed heavy corrosion considering their short service to date (photo 14).
