A Qualitative Model for Moisture Balance in Painted Vertical Wood Paneling

Stefan G. Hjort, Ph.D.

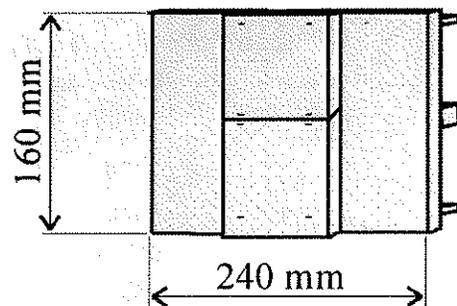
Figure 3 The paneling structure used in the CT investigations.

In a laboratory study, the moisture conditions in small samples of a paneling structure consisting of a top board and two bottom boards were measured by a nondestructive computer tomography scanning technique (CT-scanning); see Figure 3. This technique provides a three-dimensional picture of the moisture distribution. The technique is described in detail in Lindgren (1992). The top board was jointed, and special study was made of the area around the joint. Plastic

nails were used instead of steel nails in order to make the X-ray analysis possible.
