Field Observations and Laboratory Tests of Water Migration in Walls with Shiplap Hardboard Siding

George A. Tsongas, Ph.D., P.E.

CASE STUDY FIELD OBSERVATIONS

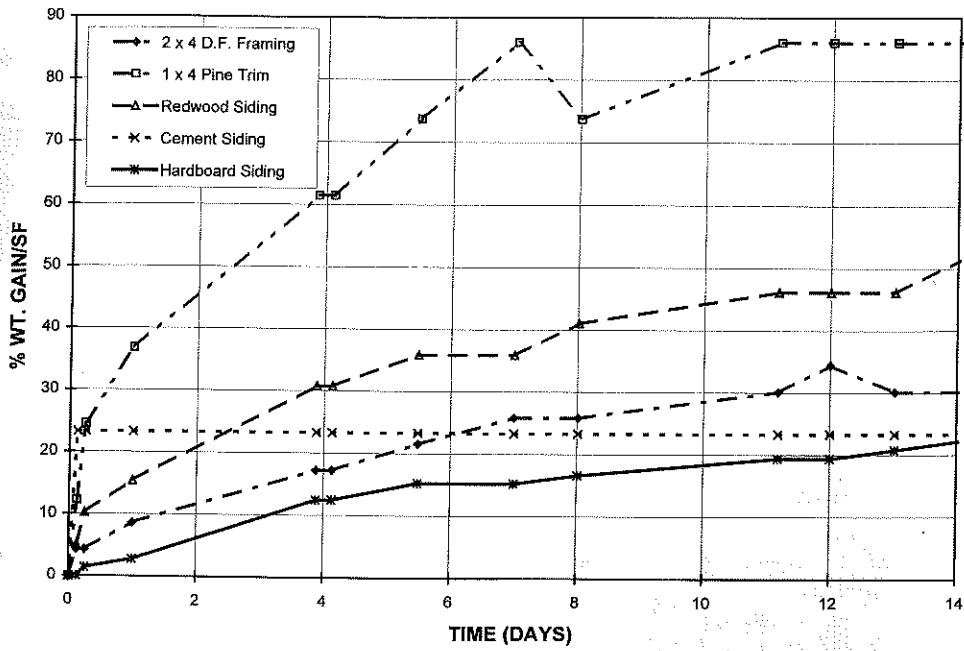
Figure 13. Comparative soak test results of hardboard siding with other wood products.

Each of the materials was submersed in water and then weighed each day for 14 days to determine their weight gain. The resultant percentage weight gain per square foot of exposed unpainted surface area is presented in Figure 13. It is seen that the hardboard siding is the least absorptive of all the materials tested. Both the cement and the redwood siding are more absorptive, especially during the first day or two. The percentage weight gain of the cellulose-reinforced cement siding was almost identical to results of earlier soak tests of the same type material (Cunningham et al. 1990). The most absorptive material is the pine trim, being about four times more absorptive than hardboard siding.
