# Carbon Monoxide Exposure from a Vehicle in a Garage

Thomas H. Greiner, Ph.D., P.E.  
Member ASHRAE

Charles V. Schwab, Ph.D.

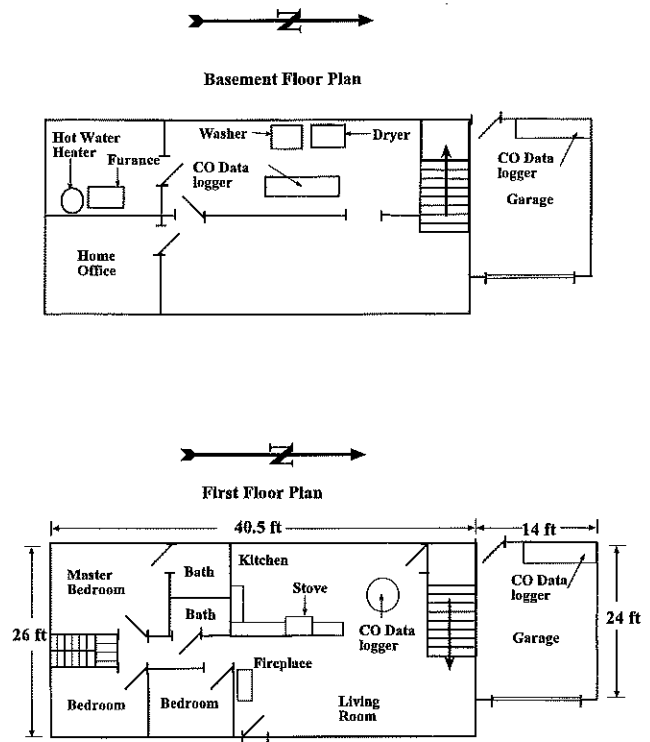
Figure 1 Floor plans of house and garage.

The standard procedure for pressure testing was followed (ASTM 1987; CGSB 1986). The house pressure testing was conducted by placing the blower door in the front door in the east wall shown in the first floor plan in Figure 1. This testing was conducting using natural conditions (no other devices operating), under various conditions using the furnace blower, and using exhaust fans in bathrooms. Analysis of the measured values was performed by supplied software (version 1992).

The garage pressure testing was conducted by placing the blower door in the exterior west door to the garage shown in

the first floor plan in Figure 1. This testing was conducted using natural conditions (no other devices operating).

The CO concentrations were measured in the house in the kitchen and basement. CO data loggers were placed on the kitchen table, as shown in the first floor plan of Figure 1, and on an exercise bench in the basement exercise room, as shown in the basement floor plan of Figure 1. The data loggers used are not temperature compensated, so they were calibrated at 70°F (21°C) and used inside the house, which was kept at 70°F (21°C). These units measure the CO concentrations with a resolution of 1 ppm and accuracy of ±3%.
