Monitoring Performance of EIFS Clad Dwellings

Eric S. Auman

William F. Egan

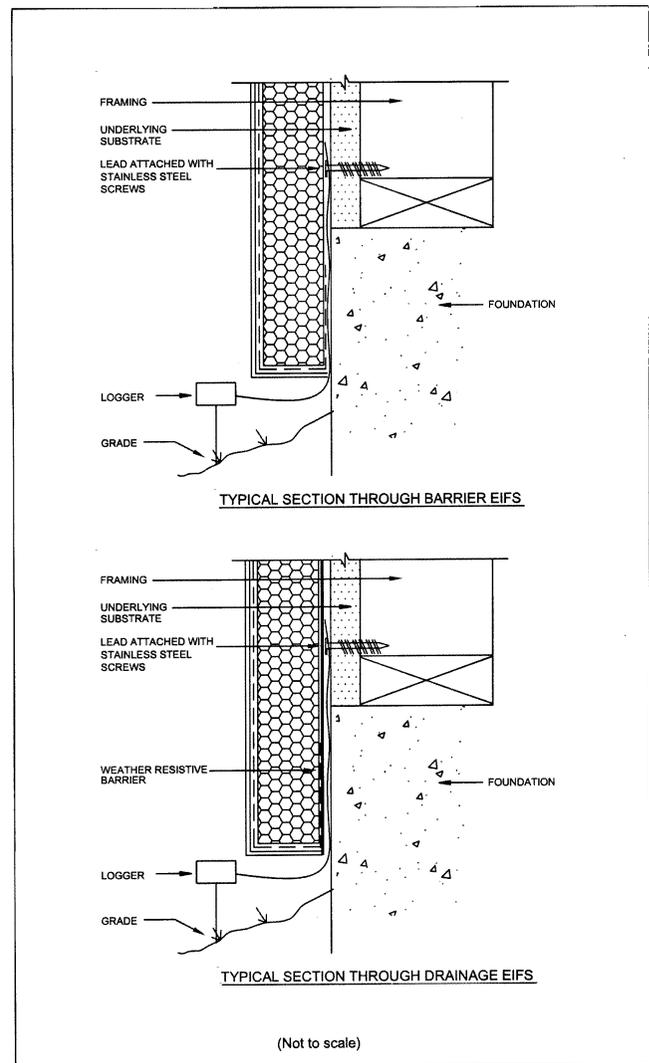
Figure 1 Typical lead/logger locations.

The logger functions by sending a pulse from the channel via a dedicated lead or cable that also contains a “switch.” The switch consists of two leads or poles a specific distance apart and mounted with stainless steel screws to the underlying substrate in both barrier and drainage-type assemblies (Figure 1). The pulse is returned through the switch back to the logger, which records voltage drops if there is moisture in the underlying substrate at that location. The voltage readings can be

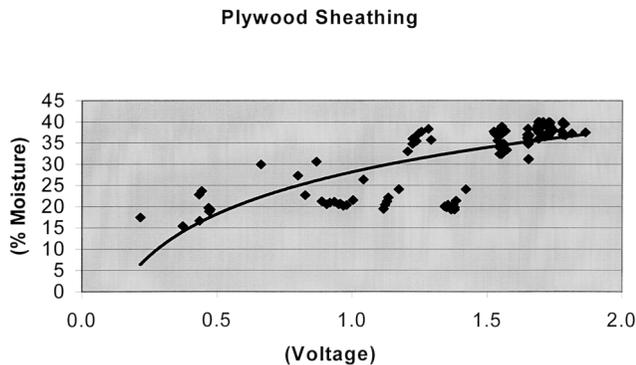
Figure 2 Voltage to percent moisture correlation.

converted to percent moisture contents based on interpolation of trend lines developed through independent laboratory testing. The testing was conducted (Kessler and Woods 2000) to correlate voltage drops to percent moisture contents in common wood-based sheathing substrate materials (Figures 2 and 3). Although equipment capable of providing direct percent moisture contents in common substrate materials would be advantageous, such equipment was not available. Consequently, voltage to percent moisture correlations were established through independent laboratory testing.

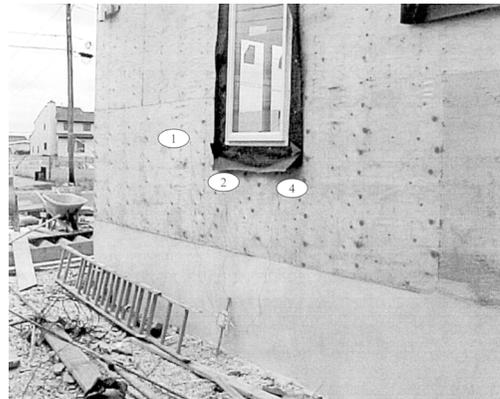
Figure 5 Residence #2, Bricktown, N.J., lead wire locations.

Background Information. In the spring of 2000, construction started on a new, three-story wood-frame home with wood-based (plywood) sheathing to be clad with a drainage type EIFS (Figure 4). The home is located on an inlet along the east coast of New Jersey. The data logger system leads were installed over the substrate in July of 2000. Figures 5 and 6 show approximate locations of the data logger leads. All leads except for #1 of logger 1 were located at window mullions or jamb/sill intersections since these were areas of windows that have been subject to water infiltration in the past. Loggers were installed only on this elevation (west) due to logistics of the project. The weather-resistive barrier was installed in August 2000, followed by the drainage type EIFS in the fall of 2000.
