Lessons to be Learned from Performance Failures of Framed Walls in High-Rise Buildings

Mark Lawton, P.Eng.

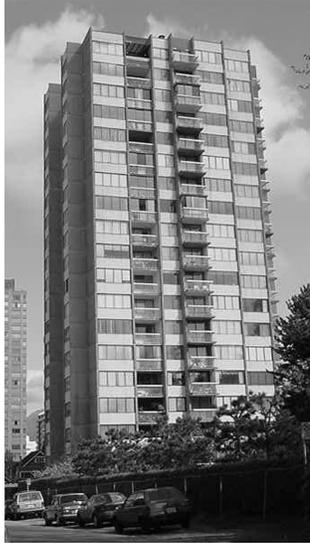
The Case 3 photos (Figures 15 to 22) are drawn from a 27-year-old building with an unusual cladding system for a high-rise building. The basic construction uses framed infill walls with strip windows spanning between parallel concrete shear walls. The wall construction consisted of a typical metal stud-framed wall (interior gypsum board, polyethylene vapor barrier, 90 mm metal studs with fiberglass insulation, exterior gypsum sheathing), but the cladding was simply metal siding that had been installed directly over the exterior gypsum sheathing without any type of weather-resistive barrier to act as a secondary moisture barrier. The walls had a history of water penetration at the window frames extending back for many years prior to our involvement, which started when the

Figure 15 Elevation showing infill section between shear walls (Case 3).

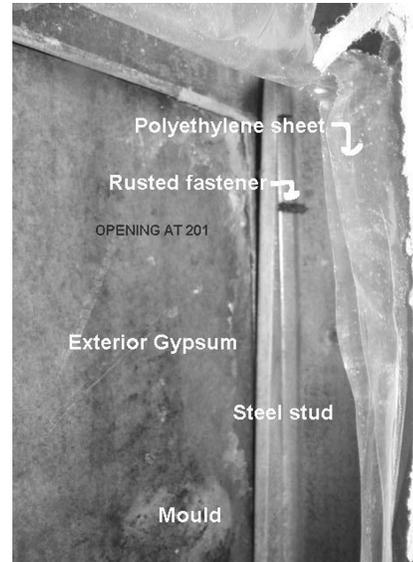
Figure 20 Interior test opening showing arrangement of materials (insulation removed).
