Moisture Performance of a Contemporary Wood-Frame House Operated at Design Indoor Humidity Levels

ABSTRACT

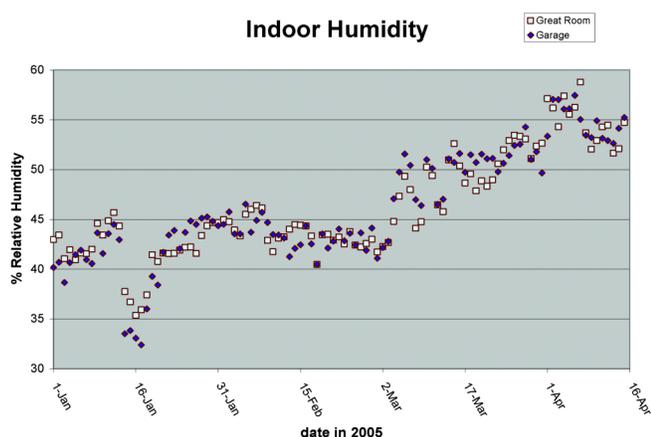
Actual indoor relative humidity levels during the mid and later parts of the fourth and fifth heating seasons are shown in Figures 2 and 3 respectively. The figures indicate that conditions were usually close to targeted values. In January of 2006,

Figure 2 Indoor humidity in the living room and garage over the period of Jan. 1—Apr. 15, 2005 (garage and house as single zone). The dip in relative humidity between Jan. 13—18 occurred when a humidifier malfunctioned, and, (after more than one attempted repair), it was replaced.

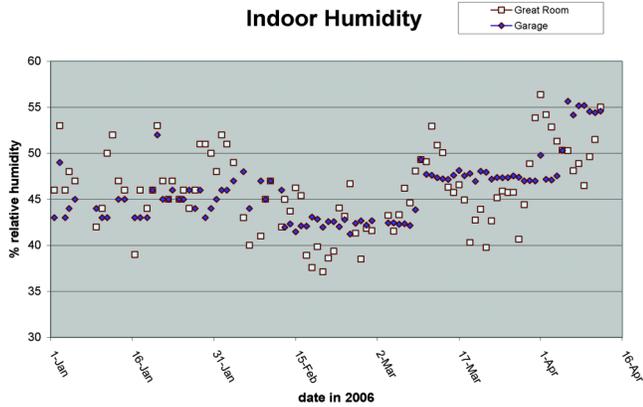
Figure 3 Indoor humidity in the living room and garage over the period of Jan. 1—Apr. 12, 2006 (garage and house as separate zones). Humidity values in garage are stable at very close to set-points after Feb 15. Humidity levels in the living room vary inasmuch as humidifiers in the house were controlled for daily moisture release, rather than for humidity set-point.

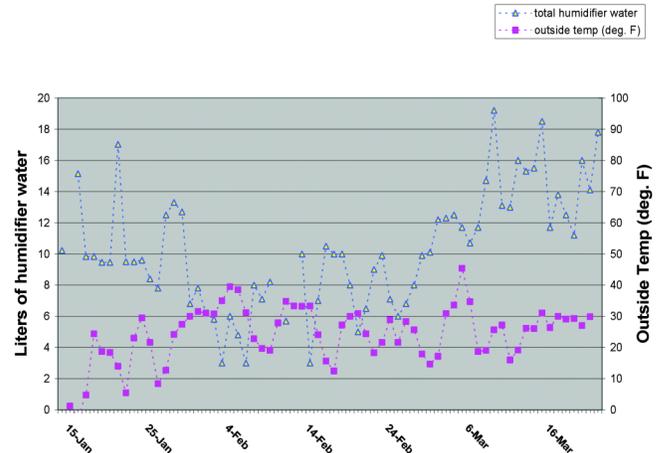
Figure 5 Daily consumption of humidifier water, plotted with outdoor daily average on-site temperature over the period of mid January through late March of 2005.

Over the later half of the 4th heating season, (when water consumption of the humidifiers was carefully measured), the combined consumption (in the house and the garage) was, on most days, considerably less than 15 liters per day (Figure 5). Humidification at very close to design levels was thus being attained, usually at much less than the anticipated moisture release rate, despite the fact that the house ACH₅₀ value was not particularly low, and, as indicated previously, the house, garage and basement were being operated as a single zone with respect to air exchange. The low measured water consumption by humidifiers was consistent with the crude

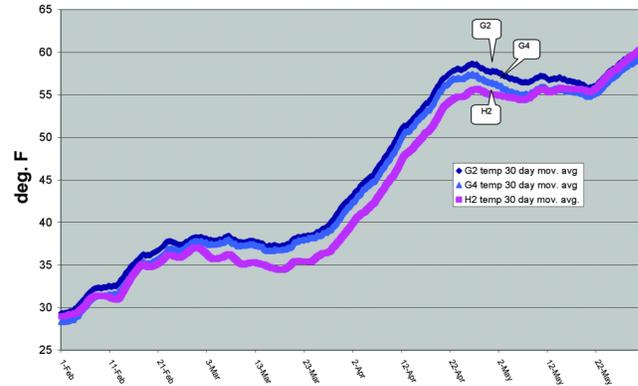
Figure 6 Temperature near the sheathing in three selected wall cavities during the winter/spring of 2005.

It is fairly clear that the more benign winter/spring moisture conditions in walls H-1, H-2, and H-3 than in walls G-1 through G-4 are associated with characteristics of the cladding systems. All the instrumented walls in the garage, owing to the directions that they faced, received more solar warming during winter and early spring than did the instrumented walls in the house. Plots of temperature (measured near the sheathing) for selected walls are shown in Figure 6.

Despite the consistently higher outer-cavity temperatures seen in Figure 6 in the walls facing ESE or SSW (walls G-2 and G-4) than in the wall facing NNE (wall H-2), the wall facing NNE showed less sheathing moisture accumulation, and (at least until early-spring) tended to show lower RH in the insulated cavity (Table 4). The primary reason for superior moisture performance of the walls clad with brick veneer or lap siding is probably air exchange between the exterior and the space(s) behind the cladding. Our observations concur with those of Murray and Tichy (2006), who observed drier conditions in walls clad with fiber cement lap siding than in walls clad with stucco¹⁴. By algebraic calculation, Straube and Burnett (1998) evaluated the theoretical benefit of cladding ventilation, and concluded that the benefit was likely substantial even when ventilation rates were modest.
