# Case Study: Performance of a House Built on a Treated Wood Foundation System in a Cold Climate

Charles G. Carll

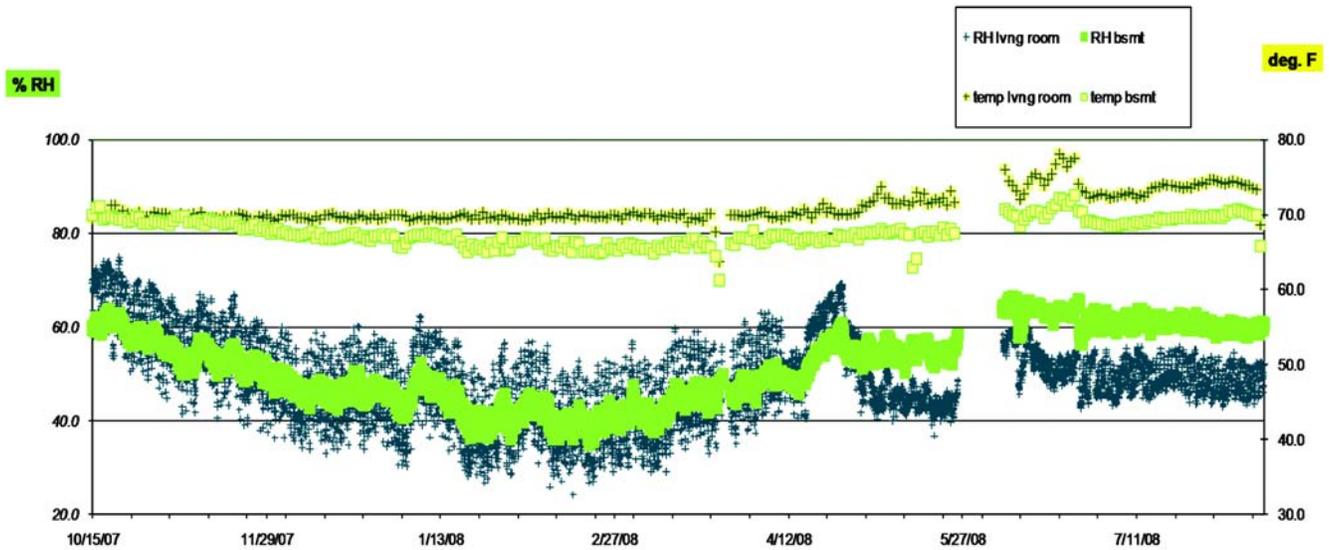
**Figure 1** Living room and basement hourly temperature and RH values from mid-October 2007 to mid-August 2008.

Conditions on the first story (living or “great” room) and in the basement over much of the 2007–2008 heating season and part of the 2008 cooling season are shown in Figure 1. The figure includes a short period in April 2008 when there was a malfunction of the heating system, and a period in June 2008 when there was a malfunction of the cooling system. Temperature and humidity plots for other years showed generally similar trends. Figure 1 indicates that basement and living room temperatures converged in mid autumn. During winter, spring, and summer, basement temperatures were consistently cooler than living room temperatures, although the temperature differences were never great. Unless there was a malfunction of the mechanical system, daily average temperature in the basement, without exception, remained within 6°F of 70°F. The basement may thus be characterized as having been a very well-tempered space, despite the fact that it is not provided with supply or return registers. The combination of conductive and radiant heat transfer from uninsulated ductwork, duct leakage, and air exchange between the house and the basement was sufficient to keep the basement at temperatures reasonably close to indoor set-point temperature conditions.

Figure 1 indicates that, during the heating season (when humidifiers were operated on first and second stories), hourly humidity conditions in the basement were relatively stable compared with those in the living room. This reflects the manner in which the humidifiers were operated: manually charged each day with an aggregate total of 10 L, and run continuously, with the charge completely evaporated before

the next day. On May 1, when humidification ceased, humidity levels in the living room decreased, but humidity levels in the basement did not. Humidity levels in both the living room and the basement were higher during the summer than during May. During the summer, lower-humidity conditions occurred when the air conditioner was functional. During summer months, humidity levels in the basement were consistently higher than in the living room, but did not exceed 70%. The highest hourly humidity levels occurred in the great room in October and in late April, when outdoor temperatures were mild and the house was humidified.
