Building Science in the Restoration of a Heritage Building

Mark Lawton, PEng
Member ASHRAE

The Hotel Georgia is a Vancouver landmark. The 12-story building opened in 1927 and since then has hosted royalty and scoundrels—and a host of famous entertainers. The hotel is registered as a protected heritage property by the City of Vancouver. It is currently undergoing a major renovation with the intent of reopening as a five-star hotel.

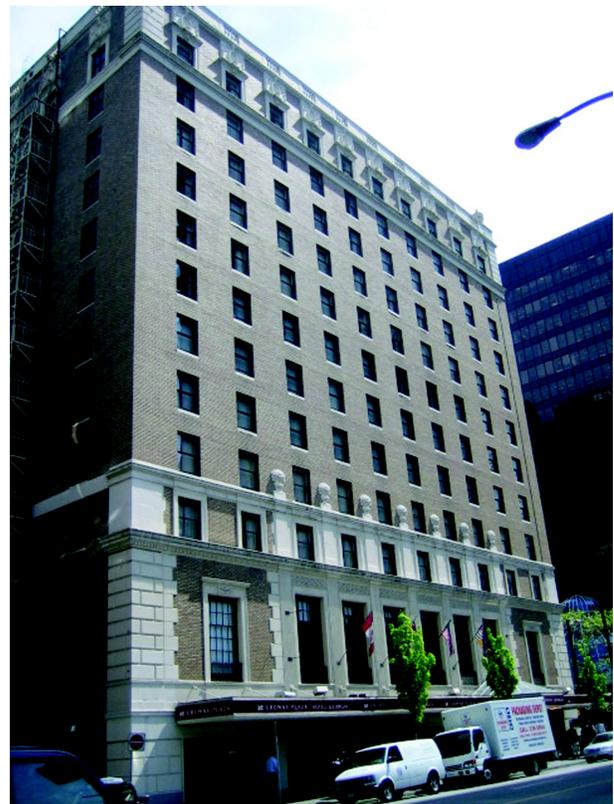
The exterior cladding is a locally produced buff-colored Claybank brick with trim elements and window sills of what Garrow called “cast stone,” a sand/cement mix with some reinforcing steel that looks like sandstone (Photo 1). These materials have been used on a number of Vancouver buildings of similar vintage.

Photo 1 South facade of Hotel Georgia Vancouver.

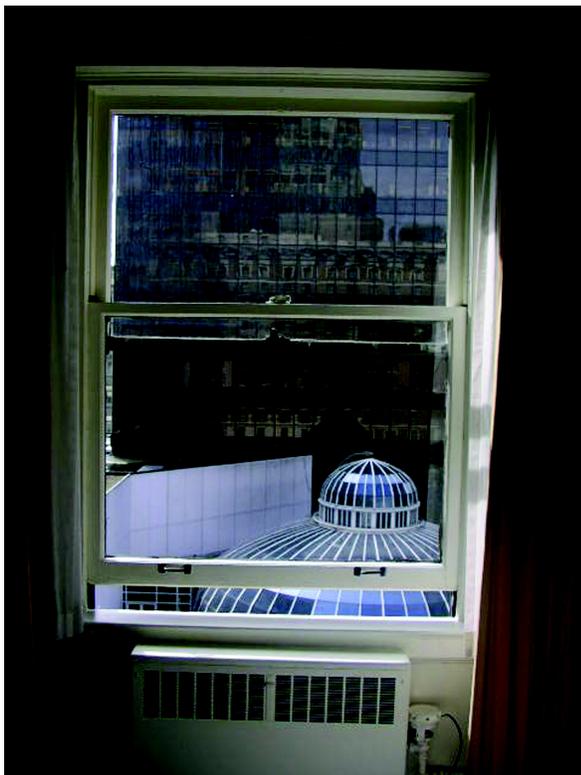
The original windows on the residential floors are one-over-one, weight-balanced, double-hung units of high quality wood (probably old growth Douglas fir). See Photo 2 and Figure 3 for typical window detail. On four of the residential floors, the original sashes had been removed and aluminum-framed, double-glazed windows had been installed into the original wood frame. We were informed that these windows were installed to meet airline standards for crew accommodation

Photo 2 Typical window in suite.

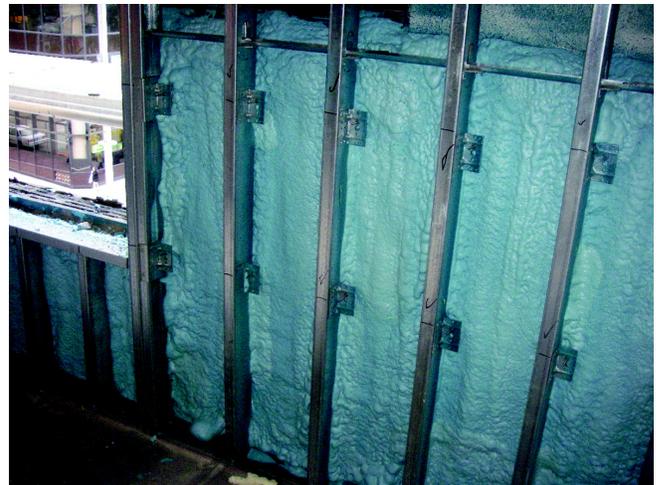
Photo 11 Insulation applied to exterior walls.

the properties of medium-density closed-cell polyurethane foam insulation (ccSPUF). The new stud wall was anchored to the slab above and below and stood off the inside face of the originals wall by about 25 mm. At about 50 mm, ccSPUF was applied to the inside face of the wall. This expanded behind the steel-stud frame and around the threaded rods, providing a continuous layer of waterproof, airtight, vapor-resistant insulation (see Photo 11). The foam engaged the studs, providing a structure strong enough to resist wind loads even if adhesion to the original wall was compromised. This was considered relevant because not all of the original plaster was removed during demolition. Long-term adhesion of the foam to plaster on the cold side of the insulation could not be assumed.

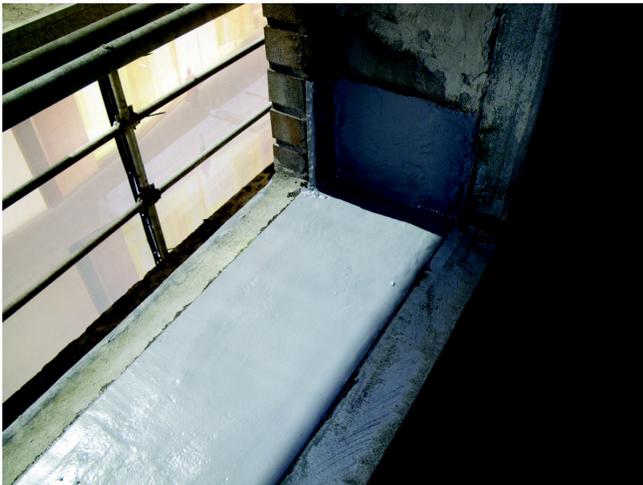
Photo 13 Waterproofed window opening.

using strap anchors back to the new structural, stud frame wall, and the window was sealed into the wall assembly using urethane sealant and ccSPUF (see Figure 4 and Photos 13 and 14).

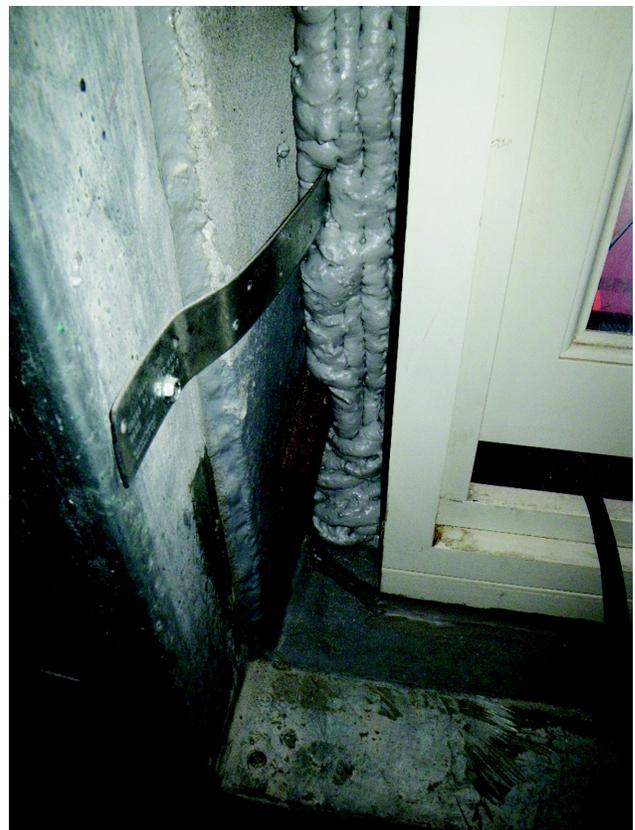
Photo 14 Window attachment and sealing.
