Timber-Frame Walls: Feasible with a Damaged Vapor Barrier?

ABSTRACT

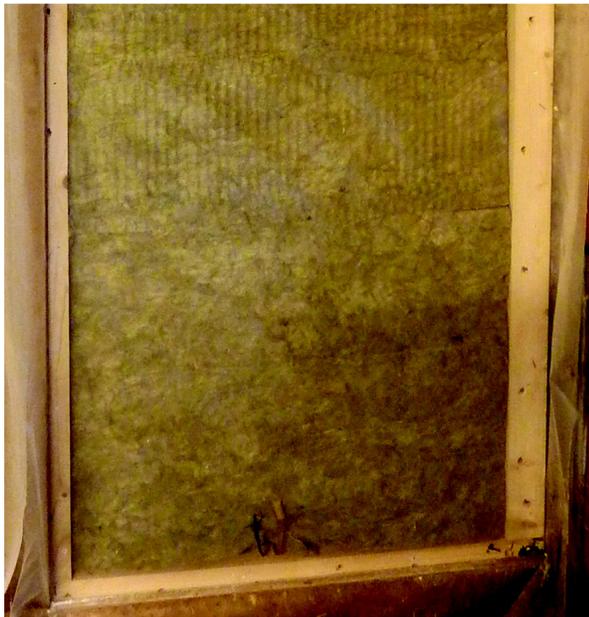
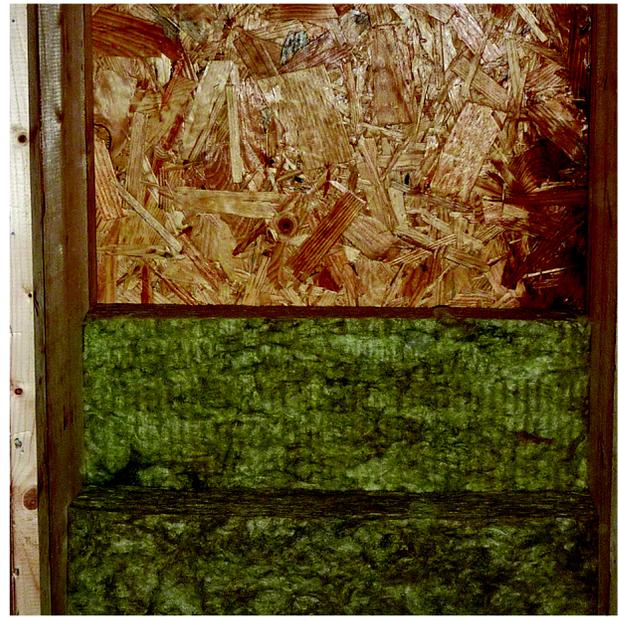
Figure 2 Inspection of element (A) after removing the inner cladding showing the vapor barrier, and (B) after removing part of the thermal insulation material showing the wind barrier.

In general, inspection of elements with an intact vapor barrier showed a moisture content behind or in the wind barrier below the critical level, although the moisture content in the

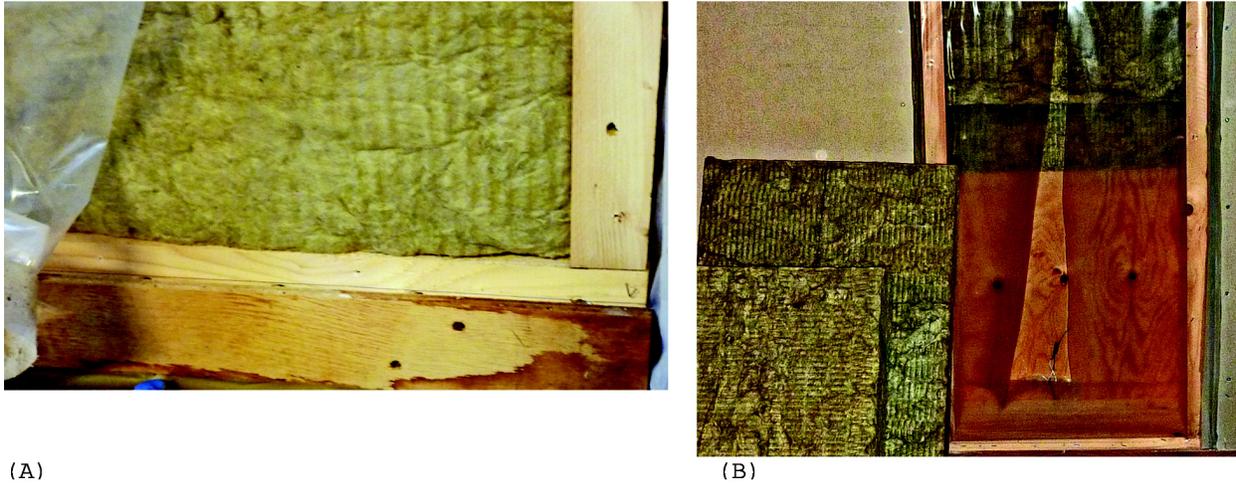
Figure 3 Elements where the vapor barrier was opened (A) along the edge, or (B) by making a cut.

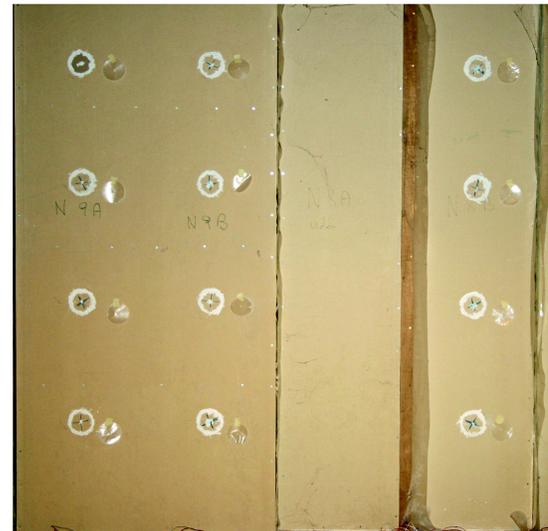
Figure 6 Elements with restored inner cladding after removing four pieces of vapor barrier.

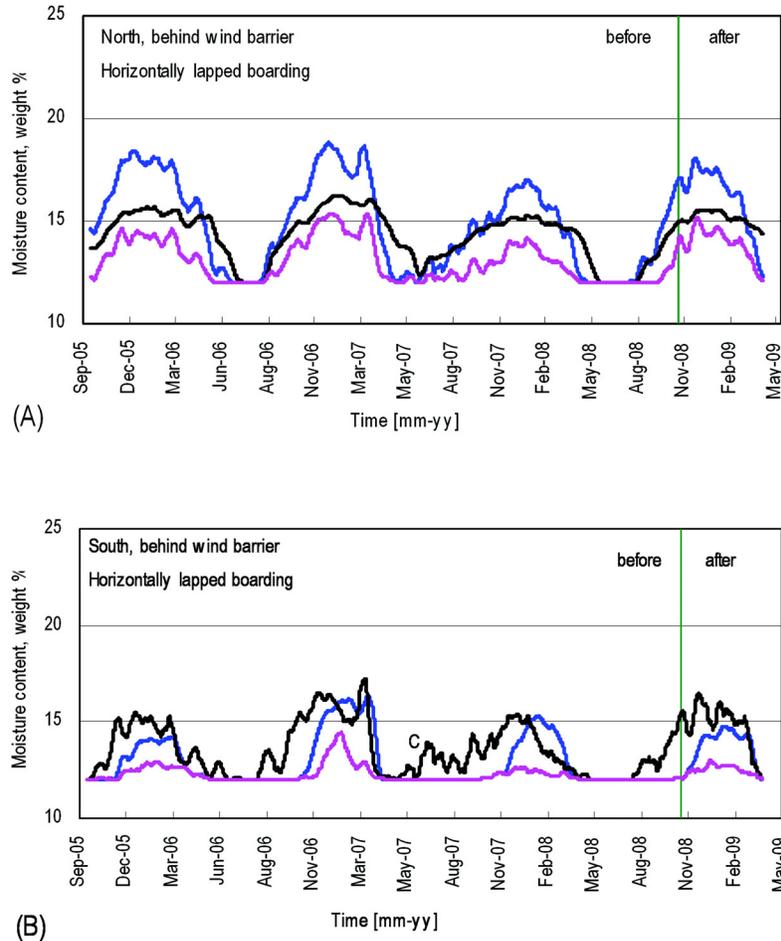
Figure 7 Moisture content (weight %) behind the wind barrier. Façade elements facing (A) north and (B) south. Horizontally lapped boarding. Ventilated cavity (cavity depth: 25 mm, element 1, black), nonventilated cavity (cavity depth: 12 mm, element 4, violet), no cavity (element 11, blue). “Before” and “after” refer to the time when holes were made in the vapor barrier.

The moisture content behind the wind barrier before and after the holes were made in the vapor barrier is shown in Figure 7 and 8. Element 11 (Figure 7) was in principle without a cavity, but because of the type of cladding (horizontally lapped boarding, see Figure 5A) there were small, isolated cavities between the wind barrier and the cladding. Element 10 (Figure 8) was partly ventilated. At the bottom was a 5 mm ventilation opening in the 12 mm deep cavity. In element 13, the type of cladding (vertical weatherboard) left no cavity at all (Figure 8). Element 13 had an intact vapor barrier.

None of the cases where holes were made in the vapor barrier showed a provable effect on the moisture content in the elements (Figures 7 and 8). This indicated that the moisture condition at the wind barrier was only slightly affected by damage to the vapor barrier (at least damage similar to that inflicted in this study). Damage that enables convection through the elements would probably have a more pronounced effect. In that case, one could question whether elements should include a ventilated cavity. Further studies are needed to explore this.

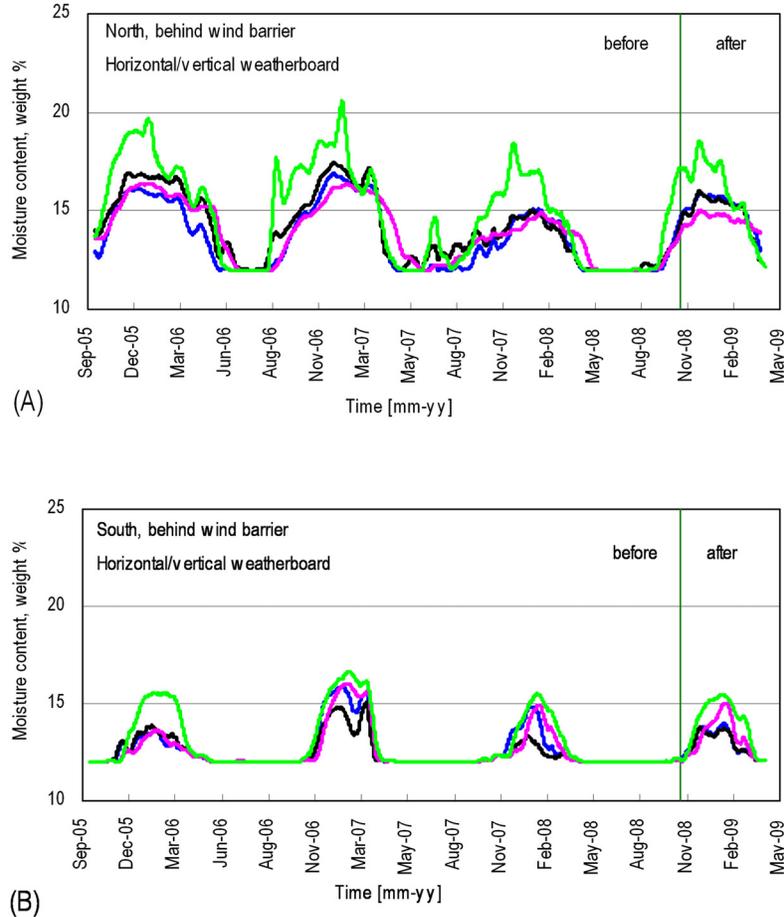
Figure 8 Moisture content (weight %) behind the wind barrier, façade elements facing (A) north and (B) south. Ventilated cavity (element 2, black), nonventilated cavity (element 6, violet), partly ventilated cavity (element 10, blue), no cavity (element 13, green). Horizontal weatherboard (elements 2, 6, and 10; cavity depth: 12 mm) and vertical weatherboard (element 13) as cladding. “Before” and “after” refer to the time when holes were made in the vapor barrier (not element 13).
