ORNL-2834
UC-25 – Metals, Ceramics, and Materials
TID-4500 (17th ed.)

AN INVESTIGATION OF THE CORROSION RESISTANCE OF BRAZING ALLOYS FOR AUSTENITIC STAINLESS STEEL FUEL ELEMENTS FOR SERVICE IN 565°F PRESSURIZED WATER

R. J. Beaver, C. F. Leitten, Jr., and J. L. English

MAR 29 1962

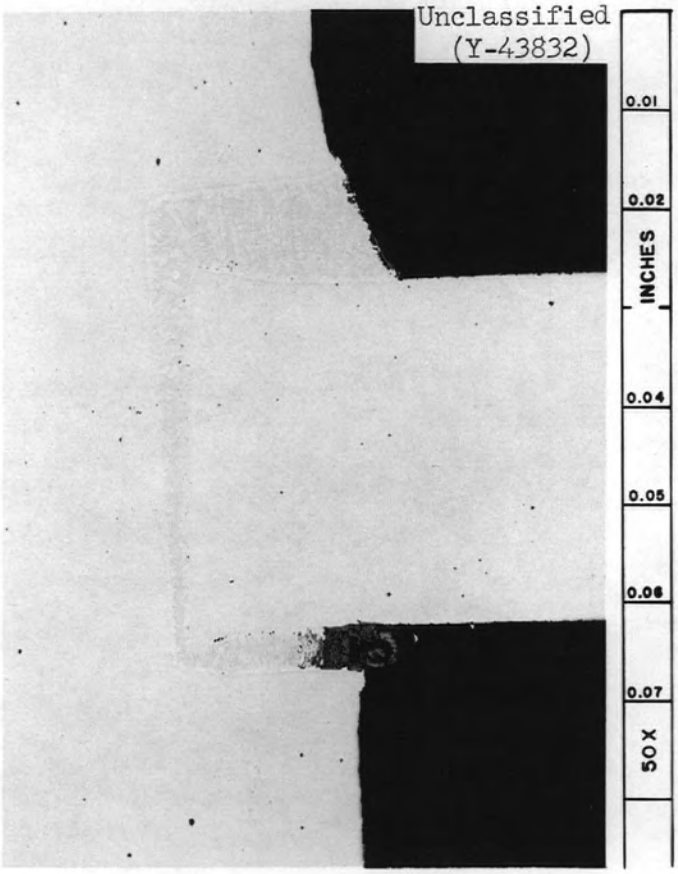
Figures 7 and 8 illustrate the general effect on the brazed joint when exposed for 16 months in pressurized water with 1 cc O_2/liter added. Corrosion at the fillets is evident. As illustrated in Fig. 8, the corrosion attack appears solely in the matrix with localized penetration to

Fig. 7. Type 304L Stainless Steel Joint Brazed with Coast Metals N.P. and Autoclave Tested for 16 Months in Distilled Water Containing 1 cc O_2/liter at 565°F and 1200 psi. Etchant: 10% oxalic acid.

Fig. 8. Corrosion of Brazed Fillet of Coast Metals N.P. Joined to Type 304L Stainless Steel After 16 Months in Static 565°F, 1200 psi Distilled Water Containing 1 cc O_2/liter. Etchant: 10% oxalic acid.

a depth of 0.002 in. The white primary phase exhibited excellent corrosion resistance. The corrosion does not seem to be catastrophic in nature and it is anticipated that the joint would not be severely weakened after exposures as long as 24 months. Figure 9 and 10 show the effect of corrosion when 50 cc H_2/liter are added. The addition of hydrogen does not appear to change the corrosion rate significantly.

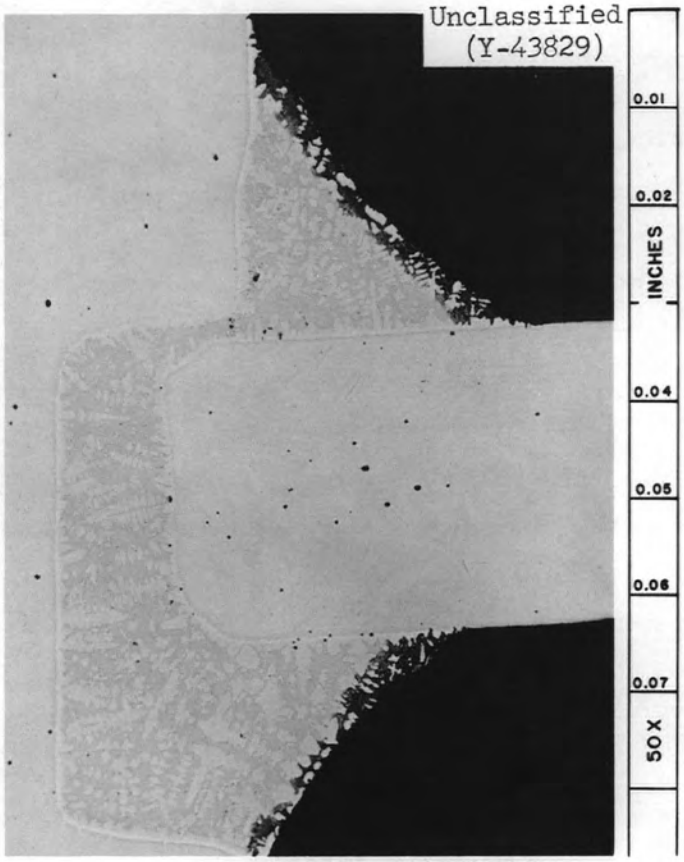
Fig. 9. Type 304L Stainless Steel Joint Brazed with Coast Metals N.P. and Autoclave Tested for 12 Months in Distilled Water Containing 50 cc H_2/liter and 1 cc O_2/liter. Etchant: 10% oxalic acid.

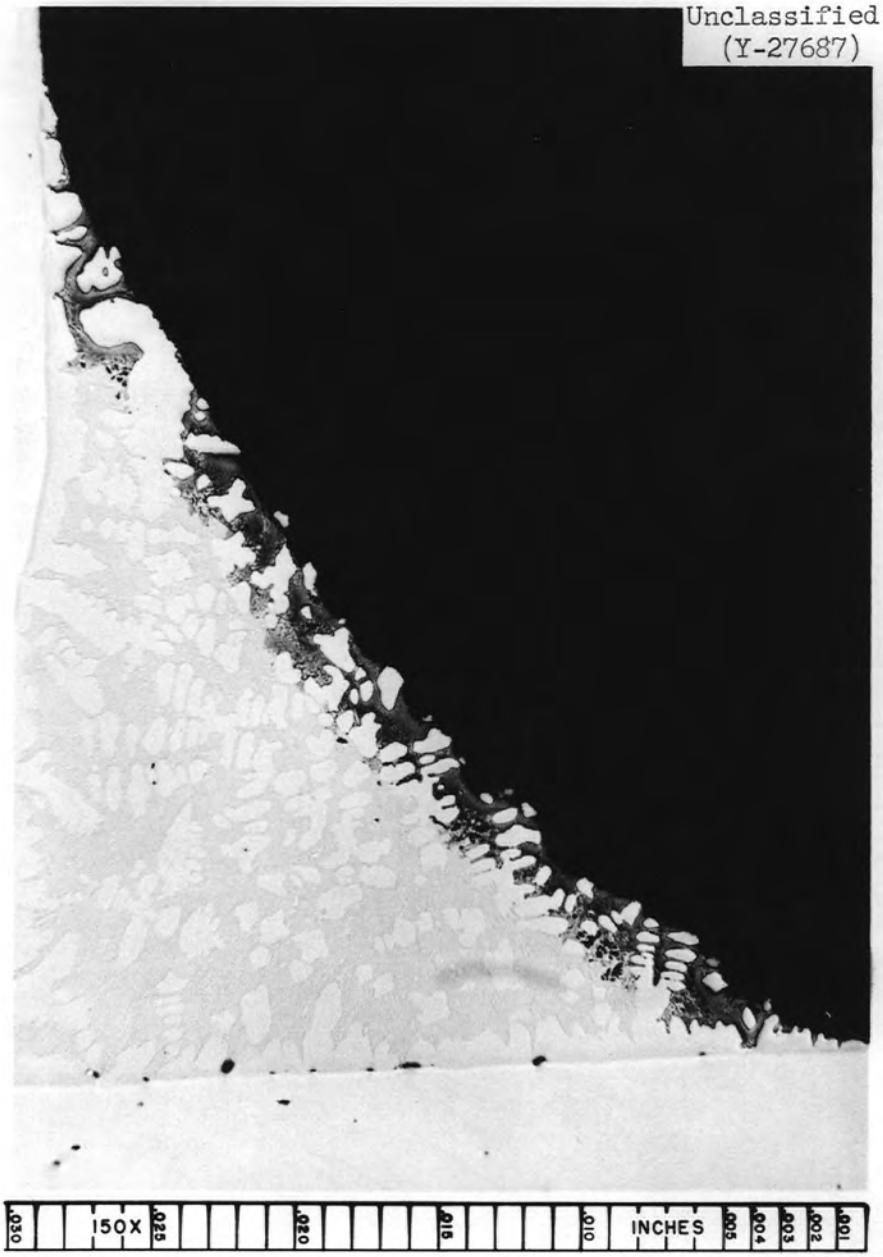
Fig. 10. Corrosion of Brazed Fillet of Coast Metals N.P. Joined to Type 304L Stainless Steel After 12 Months in Static 565°F, 1200 psi Distilled Water Containing 50 cc H_2/liter and 1 cc O_2/liter. Etchant: 10% oxalic acid.

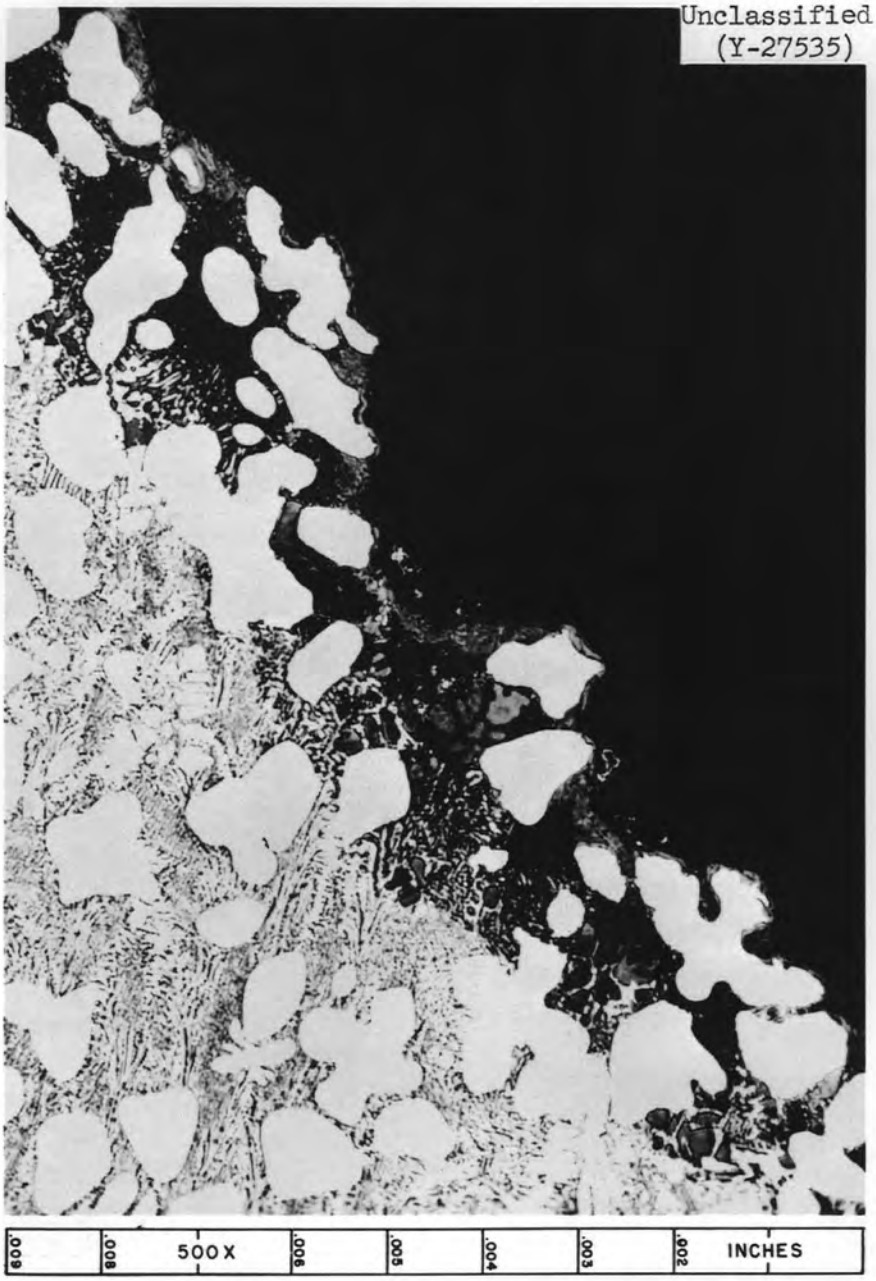
Fig. 11. Corrosion of Brazed Fillet of Coast Metals N.P. Joined to Type 304L Stainless Steel After 12 Months in Static 565°F, 1200 psi Distilled Water Containing 50 cc H_2/liter and 1 cc O_2/liter. Etchant: 10% oxalic acid.

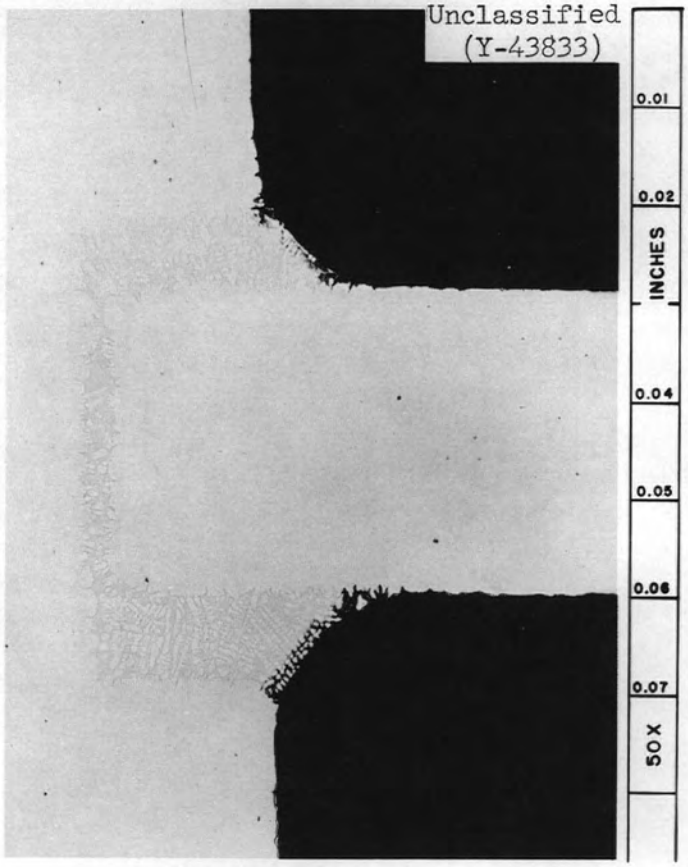
The corrosion of this alloy was quite similar to that of Coast Metals N.P. The additions of hydrogen made no significant change in appearance of the joint. Figures 11, 12, and 13, which show the effect after exposure for 16 months in pressurized water with 1 cc O_2/liter added, are representative of those exposed in water with hydrogen additions. Figure 11 illustrates the general appearance of the General Electric No. 81 brazed joint while the general attack to the matrix of the braze metal is illustrated in Fig. 12. Specific detail can be seen in Fig. 13. As with Coast Metals N.P., penetration into the matrix to a depth of 0.002 in. is evident with the primary phase exhibiting excellent corrosion resistance.

Fig. 12. Type 304L Stainless Steel Joint Brazed with General Electric No. 81 and Autoclave Tested for 16 Months in Distilled Water Containing 1 cc O_2/liter at 565°F and 1200 psi. Etchant: 10% oxalic acid.

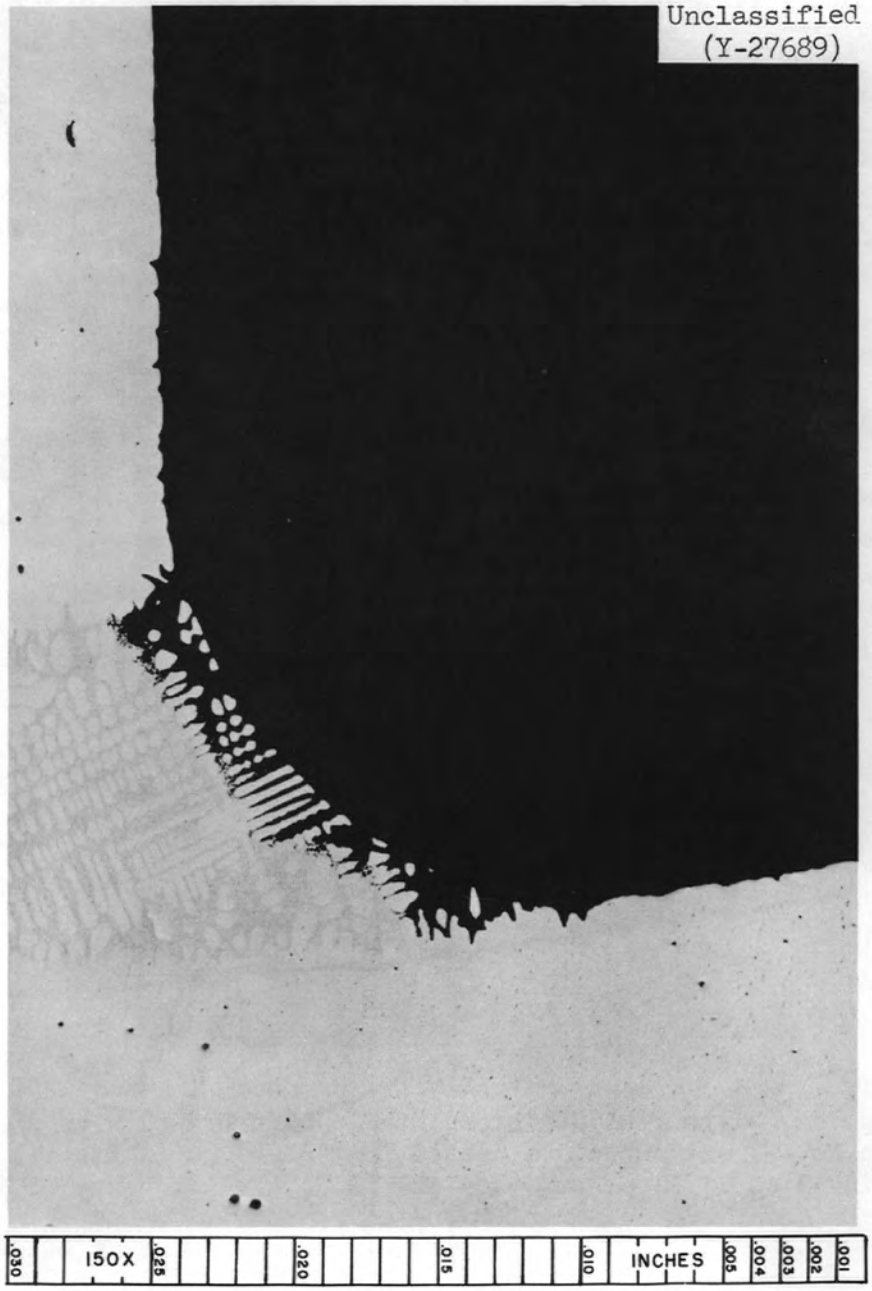
Fig. 13. Corrosion of Brazed Fillet of General Electric No. 81 Joined to Type 304L Stainless Steel After 16 Months in Static 565°F, 1200 psi Distilled Water Containing 1 cc O_2/liter. As polished.

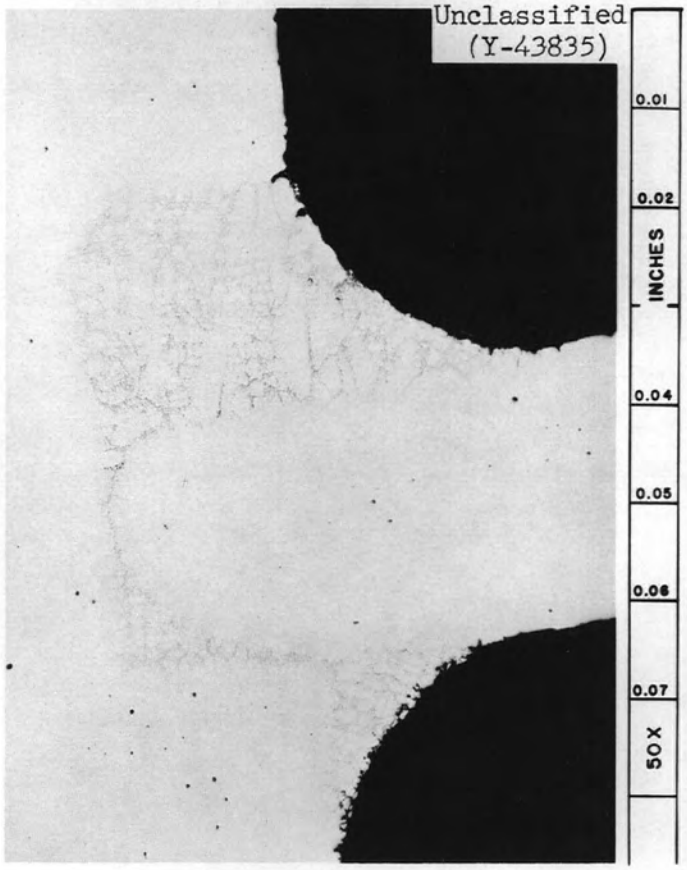
The corrosion resistance of this alloy appeared to be somewhat better than Coast Metals N.P. and General Electric No. 81. The corrosion mechanism was quite similar (attack of the matrix with the primary phase highly corrosion resistant). Penetration appeared to be 0.001 in. These effects are illustrated in Figs. 14, 15, and 16.

Fig. 14. Type 304L Stainless Steel Joint Brazed with General Electric No. 75 and Autoclave Tested for 16 Months in Distilled Water Containing 1 cc O_2/liter at 565°F and 1200 psi. Etchant: 10% oxalic acid.

Fig. 15. Corrosion of Brazed Fillet of General Electric No. 75 Joined to Type 304L Stainless Steel After 16 Months in Static 565°F, 1200 psi Distilled Water Containing 1 cc O_2/liter. As polished.

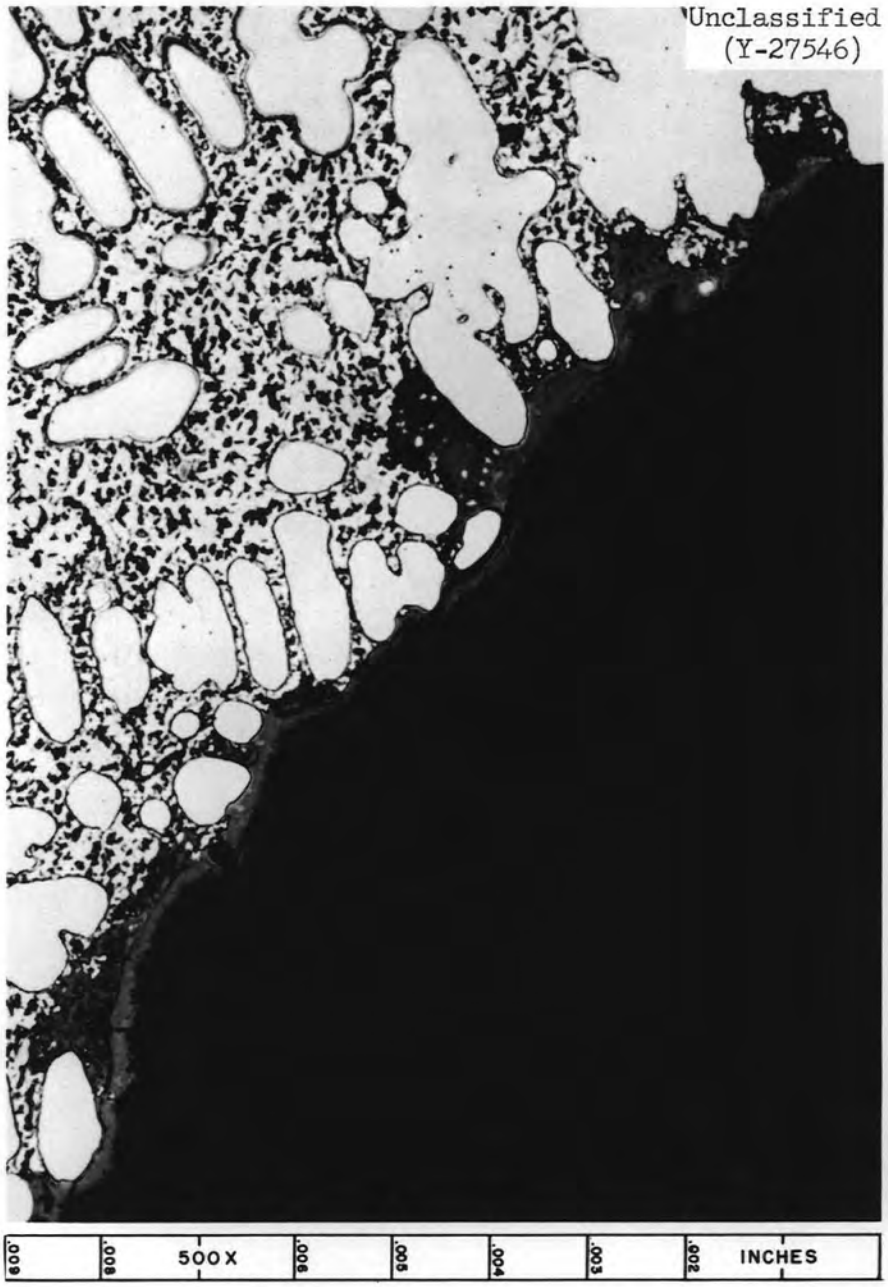
Fig. 16. Corrosion of Brazed Fillet of General Electric No. 75 Joined to Type 304L Stainless Steel After 16 Months in Static 565°F, 1200 psi Distilled Water Containing 1 cc O_2/liter. Etchant: 10% oxalic acid.

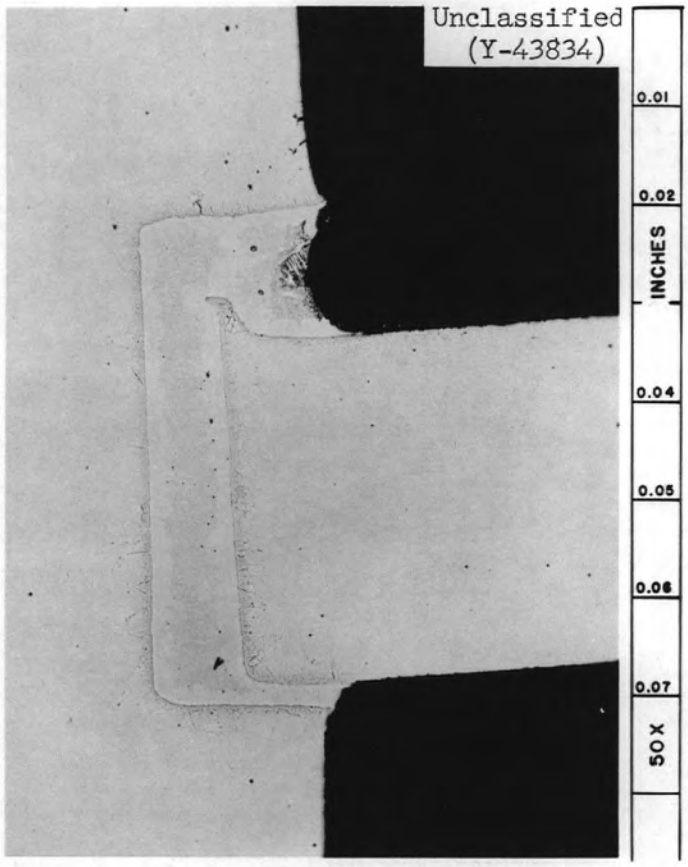
This alloy exhibited good corrosion resistance in the 16-month test. Corrosion appeared to be the same whether the water contained 1 cc O_2/liter or 1 cc O_2/liter and 50 cc H_2/liter. As shown in Fig. 17, the good behavior

Fig. 17. Type 304L Stainless Steel Joint Brazed with Low-Melting Nicrobraz and Autoclave Tested for 16 Months in Distilled Water Containing 1 cc O_2/liter at 565°F and 1200 psi. Etchant: 10% oxalic acid.

of this alloy may be due to the presence of a single, apparently very corrosion resistant phase, particularly in locations where joint clearances were less than 0.003 in.

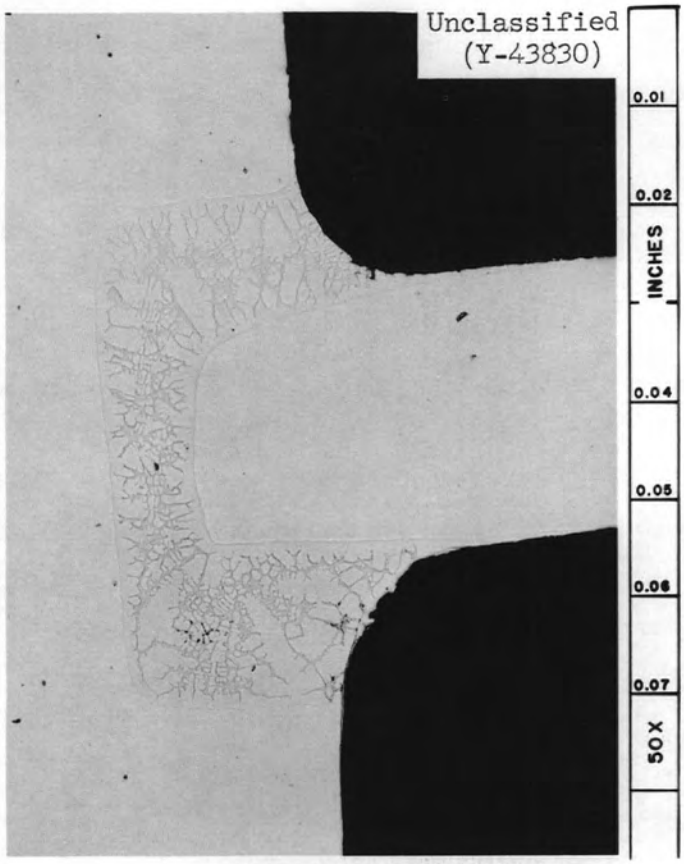
This alloy exhibited excellent corrosion resistance in the 16-month test. Corrosion appeared to be the same regardless of oxygen and/or hydrogen additions. As illustrated in Fig. 18, there is some evidence of localized fissuring extending 0.007 in. into the brazed fillet. General attack, however, appeared to be limited to less than 0.001 in.

Fig. 18. Type 304L Stainless Steel Joint Brazed with 60% Pd–37% Ni–3% Si Alloy and Autoclave Tested for 16 Months in Distilled Water Containing 1 cc O_2/liter at 565°F and 1200 psi. Etchant: 10% oxalic acid.

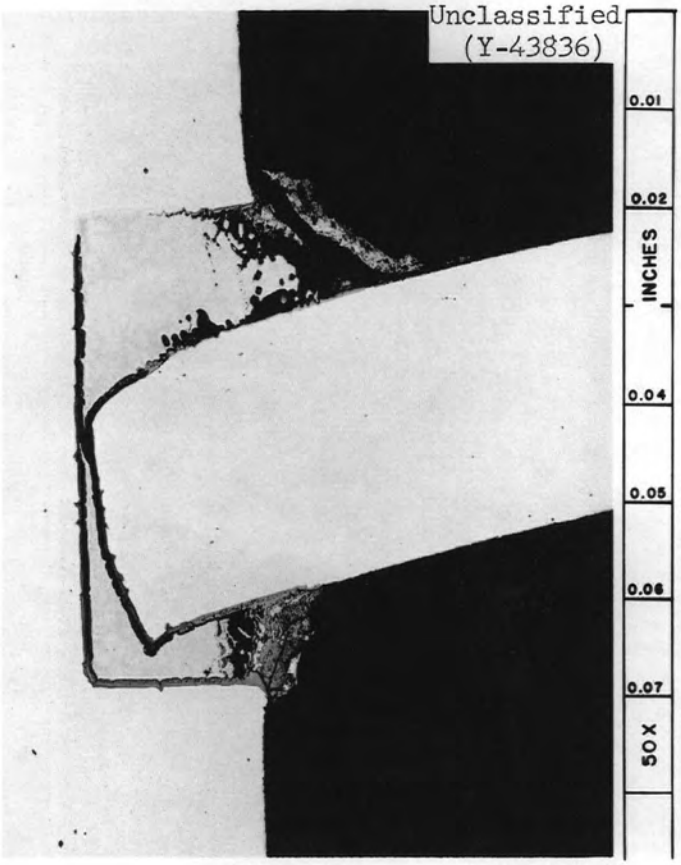
The corrosion resistance of an 80% Cu–20% Ni alloy in pressurized water with 1 cc O_2/liter added was poor, as evidenced by the attack illustrated in Fig. 19. A marked improvement was observed when 50 cc H_2/liter were added. This is evident in a comparison of Fig. 19 with Fig. 20. Increasing the copper content to 90% appeared to somewhat decrease the corrosion resistance in the water containing 50 cc H_2/liter. This effect can be seen by comparing Fig. 21 with Fig. 20. It is to be observed, however, in the specimen brazed with the 90% Cu–10% Ni alloy that small clearances at the stainless steel joints appear to be desirable.

Fig. 19. Type 304L Stainless Steel Joint Brazed with 80% Cu–20% Ni Alloy and Autoclave Tested for 16 Months in Distilled Water Containing 1 cc O_2/liter at 565°F and 1200 psi. Etchant: 10% oxalic acid.

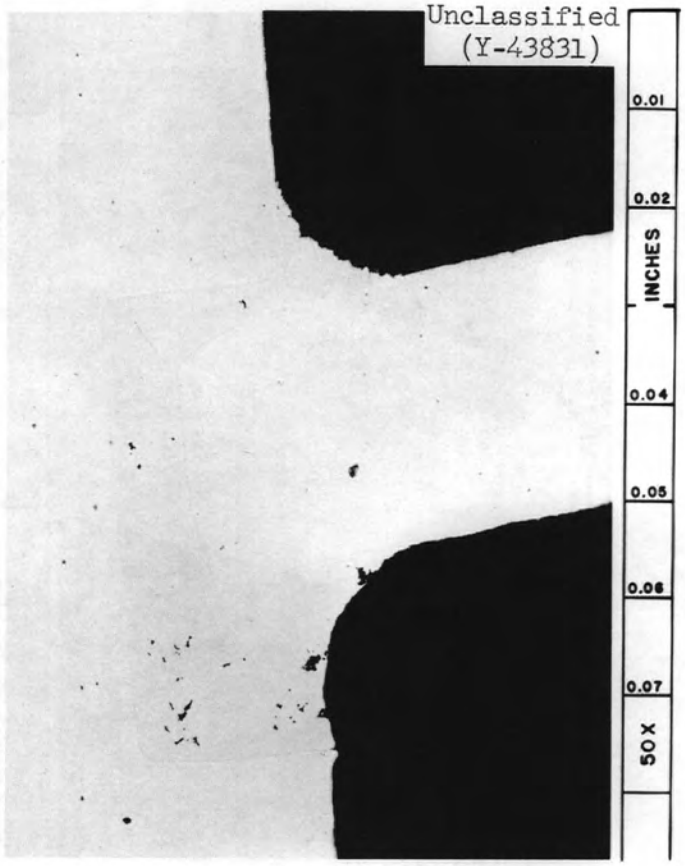
Fig. 20. Type 304L Stainless Steel Joint Brazed with 80% Cu–20% Ni Alloy and Autoclave Tested for 12 Months in Distilled Water Containing 50 cc H_2/liter and 1 cc O_2/liter at 565°F and 1200 psi. Etchant: 10% oxalic acid.

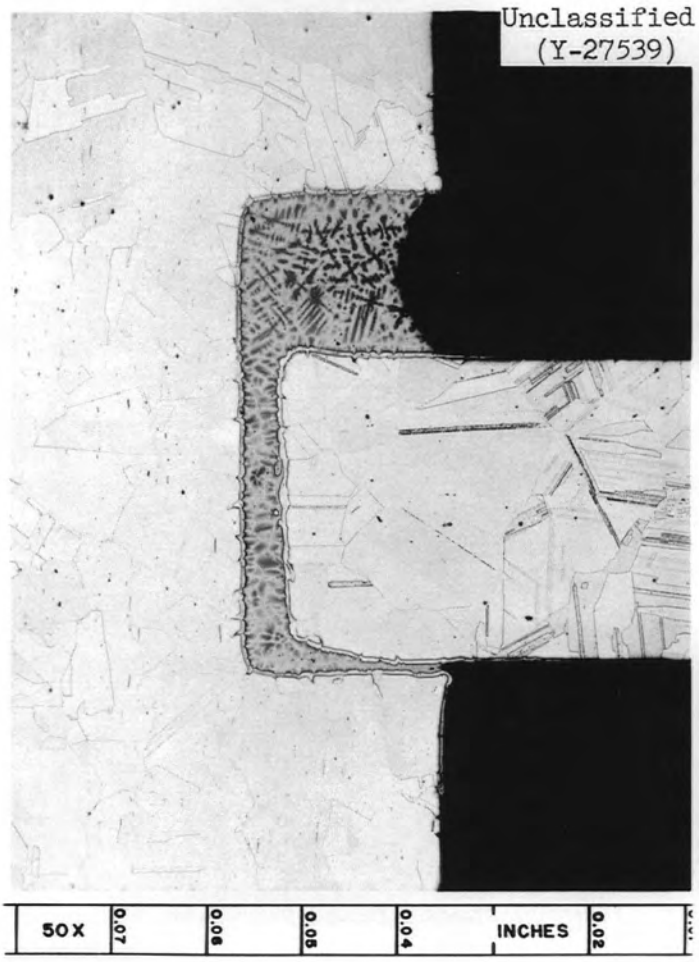
Fig. 21. Type 304L Stainless Steel Joint Brazed with 90% Cu–10% Ni Alloy and Autoclave Tested for 12 Months in Distilled Water Containing 50 cc H_2/liter and 1 cc O_2/liter at 565°F and 1200 psi. Etchant: 10% oxalic acid.
