ORNL/RAP-25

**The Site Corrective Measures
Program Maintenance and
Surveillance Plan
FY 1988-1997**

Date of Issue - September 1987

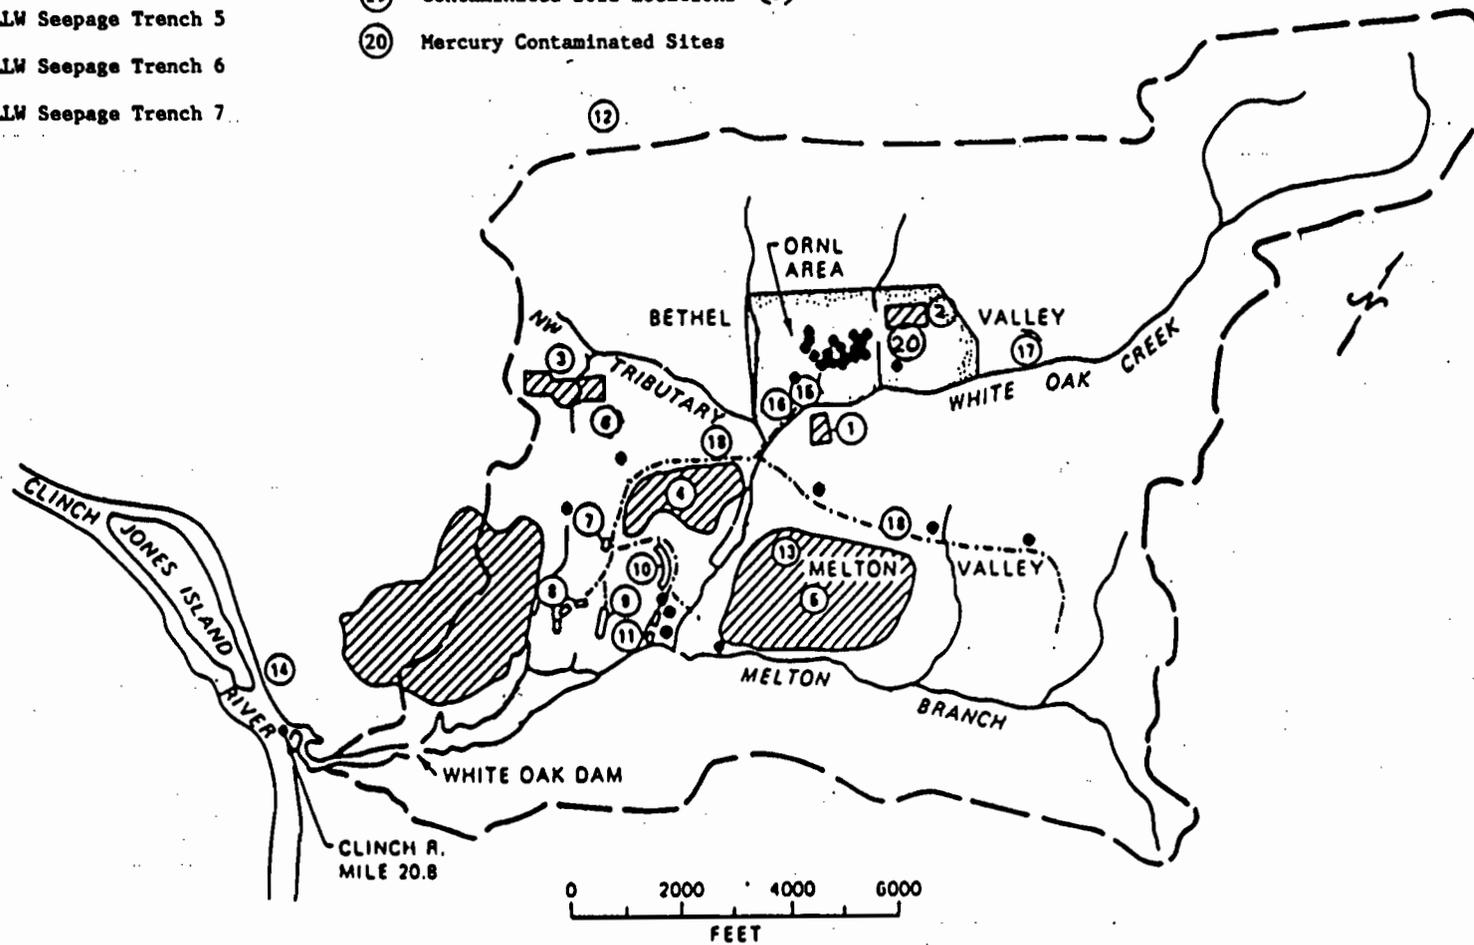
Fig. 1. Overview of ORNL SCMP site locations

An overview of the 75 inactive facilities currently managed by the SCMP is shown in Table 1. The additional 11 active facilities included in the program are also indicated in Table 1. The locations of the SCMP sites are shown in Fig. 1.

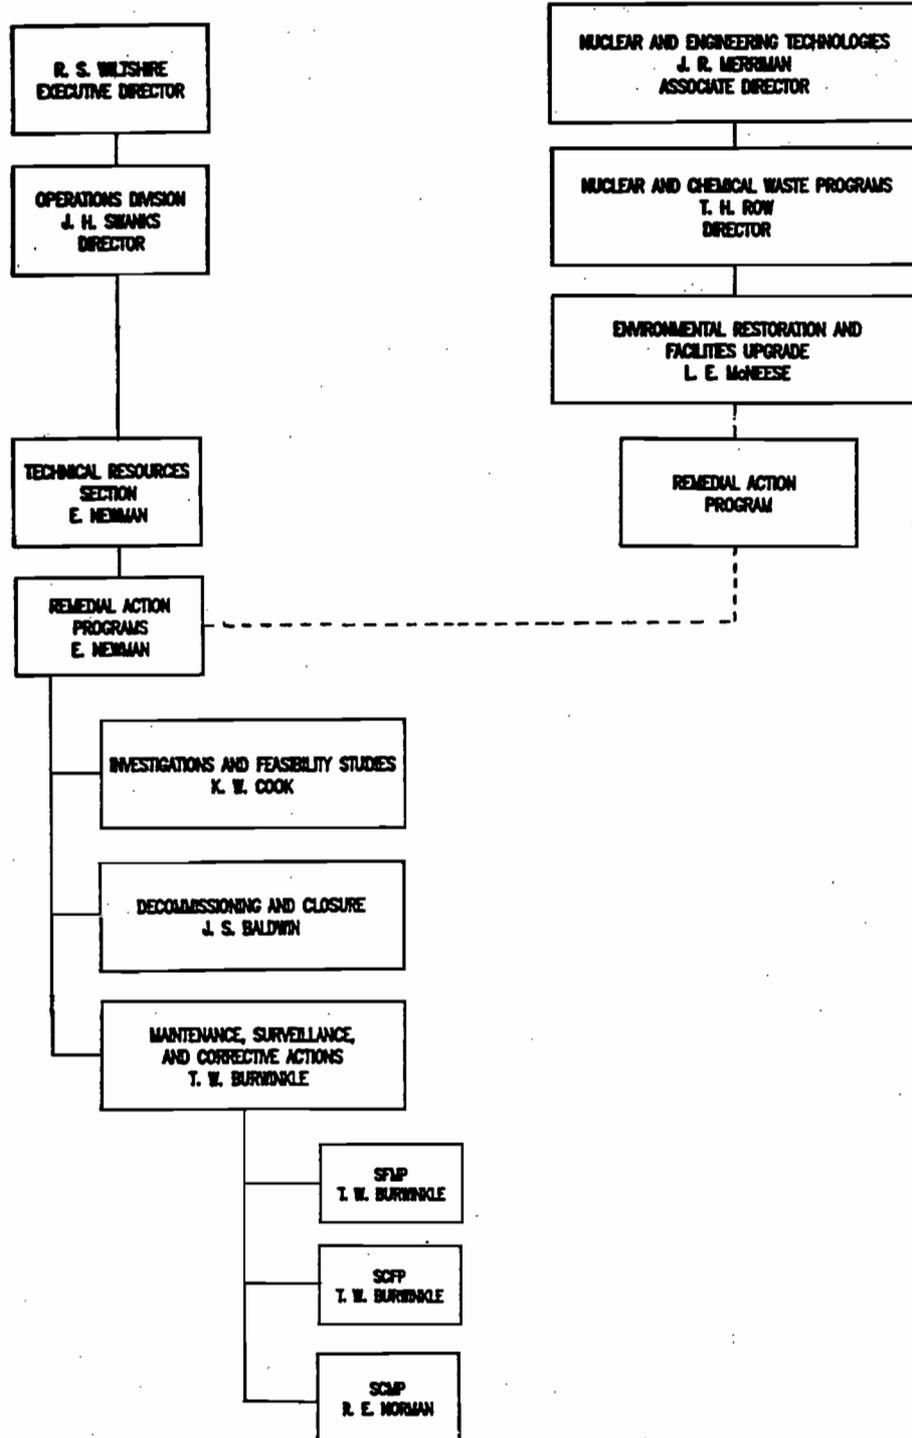
Fig. 2. Remedial Action Program organizational structure

In summary, the Operations Division has direct responsibility for the SCMP sites, including the M&S activities. In addition, eight other divisions have active participation in the program by their direct or indirect support. These are:

1. HASRD,
2. EC&HP,
3. Quality Department (QD),
4. Plant and Equipment (P&E),
5. Analytical Chemistry (AC),
6. Environmental and Occupational Safety (E&OS),
7. Laboratory Protection (LP), and
8. Engineering (ENG).
