ORNL/CON-255

Moisture Measurements in Single-Family Houses with Attics Containing Radiant Barriers

MOISTURE MEASUREMENTS IN SINGLE-FAMILY HOUSES
WITH ATTICS CONTAINING RADIANT BARRIERS

Date Published: February 1989

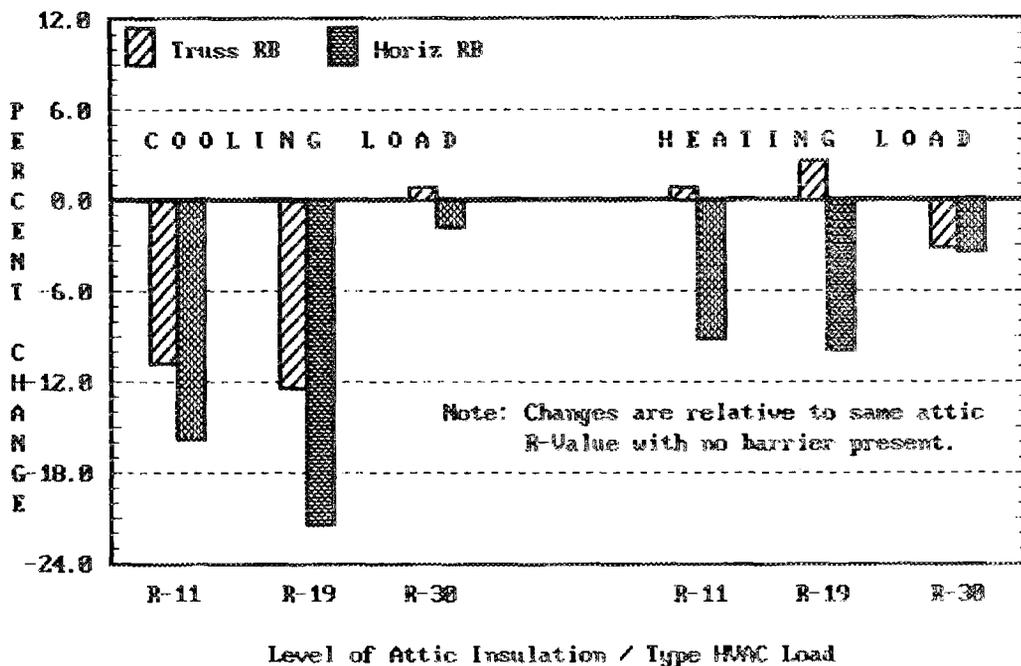
Fig. 1.1 Summary of radiant barrier effects on Karns house loads.

The results of the energy performance testing are summarized in Fig. 1.1. The cooling results testing R-11 attic insulation show that a TRB reduced the house cooling load by 10%, while an HRB reduced the load by 16% compared with R-11/no RB. The cooling results with R-19 attic insulation show that a TRB reduced the cooling load by about 12%, while an HRB reduced the load by 21% compared to R-19/no RB. RBs had very little effect when used in combination with R-30 insulation. An HRB tested in the heating mode with R-11 decreased the heating load by an average of 9%, while a TRB showed a very slight increase in the load of 0.8% compared with R-11/no RB. An HRB with R-19 decreased the heating load by an average of 10%. R-30 with a RB showed a reduction of 3.5% for both HRBs and TRBs. The heating load reduction with R-30 and a TRB is inconsistent when comparing the trends obtained from R-11 and R-19 with TRBs, and no explanation is offered for this behavior. Note, however, that the absolute values of the R-30 load changes are relatively small compared with those of R-11 and R-19 loads.

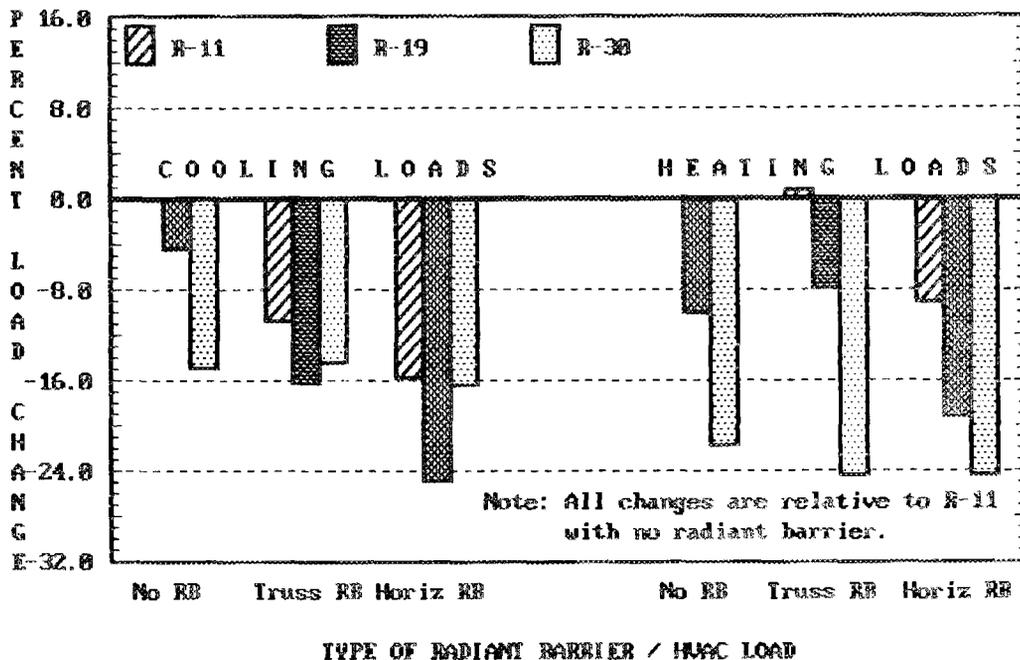
Fig. 1.2 Affect of radiant barrier/attic insulation on Karns HVAC loads.

The results of the heating season test of 1985-86 (for R-19) and 1986-87 (for R-11 and R-30) were integrated using the DOE 2.1 building simulation program. Figure 1.2 summarizes both the heating and cooling tests and shows the effect of an RB relative to R-11 attic insulation with no RB. The results show that R-19 with a HRB outperforms all the other options in the cooling mode, including R-30 with an HRB. An HRB in combination with R-19 ceiling insulation reduced the cooling load by 25% in comparison with R-11/no RB. This situation is not the same in the heating mode, where R-30 alone or with either type of RB

outperforms R-19 with an HRB. We speculate that an HRB works more as a convective barrier in the heating mode than as a RB. However, we have no evidence to support this. We also believe that the size and quantity of perforations in an HRB had little affect on its energy performance, but, again, this is conjecture.

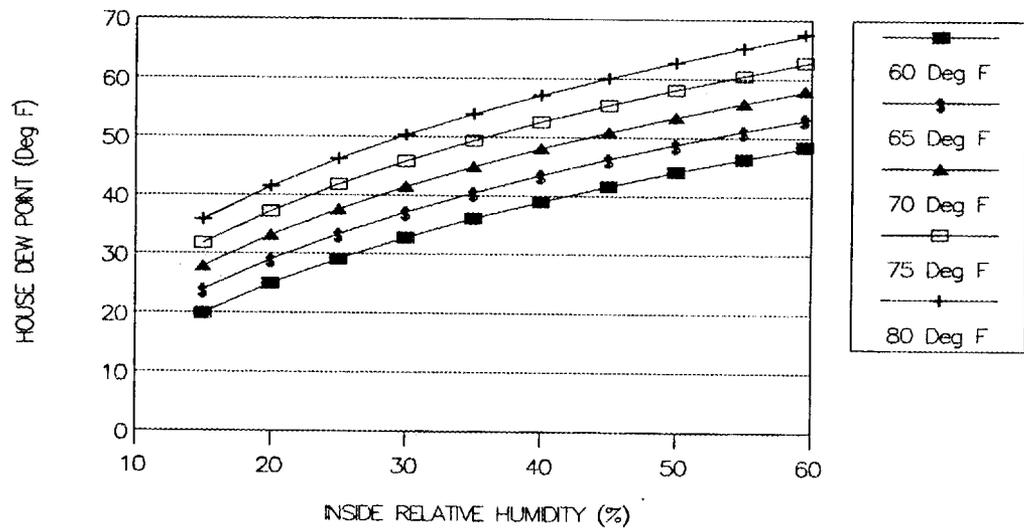
Fig. 2.1 House dew point vs relative humidity for various indoor temperatures.

Figure 2.1 shows the relationship between RH, dry bulb temperature, and the dew point temperature.

other two houses during this period. The plaster board on the lower inside of the window frame was extremely moist in house No. 3 during these cold periods. Clearly, 55% RH is much too high an indoor humidity to maintain in a house during cold periods. Figure 2.1 shows that the inside dew point is 55°F when the inside dry bulb temperature is 70°F and the RH is 55%.

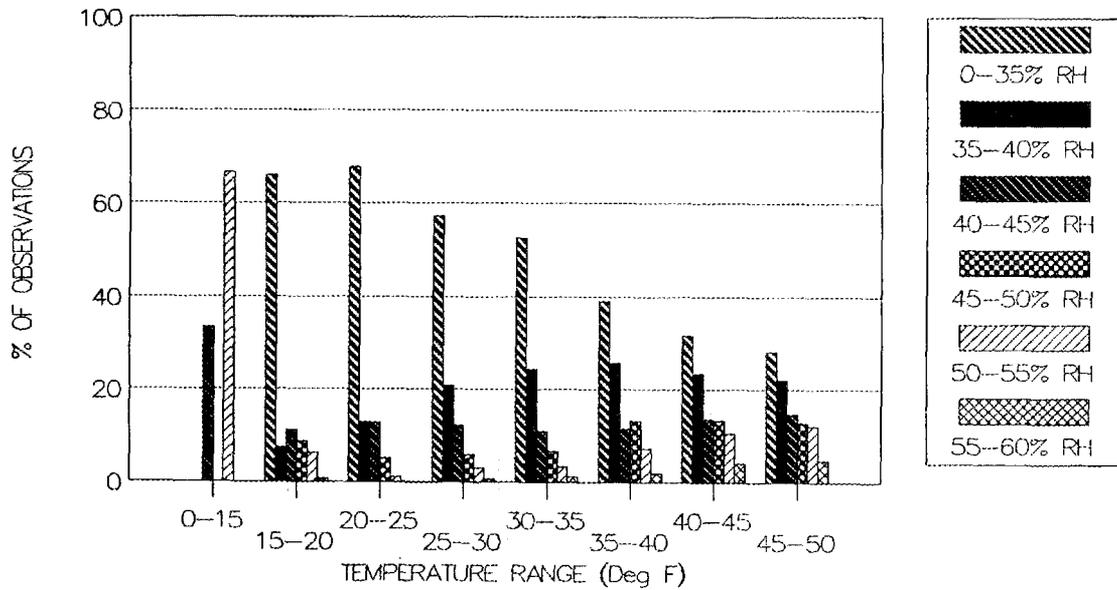
Fig. 2.2 TVA Solar Homes for the Valley relative humidity data.

Table 2.1 and Fig. 2.2 summarize the results of the SHFV RH data. Table 2.1 gives the number and percentage of observations (i.e., 15-minute data points) that occur in each outdoor temperature range in each RH range. Fig. 2.2 graphically displays the information in Table 2.1.

The main conclusion drawn from Table 2.1 and Fig. 2.2 is that RHs above 45% are not common when ambient temperatures are less than 35°F (i.e., at outdoor temperatures when condensation may be a problem). The percentage of observations for the 45-50% humidity range was well below 10% for each temperature range less than 35°F.

It should be noted that the results for the 0°F - 15°F range should be viewed with caution since there were only three observations in this temperature range from a grand total of over 49,000 observations. As would be expected given the dryness of outdoor air during winter, most of the RHs in the SHFV data were in the 0-35% range. In the outdoor temperature ranges below 35°F, the occurrence of RHs in the 0-35% range was greater than 50%. During the coldest temperature ranges, 15-20°F and 20-25°F, the occurrence of 0-35% RH observations was almost 70%. The three lowest RH ranges (i.e., 0-35, 35-40, and 40-45%) account for 84, 94, and 90 respectively, and 88% of all the observations in the below 35°F temperature ranges.

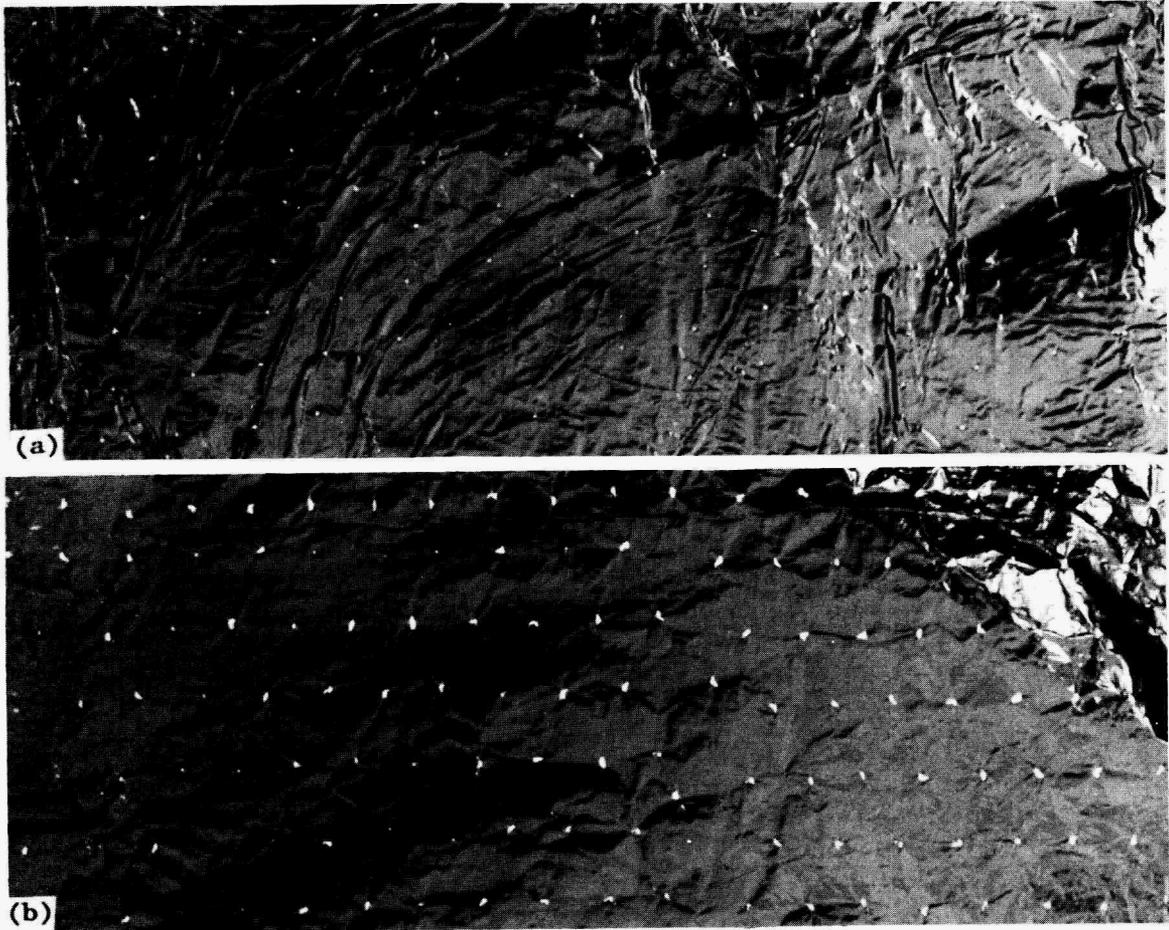
Figs. 3.1 (a-b) Perforated radiant barrier materials with different hole sizes.

The perforated RB material used in this work was different from that used in the 1985-86 winter testing. Although the material had come from the same source, the size of the perforations was different. Figures 3.1(a-b) are photographs of sections of each of the two materials and show the differences in the hole sizes. Table 3.1 compares data obtained from a surface scan analysis of the two barriers. Material #1 had been used in the previous winter testing, and material #2 was used in this current work. Figures 3.2(a-b) are bar graphs depicting the data from Table 3.1. The average hole size had increased from 0.012 to 0.040 in. The percentage hole area increased from 0.05 to 0.46%. The number of perforations in the barrier essentially was unchanged -- the holes were located on about 5/8-in. staggered centers. Also, the holes in material #2 appeared to be more triangular in appearance than those in material #1. We assumed that the manufacturer of the material had increased the hole size to cope with moisture dissipation.

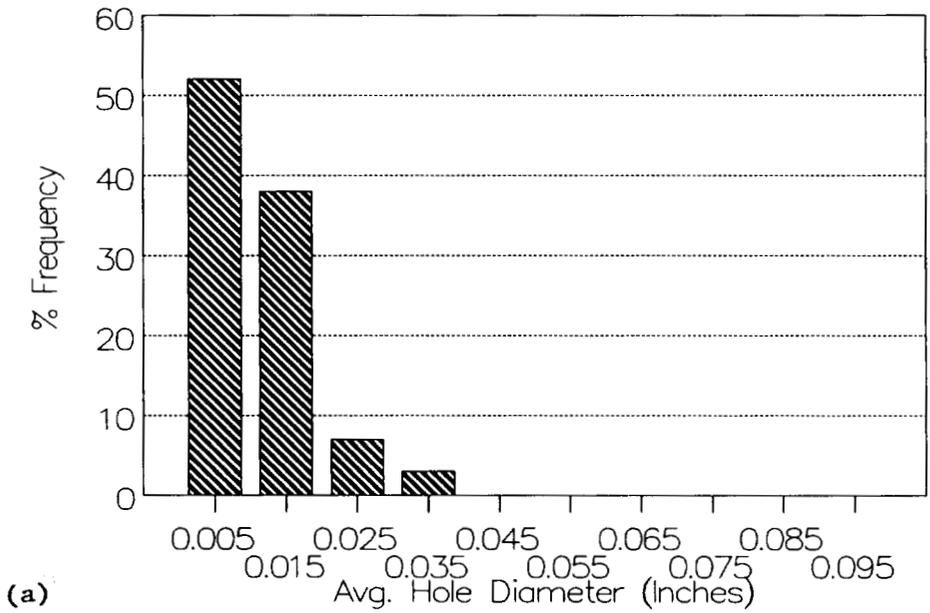
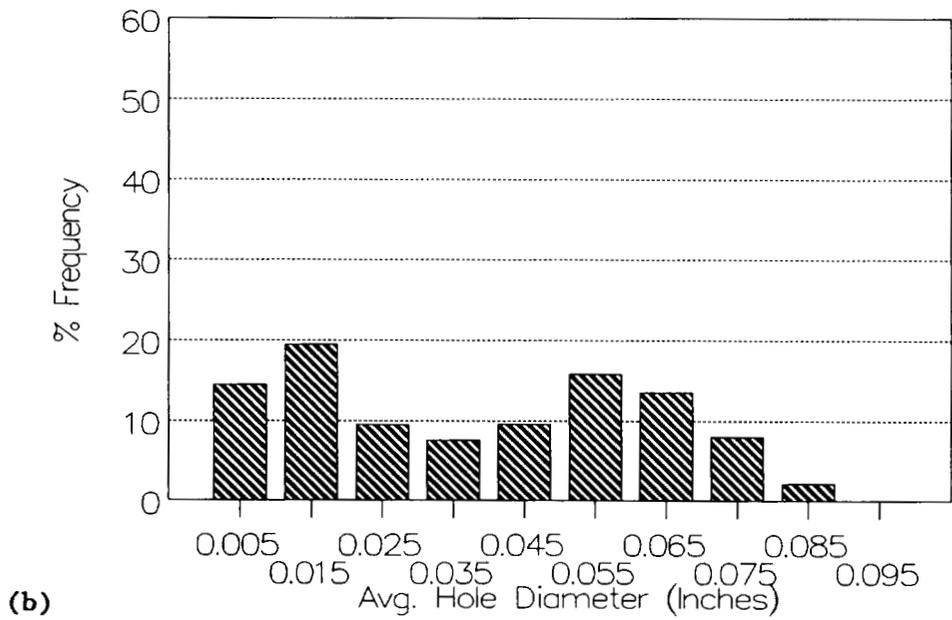
MATERIAL #1 BY SURFACE SCAN ANALYSIS

MATERIAL #2 BY SURFACE SCAN ANALYSIS

Fig. 3.2(a-b) Hole size distributions in perforated radiant barriers.

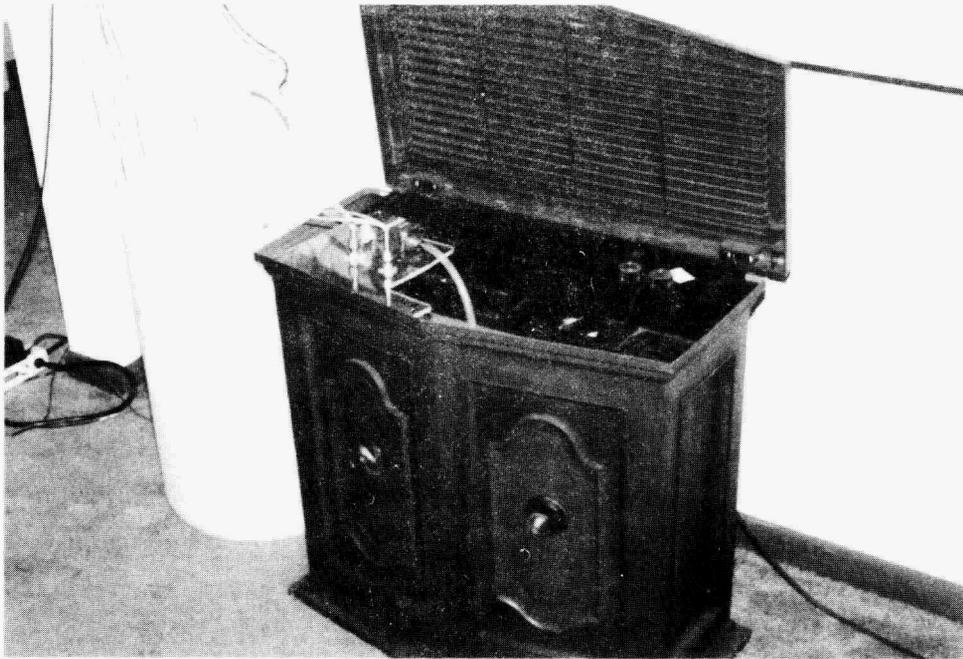
Fig. 4.1 Humidifier setup used to supply moisture to test houses.

Humidity was added to the houses by means of free-standing humidifiers (Fig. 4.1). A 15-gallon plastic jug next to each humidifier served as a makeup water reservoir to keep the water in each humidifier at the same approximate level. Two floats, located in the left corner of each humidifier, actuated a small solenoid pump when approximately 200 ml of water had been added to the house air. Water was pumped from the plastic jug to the humidifier in this manner. The stroke of each solenoid pump was adjusted to give a constant delivery volume of 2 ml per stroke. Pump repeatability was very good and held constant throughout the winter. Each stroke of the pump generated a pulse that the data collection system used to monitor the dynamic addition of water to each house. Table 4.1 shows the average conditions under which the houses were maintained along with the dates of operation for each phase of the testing.

One thing that became apparent during the testing was that the output capacity of one humidifier (approximately 6 gallons per day) during cold (less than 25°F) weather was not sufficient to maintain the indoor RH at 55% at 70°F. Therefore, during the second phase of the testing, the RH of house No. 3 was raised to 55% and a second humidifier was added to ensure that this high level of indoor RH could be maintained.

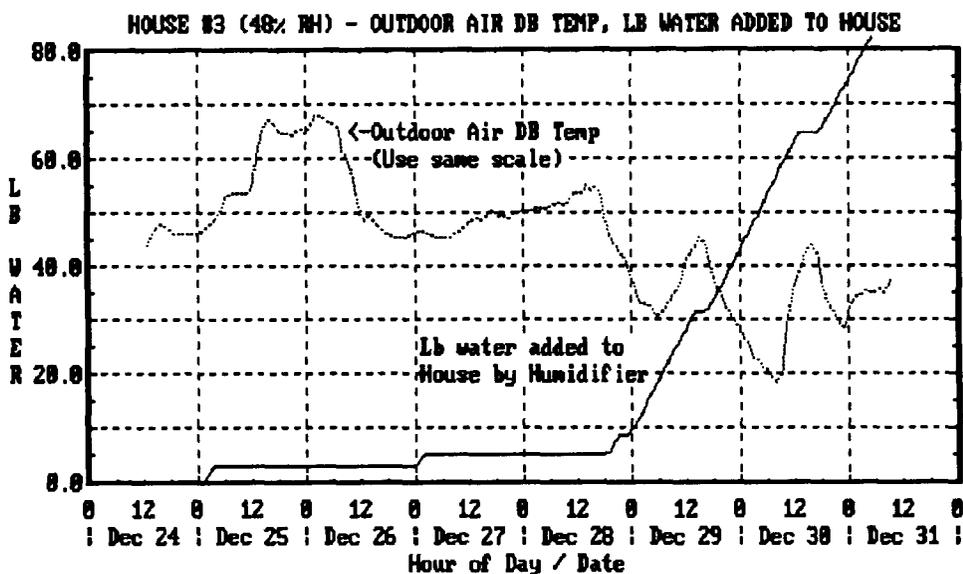
Fig. 4.2 House No.3 (Dec. 24-31) humidifier water addition and outdoor air temperature.

Figures 4.2 and 4.3 are plots that illustrate the amount of moisture which was added to house No. 3 and the corresponding outdoor dry bulb temperature for a warm week and a cold week respectively. The cycling of the humidifier is clearly shown in Fig. 4.2, while the essentially constant on condition of the humidifier is shown in Fig. 4.3.

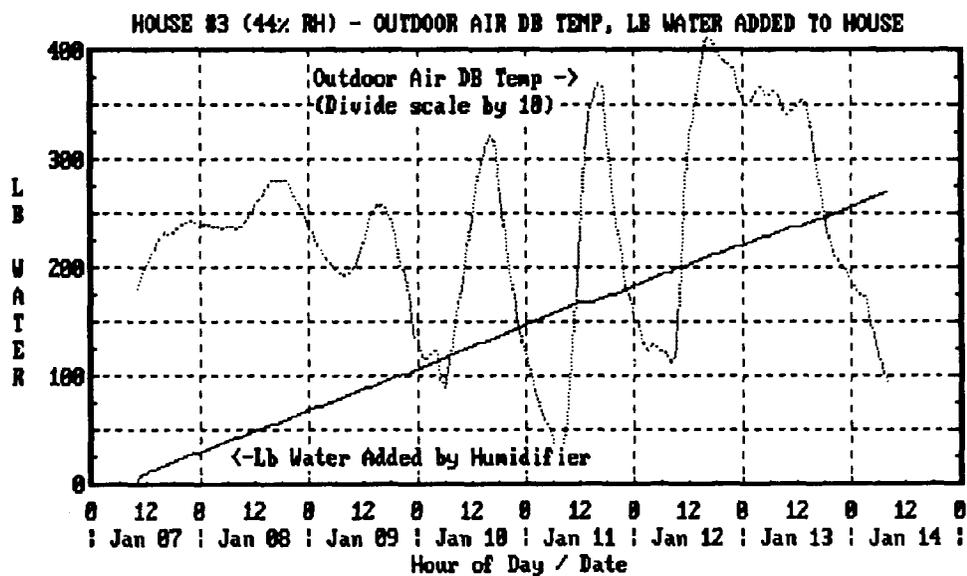
Fig. 4.3 House No.3 (Jan. 7-14) humidifier water addition and outdoor air temperature.

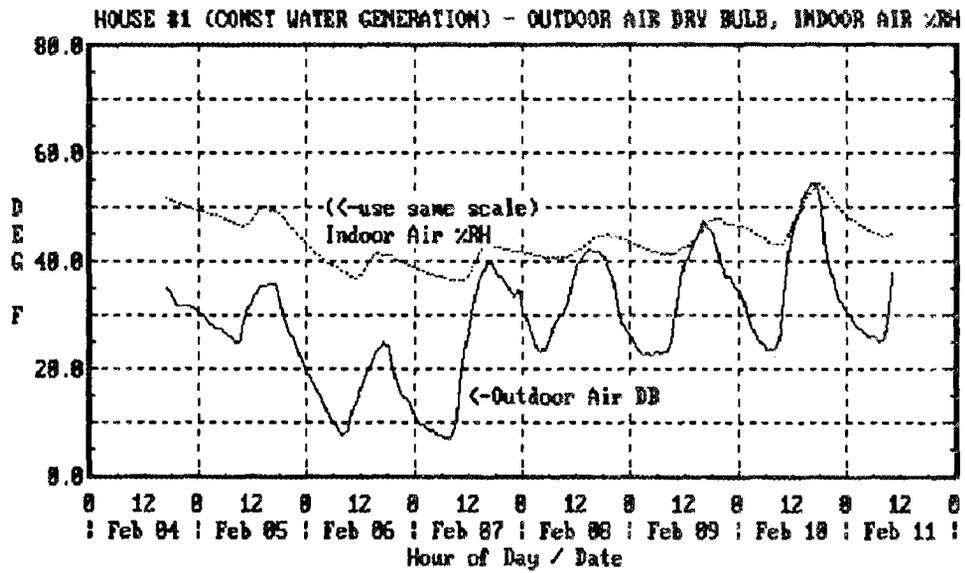
Fig. 4.4 House No.1 (constant water generation)--indoor relative humidity and outdoor air temperature.

The third phase of the testing was designed to test in house No. 1 the 25 lb/day estimated water generation in a typical home. However, the actual experimental water generation rate was close to 30 lb/day because of humidifier control limits. Also, the unfaced R-19 in house No. 3 was replaced that had R-19 with a kraft paper vapor barrier facing. The RH in house No. 1 was therefore allowed to float, and that in house No. 3 was maintained at 55% with only one humidifier. Figure 4.4 is a time series plot for approximately a week of the inside RH in house No. 1 and the outside temperature. The indoor RH was about 35% at about 70°F and 55% at 55°F. Figure 4.5 shows the cumulative amount of water added to the house air over the same weekly period. Note that the relatively constant slope signifies a uniform rate of water addition to the house.

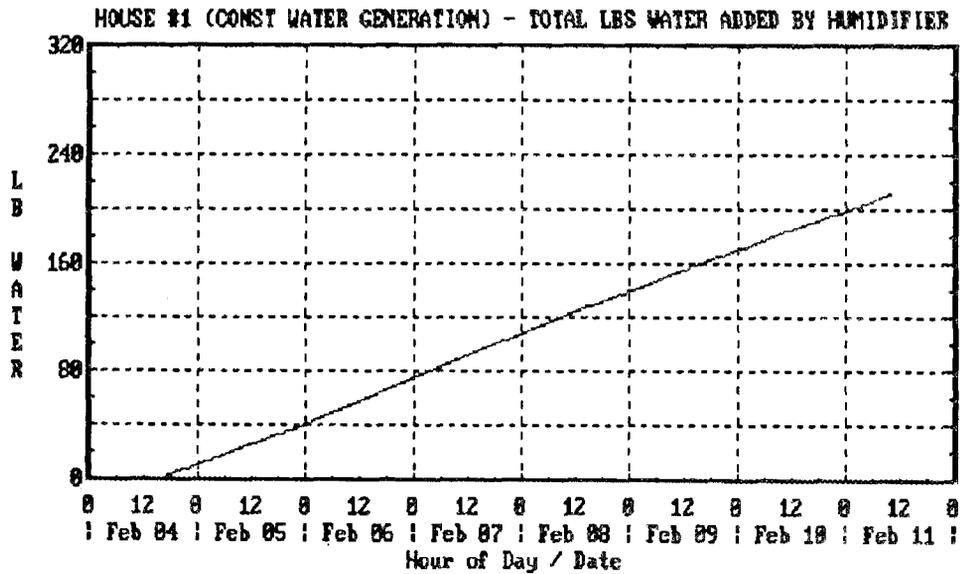
Fig. 4.5 House No.1 (constant water generation)--water input by humidifier.

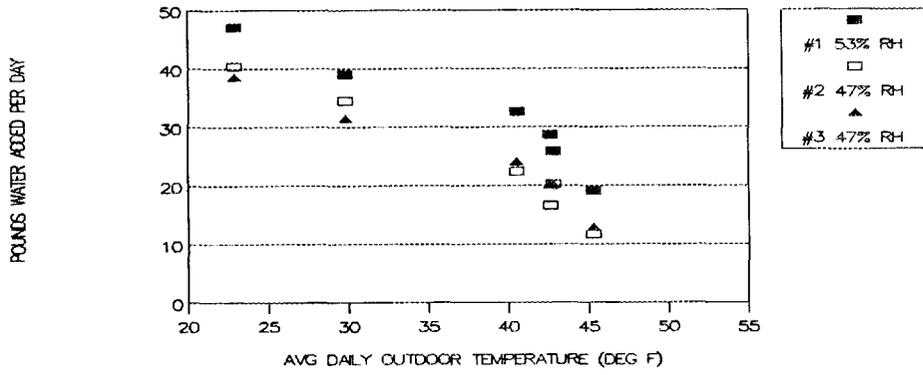
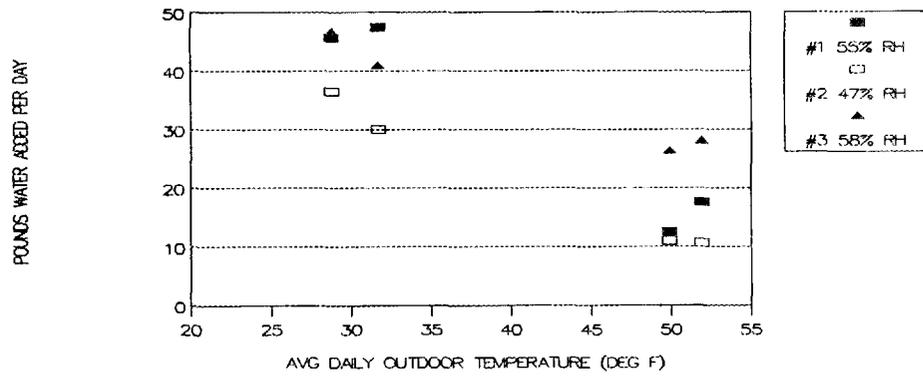
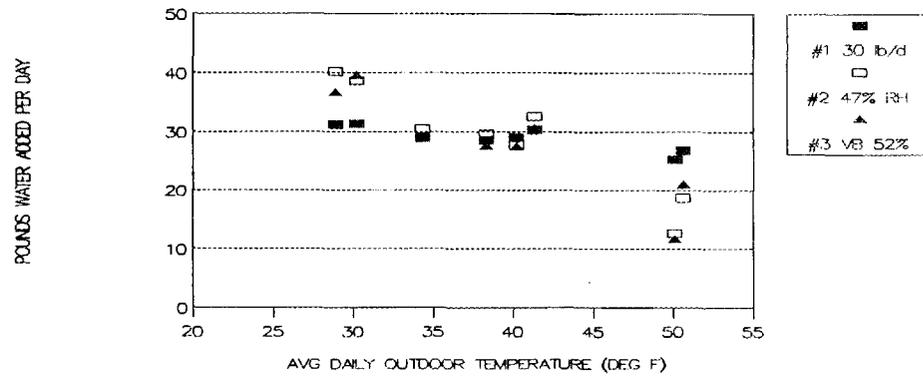
Figs. 4.6 (a-c) Average daily water addition to Karns houses vs average outdoor temperature.

Table 4.2 contains a summary of the humidifier addition of water to the houses along with dates and average indoor RHs. Figures 4.6(a-c) are plots that attempt to show the data in Table 4.2 more clearly and to illustrate that the data are somewhat consistent.

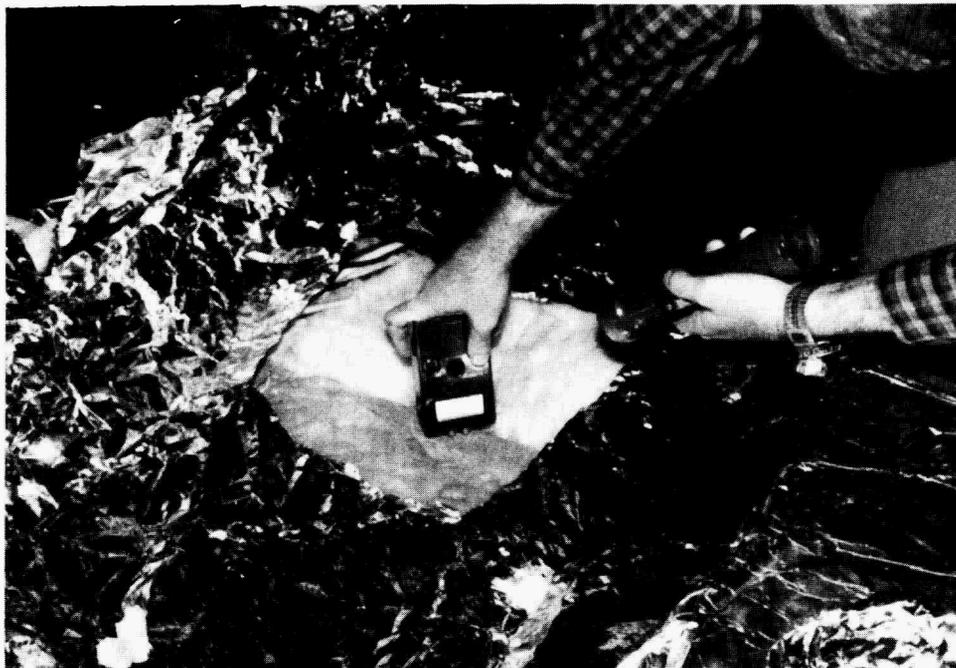
Fig. 4.7 Delmhorst probe.

A model J-1/C wood moisture content measuring instrument manufactured by the Delmhorst Instrument Company was used to manually take the moisture content data (Fig. 4.7). The instrument had a range of from 6 to 30 wt% water and was calibrated for Douglas fir at 70°F by the manufacturer. Temperature and wood type (our trusses were made from southern yellow pine -- see Fig. C.2 in Appendix C) corrections had to be made to all readings before they were meaningful. Measurements below 7% moisture content (uncorrected meter readings) are not as accurate as higher readings in the 8-12% range, although Delmhorst states an estimated accuracy of +/-0.5% for the 6-12 wt% range. All moisture measurements were taken in approximately the same four locations in each house (Fig. 4.8).

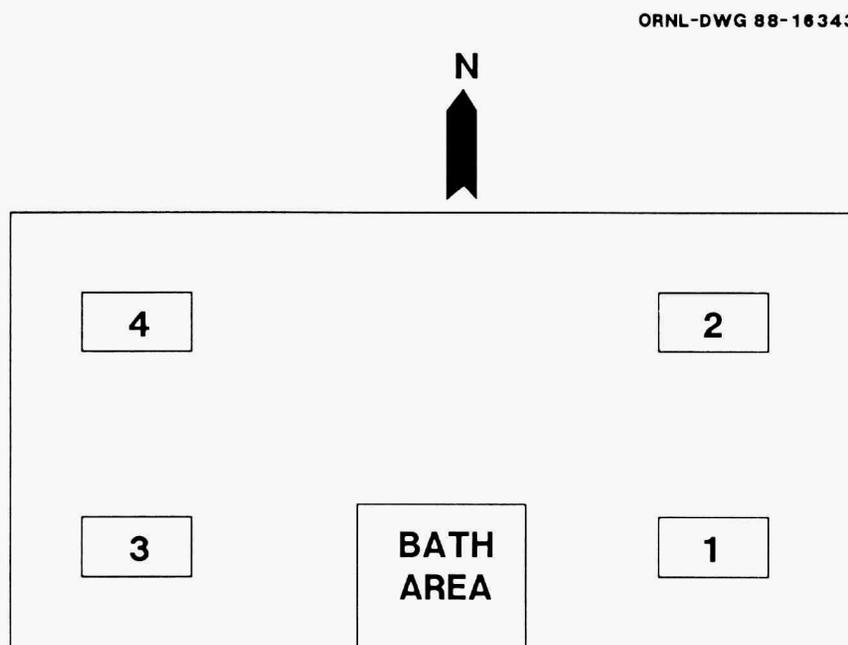
Fig. 4.8 Attic locations of wood truss moisture measurements.

Figures 4.9(a-c) are plots of the corrected wood moisture measurements made in each of the three houses at location 1 (see Fig. 4.8). The most obvious thing about the plots is that the measurements appear to be very similar. The initial 20 days of data are not plotted because they registered at or just below the lowest (6% uncorrected) range of the meter. However, a best guess of the corrected moisture content during that period would be about 7.5-8.0%. All of the testing periods are plotted, and the moisture content of house No. 1 at 55% RH appears to be slightly higher than that at house No. 2 (46% RH). Also, the presence of a vapor barrier (added for Phase 3 of the testing) in house No. 3 at 55% RH appears to lower the wood moisture content very slightly. The maximum moisture levels peak out at about 11%, which is

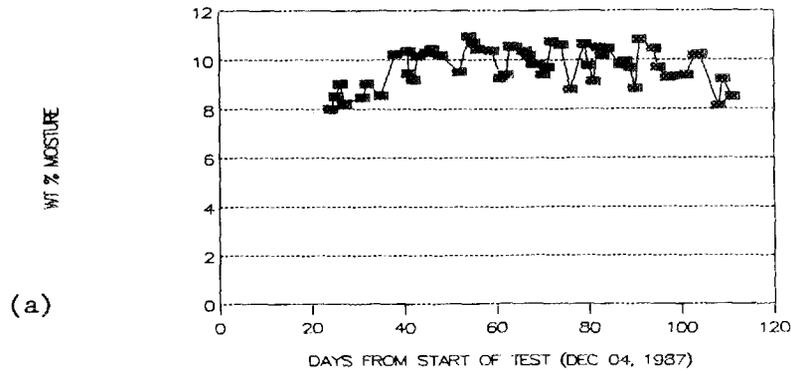
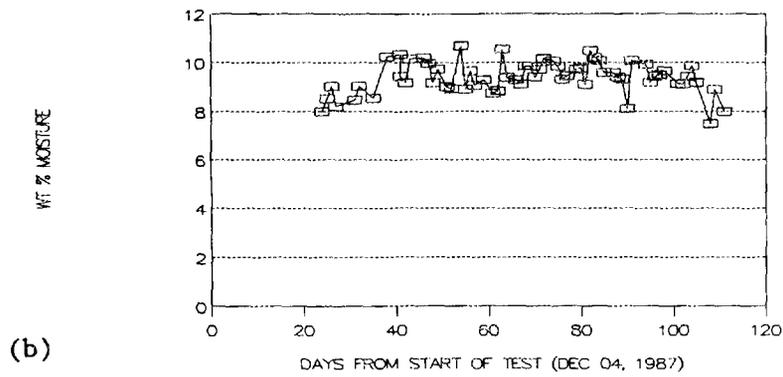
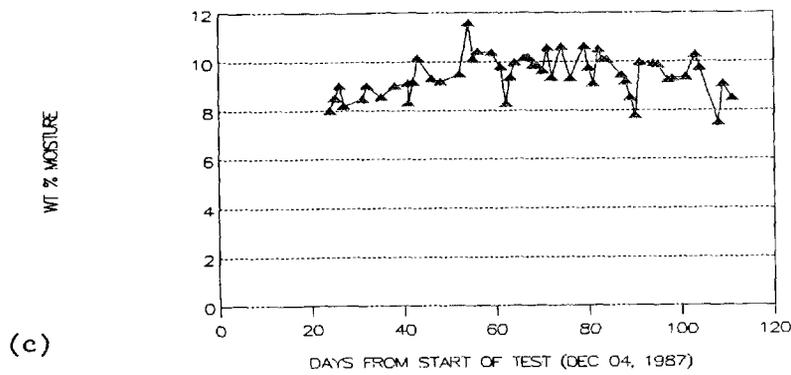
Figs. 4.9 (a-c) Measured attic truss moisture (wt%) under horizontal barriers.

well below the maximum fiber saturation value of about 28-30%. These moisture levels are very similar to those reported for the winter in a New Jersey house¹ with no RBs installed.

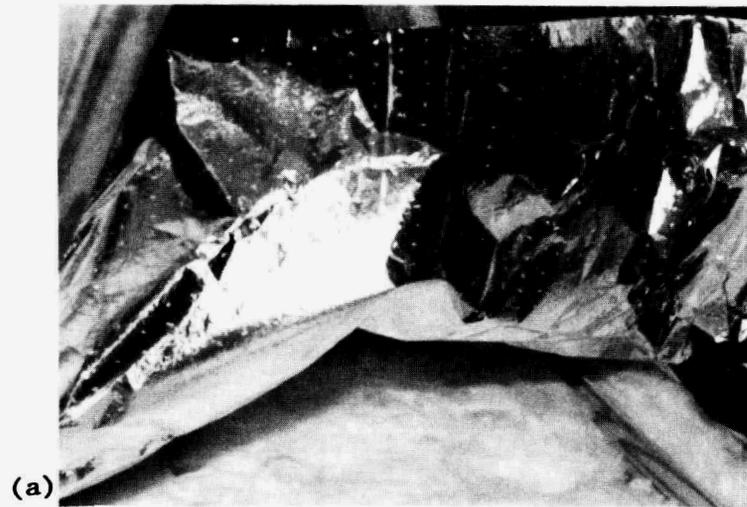
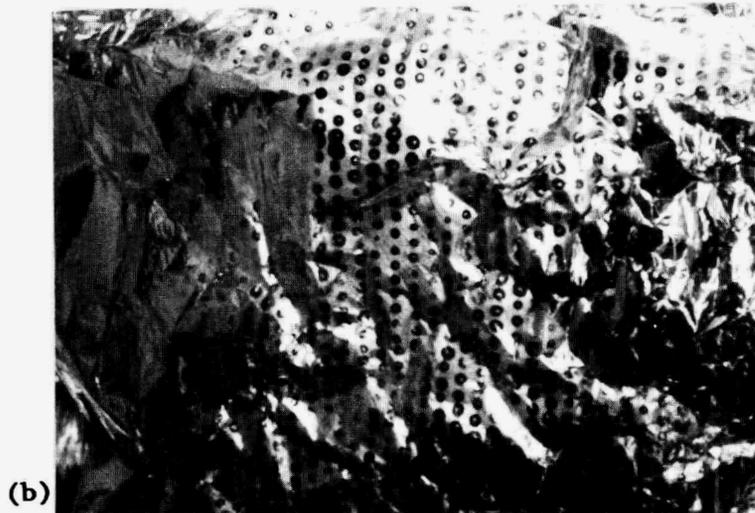
Figs. 4.10 (a-c) Photographs of dry/wet horizontal radiant barriers.

Figures 4.10(a-c) are photographs (taken in the morning hours) of a dry RB, a moderately wet RB, and a heavily wet RB taken during the course of the testing. The perforations do show on the dry barrier [Fig. 4.10(a)]. The moderately wet barrier, Fig. 4.10(b), presents an interesting story, because dry circular areas surround most of the perforations on the barrier, indicating that condensed moisture was being vaporized and was passing through the perforations into the attic air. Evidently perforations in an RB do facilitate the transfer of moisture from an HRB to the attic air.

Figure 4.10(c) shows a barrier with a heavy amount of condensation on the underside. Drops of water can be seen in several locations on the barrier, and several large drops also can be seen on the top surface of the insulation. No significant dry areas are visible around

the perforations, leading one to conclude that moisture is forming on the barrier much faster than it can be dissipated. Therefore, a net accumulation of moisture was taking place at that time.

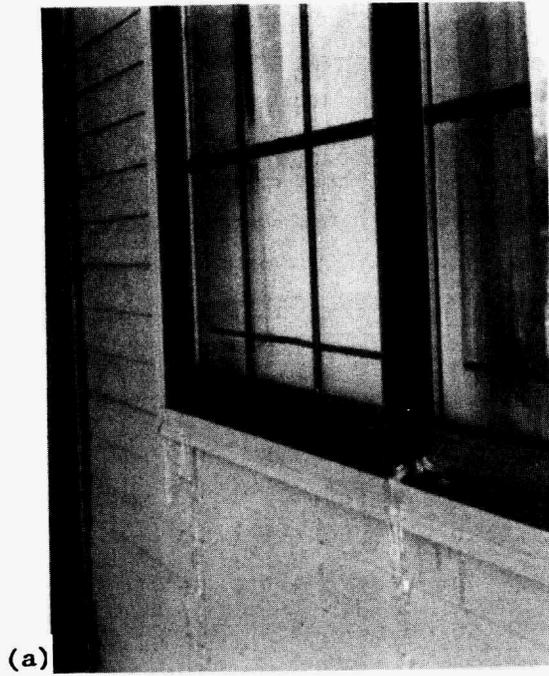
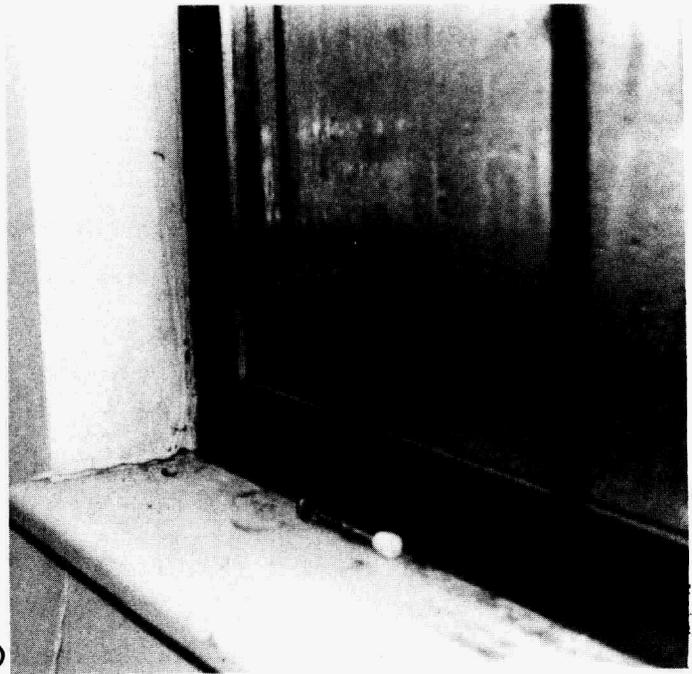
Figs. 4.11 (a-b) Photographs of house No.3 windows with condensation.

In addition to attic conditions, one of the more significant observations was the condition of the windows. Often one could predict how the underside of an HRB would appear in the attic by observing the amount of condensation on the windows inside the house. Figures 4.11(a-b) are photographs taken on a cold January morning of the great room window in house No. 3, with an indoor RH of 55%. The icicles on the outside window frames formed from condensed water leaking from the inside of the double-pane windows. Conditions were the same at the

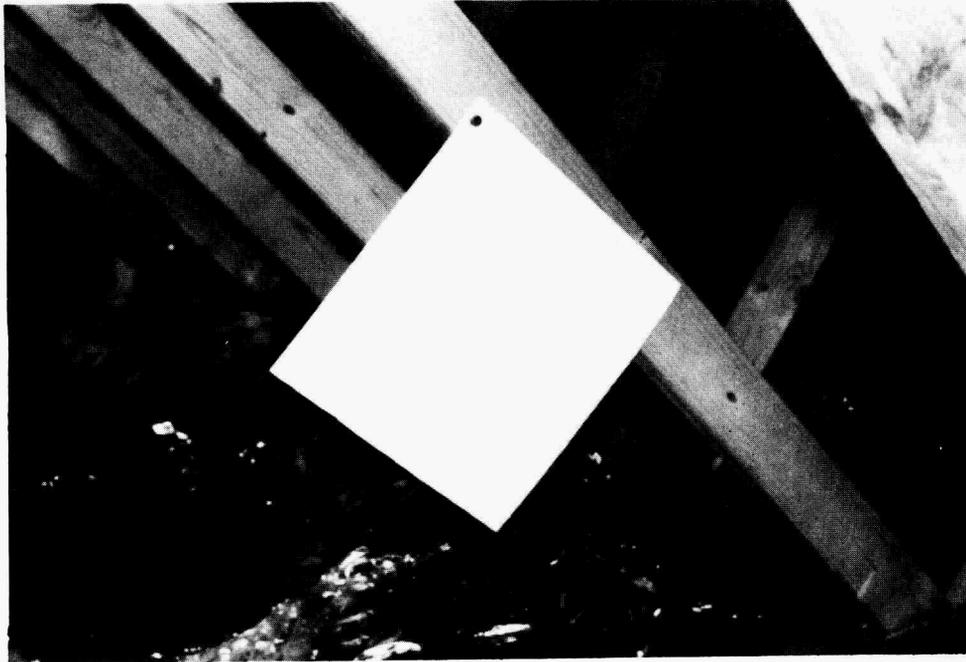
Fig. 4.12 Photograph of attic control blotter.

Four sections of 12 x 12-in. blotting paper (each section weighed approximately 40 g when dry) were placed in the attic of each house on the top surface of the insulation under the RB in proximity to those locations where the wood moisture measurements were made. A fifth control blotter was pinned to an attic truss so that it was exposed to the free attic air space. Figure 4.12 is a photograph of one of the control blotters in place. It was thought that the blotters would indicate any moisture accumulation that might occur in the insulation under the barriers. The control blotter would be reference for any changes in blotter weight that occurred as a result of natural attic ambient conditions.

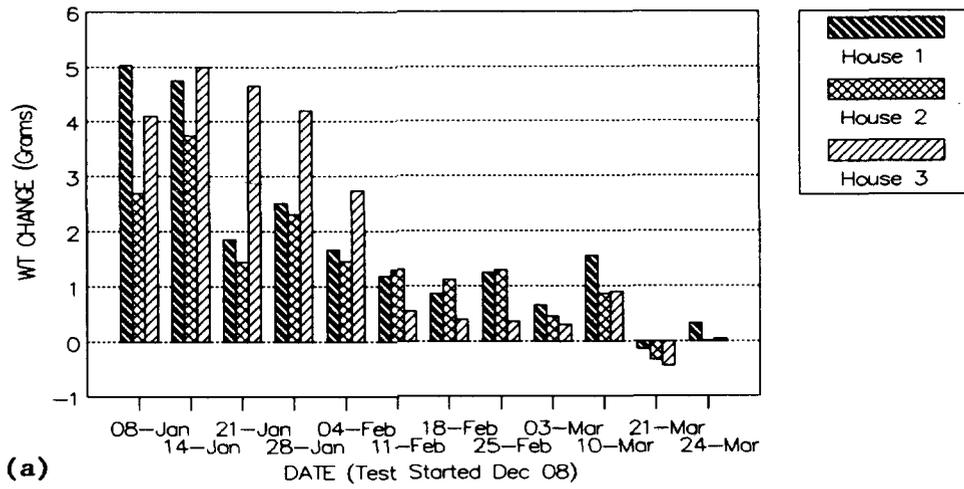
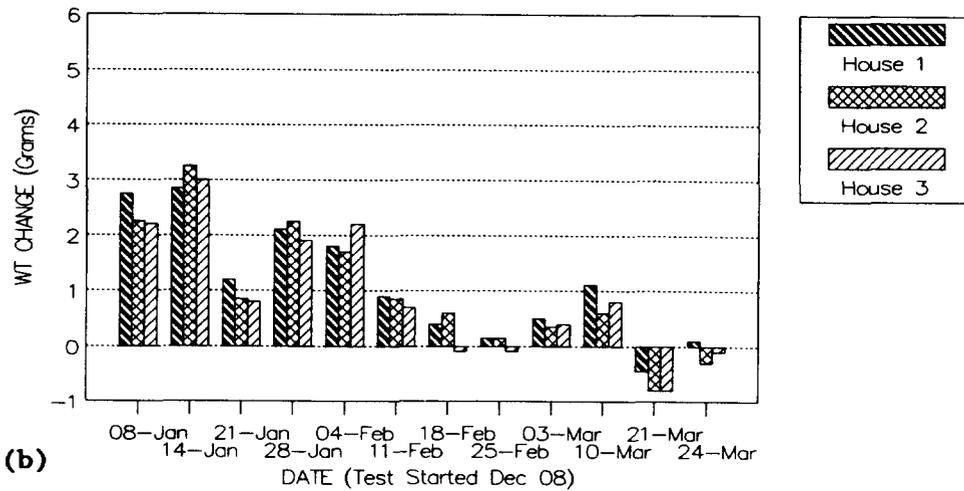
Figs. 4.13 (a-b) Average weight changes in blotters in Karns attics.

Figure 4.13(a) shows the weight changes of the blotters under the HRB, while Fig. 4.13(b) shows the weight changes of the control blotters. Figure 4.14 is a comparison between the two plots, showing the interesting result that the change in the weight of the blotters under the barrier was not much different than the control blotters. On those occasions when there is a significant difference between the weight changes from under the HRB blotter and the control blotter, the weighings showed that one of the four blotters in the attic had wet areas on it (Table A.2). The wet areas were caused by condensation dripping from the HRB. Table A.4 also shows that the attic is not uniform in its moisture content; some areas appear to be wetter than others. This fact agrees well with the conclusion drawn from visual observations.

The blotters were removed from their locations at approximate one-week intervals, weighed on a triple beam balance, and returned to their respective attic locations for another weekly cycle. Table 4.4 contains a summary of the average blotter weight changes, while Figs. 4.13(a-b) in the bar graph form depict the weight changes. Table A.3 in Appendix A contains a complete listing of each individual weighing, which indicates variation in the blotter weights. This result agrees with the conclusions from the visual observations that the attics were not uniform so far as moisture content is concerned.

A comparison of Figs. 4.13 and 4.14 with Table 4.2 shows that the average Under Horizontal Radiant Barrier Blotter (UHRBB) weight gains are higher for higher indoor humidities than for lower humidities. This comparison is in agreement with the visual observations. The period from February 18 - March 24 for house No. 2 at a reduced attic ventilation area ratio (1/300 compared to the normal 1/150 ft² effective vent area per ft² attic floor area) shows a slight relative increase in the UHRBB weights compared to that of house No. 3 from the preceding two weeks (February 4-18). This increase suggests that the higher attic vent rate may be helpful in reducing the accumulation of moisture in the attic. However, the differences are slight, since the absolute values of the weight gains are small. Colder weather over an extended period would probably accentuate the difference.

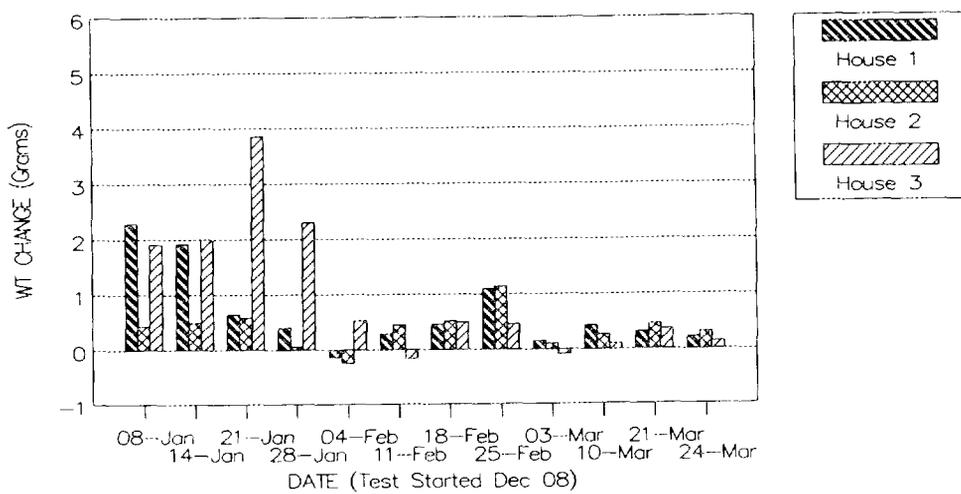
Fig. 4.14 Difference in weight between blotter under horizontal radiant barrier and control blotter.

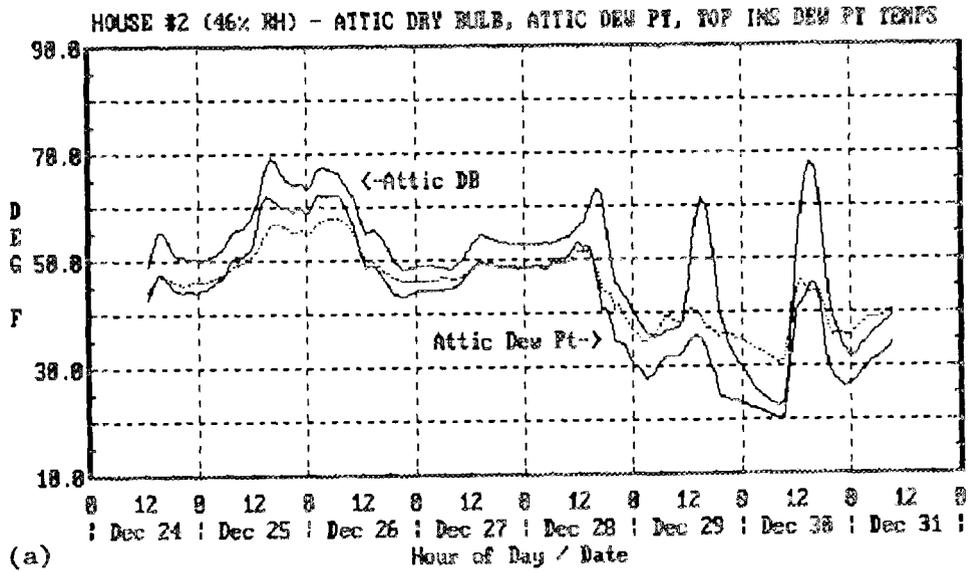
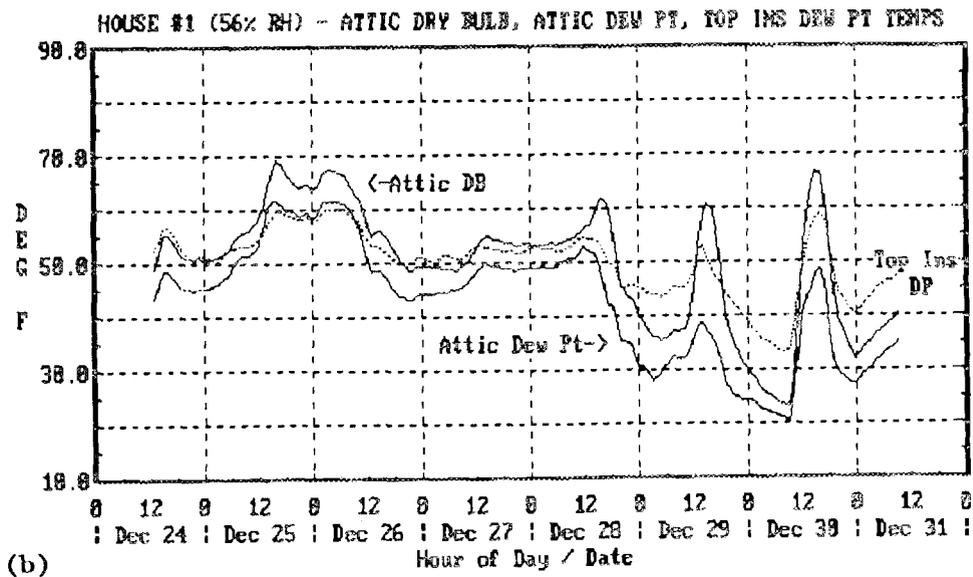
Figs. 4.15 (a-b) Houses No. 2, No.1--attic dry bulb, attic dew point, and top of insulation dew point temperatures (Dec. 24-31).

Figures 4.15(a-b) are time series plots for house No. 2 (46% RH) and house No. 1 (56% RH), respectively, on which the attic air dry bulb, top of insulation under HRB dew point, and attic air dew point are plotted for the week between December 24-31. The average outdoor dry bulb temperature for this period was 45.3°F, a relatively warm value. Plotting these values shows that conditions should be favorable for condensing moisture on the bottom of the HRB whenever the attic air dry bulb temperature was less than the dew point temperature at the top of the attic insulation under the RB.

Figure 4.15(a) shows that the attic air dry bulb temperature (top solid line) did not go below the top of insulation dew point temperature (dotted line) until the morning hours of December 29. When moisture could form on the bottom surface of the HRB. A visual observation (Table 4.3) confirmed that a light coating of moisture was present under the HRB in house No. 2. In the afternoon hours the attic temperature warmed up and the condensed moisture vaporized from the HRB into the attic air. Note that so long as the attic dew point temperature (bottom solid line) was below that on the top surface of the insulation that a water vapor partial pressure driving force existed to promote the transport of water vapor from the HRB to the attic air through the perforations in the HRB.

Figure 4.15(b) is similar to Fig. 4.15(a) except that house No. 1 at a higher 56% RH is featured. A comparison of the two plots shows that the dew point temperature on top of the insulation in house No. 1 was usually higher than that in house No. 2. This means that the attic dry bulb temperature was able to cross the HRB dew point line more often than it could in house No. 2. This occurrence is only logical as more moisture was being generated in house No. 1.

The fact that a water vapor partial pressure-driving force existed between the bottom surface of the HRB (assumed to be the same as that of the top surface of the attic insulation) and the adjacent attic air means that moisture can be transported from under the HRB to the attic air at the same time it is condensing on the HRB. This fact explains why condensed moisture does not necessarily accumulate in the attic insulation. Also, since vapor pressure is an exponential function of temperature, warmer temperatures provide greater driving forces for moisture transport.

Figure 4.15(a) shows that condensation occurred again in house No. 2 from about 6 p.m. on December 29 until about noon on December 30. The outdoor air temperature dropped sharply on December 29 (Fig. B.4 in Appendix B), causing conditions favorable for condensation.

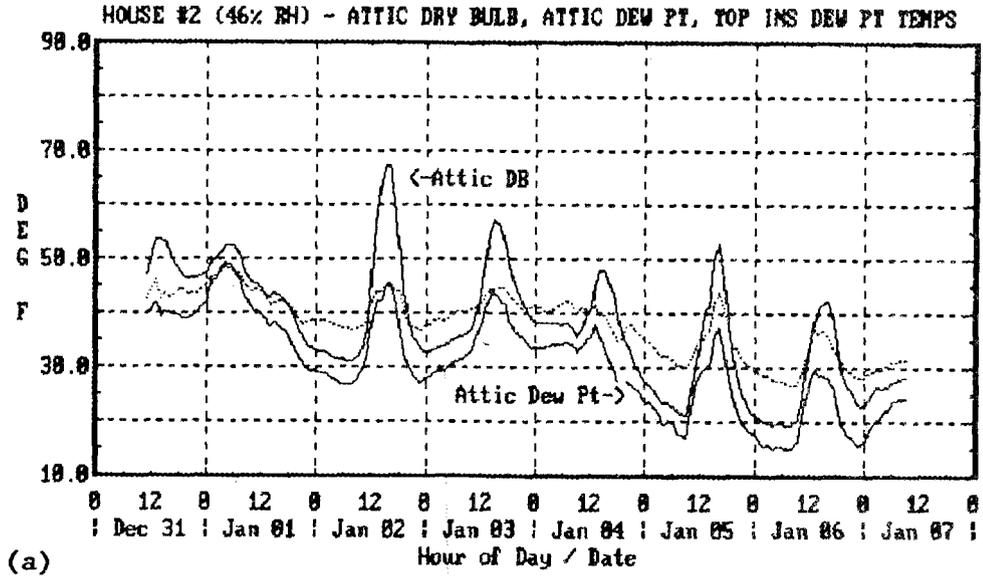
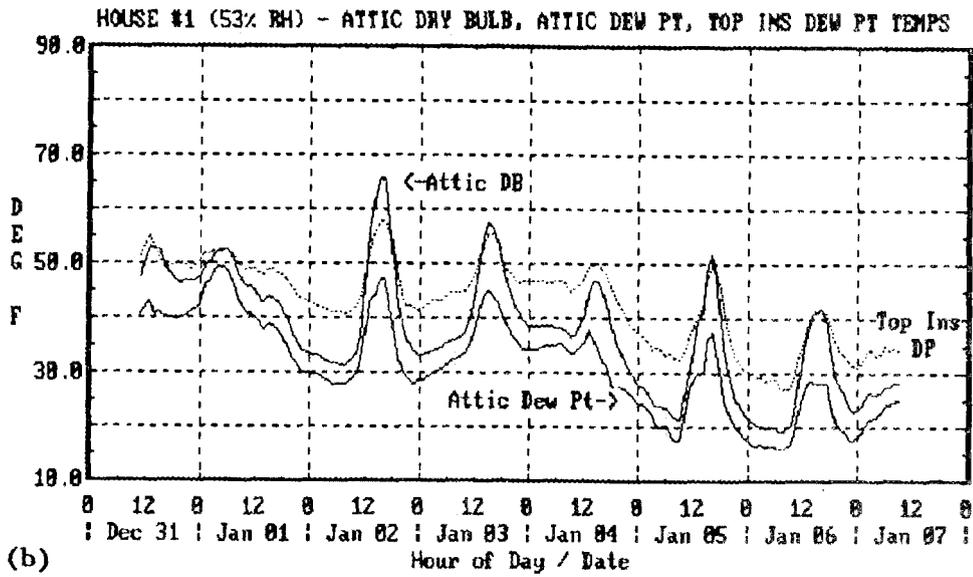
Figs. 4.16 (a-b) Houses No.2, No.1--attic dry bulb, attic dew point, and top of insulation dew point temperatures (Dec. 31-Jan.7).

Figures 4.16(a-b) covering the period December 31-January 7, are similar to Figs. 4.15(a-b), differing in that the average temperature during this week was 29.9°F, somewhat colder than the 45.3°F of the previous week. The RHs in both houses were similar to those from the previous week when house No. 2 at 46% and house No. 1 was 53% RH. It is apparent from Figs. 4.16(a-b) that condensation was forming more often on the HRB in both houses than during the warmer week depicted in Figs. 4.15(a-b). House No. 1 with the higher RH shows a greater

tendency to condense moisture on the HRB than did house No. 2. The diurnal nature of the condensing and vaporizing moisture cycle is nicely illustrated by Fig. 4.16(a).
