ORNL/CON-255

Moisture Measurements in Single-Family Houses with Attics Containing Radiant Barriers

MOISTURE MEASUREMENTS IN SINGLE-FAMILY HOUSES
WITH ATTICS CONTAINING RADIANT BARRIERS

Date Published: February 1989

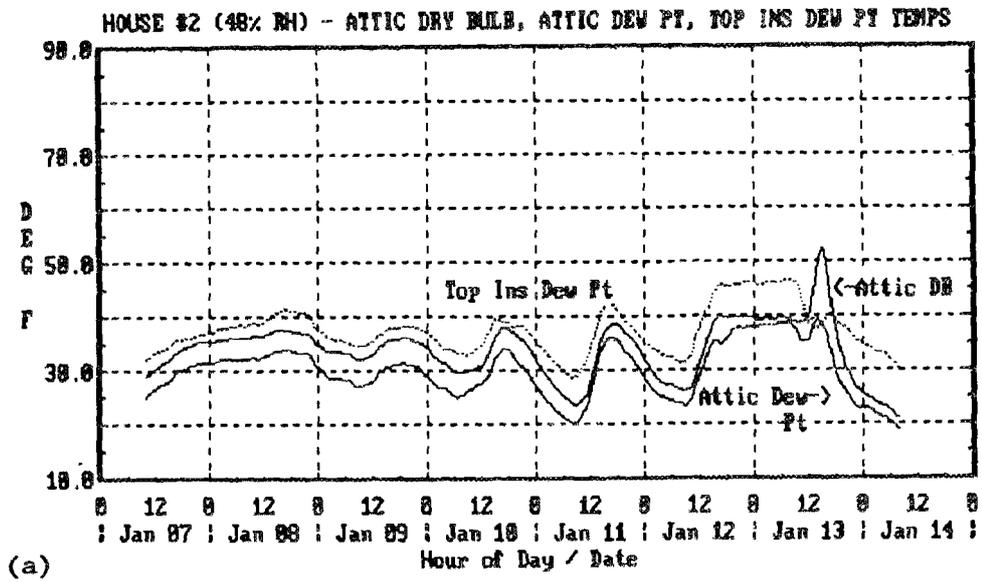
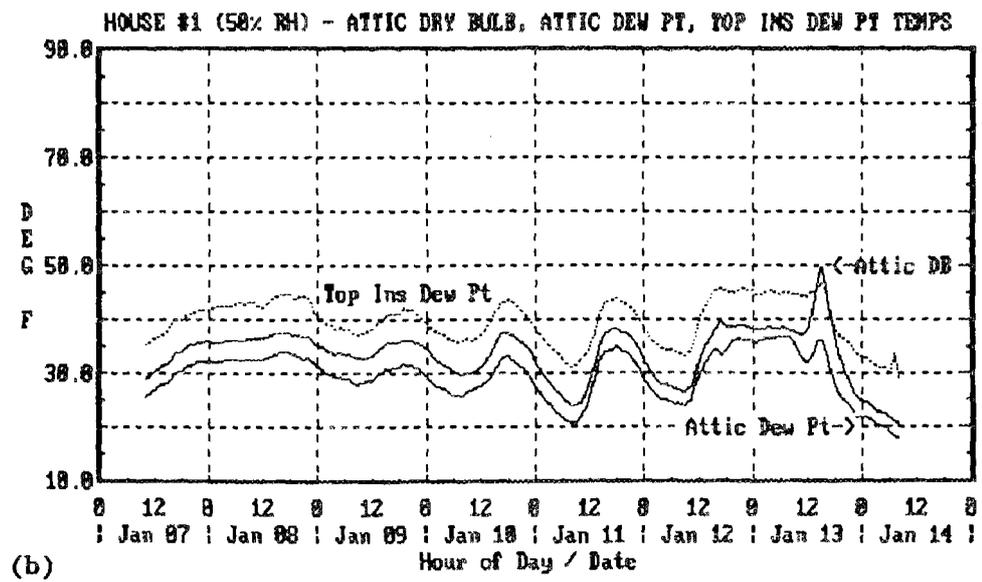
Figs. 4.17 (a-b) Houses No.2, No.1--attic dry bulb, attic dew point, and top of insulation dew point temperatures (Jan. 7-14).

Figures 4.17(a-b) showing data of January 7-14 are also similar to the previous two sets of figures, except that the average temperature during this period was 22.9°F, much colder than the previous two weeks. The plots show that the attic dry bulb temperature was almost always below the top of the insulation dew point temperature, so that condensation was present continually. Visual observations from Table 4.3 are in agreement with these data. Note that the humidifier in house No. 1 could not maintain a RH above 50% during this period (Table 4.2). The HRB blotter weight gains discussed in Sect. 4.4 were extremely high for this week, suggesting that moisture may have formed under the HRB faster than it dissipated. This suggests that prolonged cold weather conditions similar to those of January 7-14, which are common in northern climates, may be a cause for concern if a HRB is installed in a humid northern home. Testing of HRBs in colder climates is definitely recommended. Note, however, that prolonged cold weather is unusual for southern locations and that no permanent ill effects on our houses were noted during our testing.

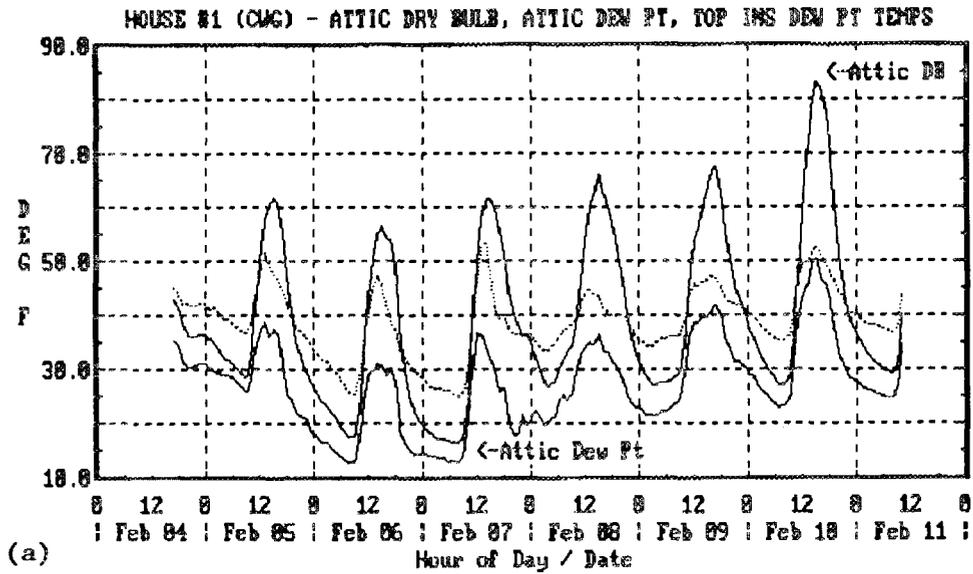
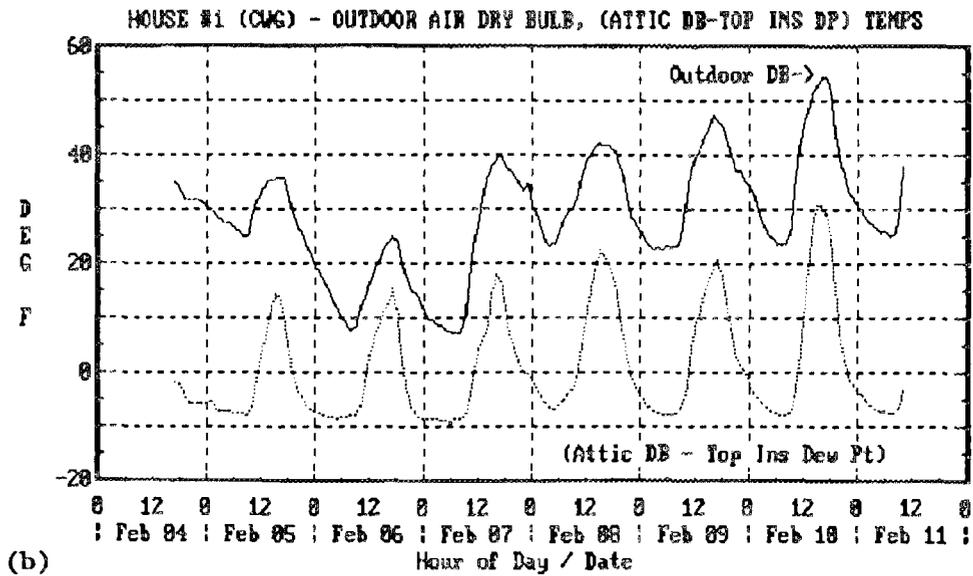
Fig. 4.18 (a) House No.1--outdoor dry bulb temperature, attic dew point, and top of insulation dew point temperatures (Feb. 4-11) (b) House No.1--outdoor dry bulb temperature, temperature difference (attic dry bulb--top insulation dew point).

Figures 4.18(a), 4.19(a), and 4.20(a) are plots similar to Figs. 4.15 to 4.17, except for the week of February 4-11. Corresponding plots 4.18(b), 4.19(b) and 4.20(b) include the outdoor dry bulb temperature as well as the temperature difference (attic dry bulb/top insulation dew point) for all three houses. The (b) plots of these three figures make it somewhat easier to see when condensation under the HRB occurred. Whenever the temperature difference (attic dry bulb/top insulation dew point) becomes negative, condensation can occur. Some end effects may be noted in houses No. 1 and No. 3 for the beginning of the week, since house No. 1 was changed from 53% indoor RH

The average temperature during the week of February 4-11 was 29.0°F, very close to the 29.9°F indicated in Figs. 4.16(a-b). The (b) plots of Figs. 4.18 to 4.20 once again show the diurnal nature of the condensing/vaporization moisture cycle. The figures also show that during normal daily temperature swings moisture tended to condense on HRBs at an outdoor temperature of about 30-35°F.

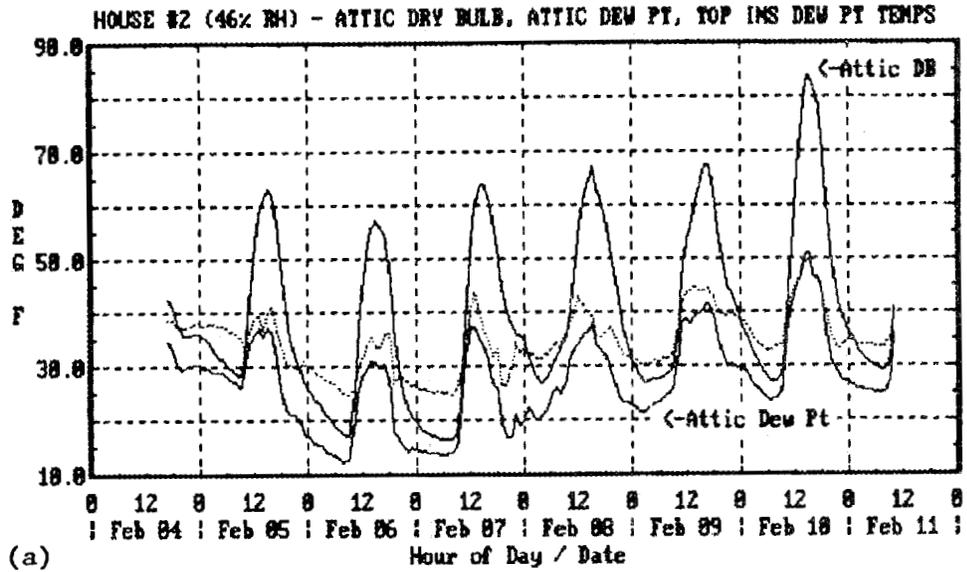
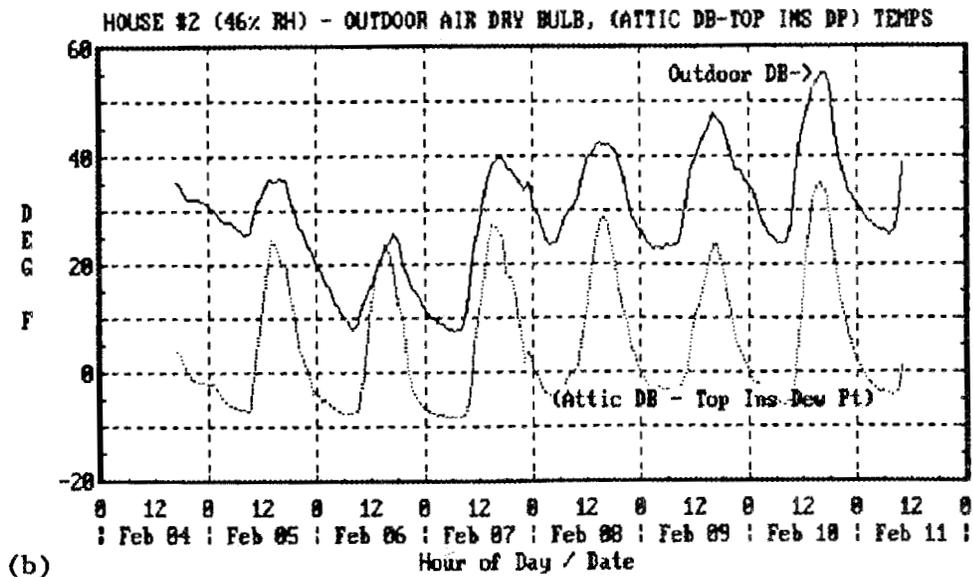
Fig. 4.19 (a) House No.2--attic dry bulb temperature, attic dew point, and top of insulation dew point temperatures (Feb. 4-11)
 (b) House No.2--outdoor dry bulb temperature, temperature difference (attic dry bulb--top insulation dew point).

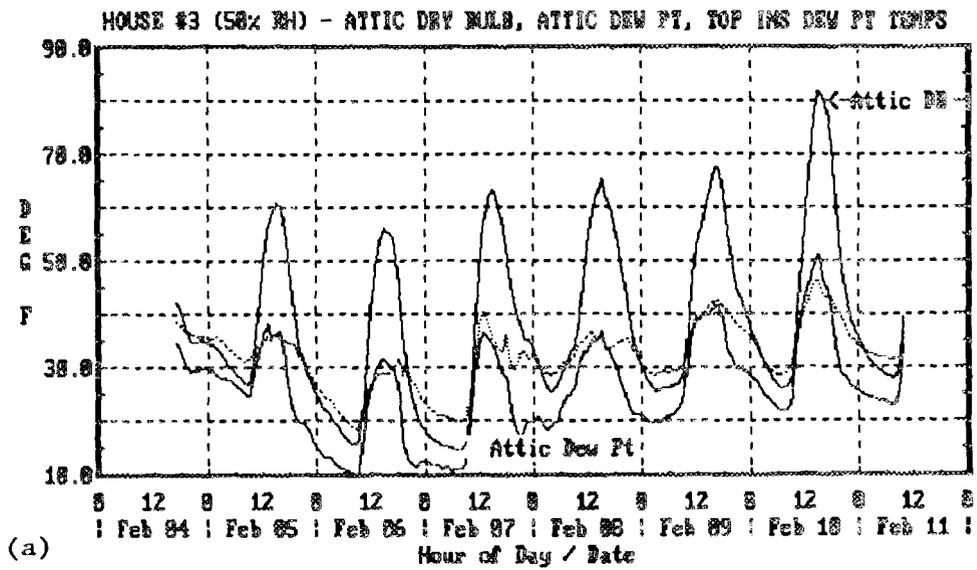
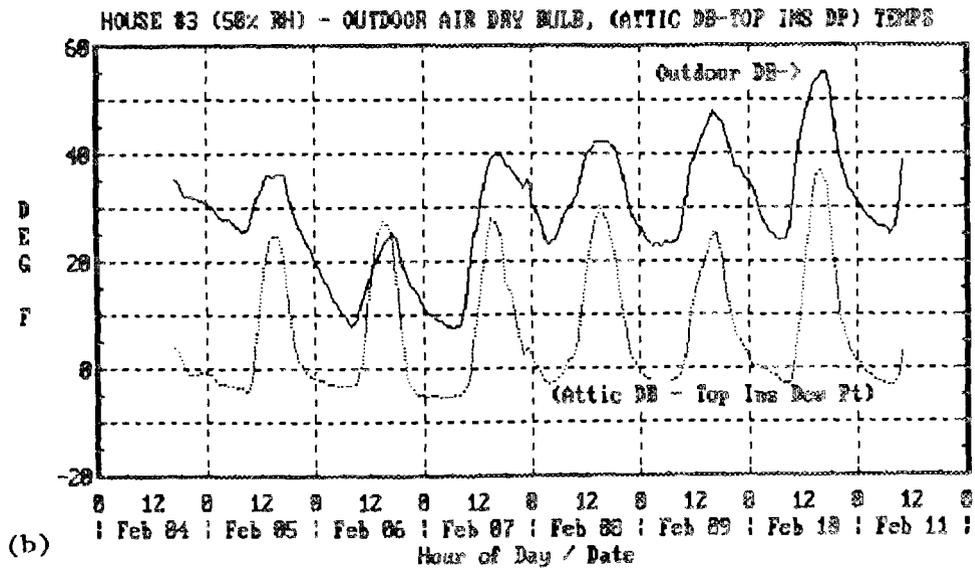
Fig. 4.20 (a) House No.3--attic dry bulb temperature, attic dew point, and top of insulation dew point temperatures (Feb. 4-11)
 (b) House No.3--outdoor dry bulb temperature, temperature difference (attic dry bulb--top insulation dew point).

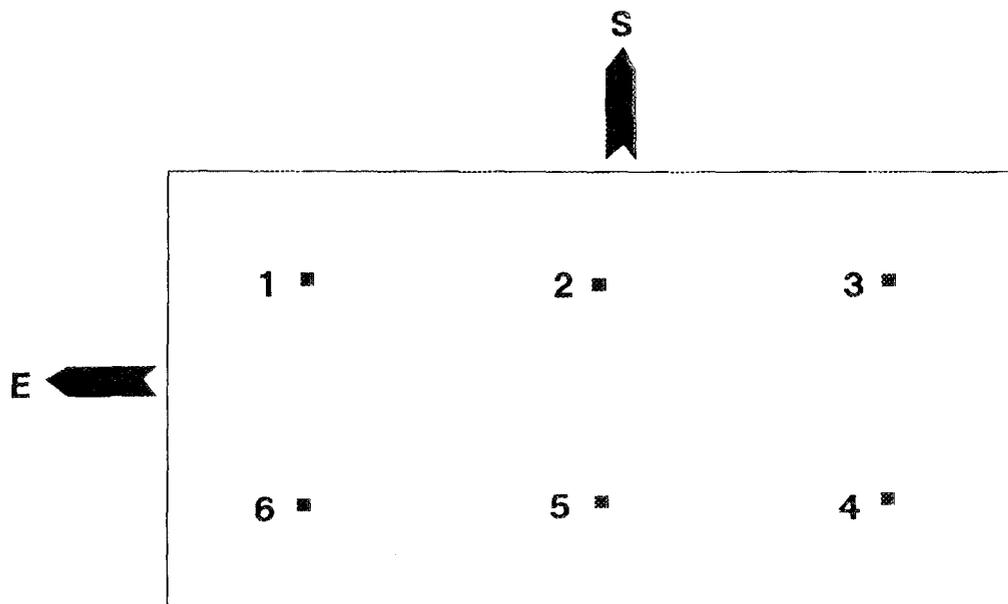
ORNL-DWG 86-17818

Fig. 4.21 Locations of samples taken from horizontal radiant barrier for emissivity measurements.

Table 4.5 lists the measured emissivities of samples of HRB material removed from the Karns test house attics. Samples were taken from the attic locations depicted in Fig. 4.21 and were analyzed with a Devices and Services Model AE Emissometer, shown in Fig. 4.22. The perforations in the HRB appear to add some variability to the readings,

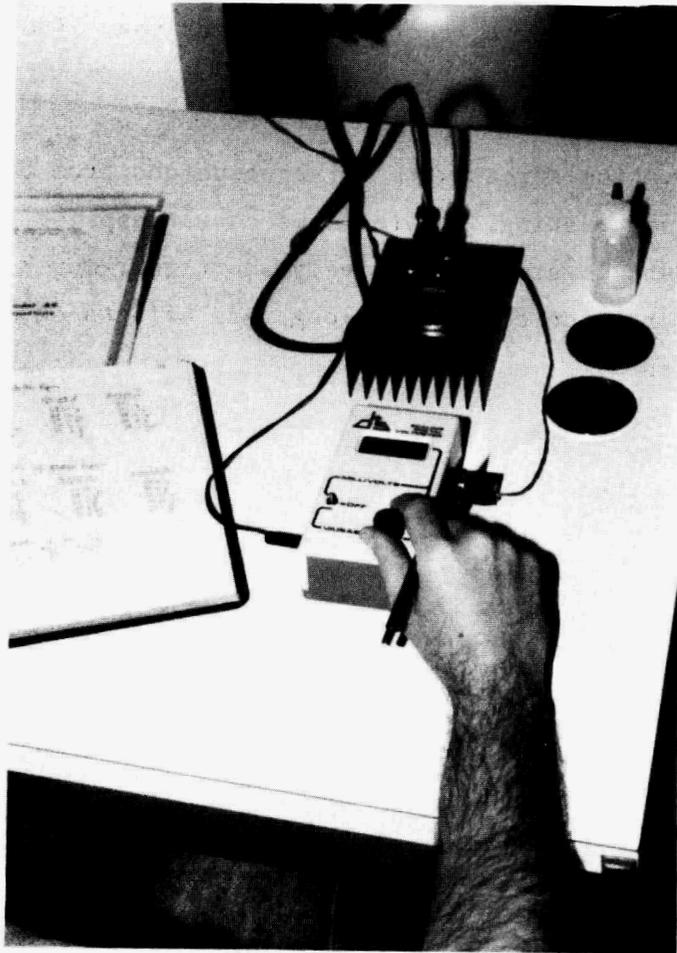
Fig. 4.22 Photograph of an emissometer.

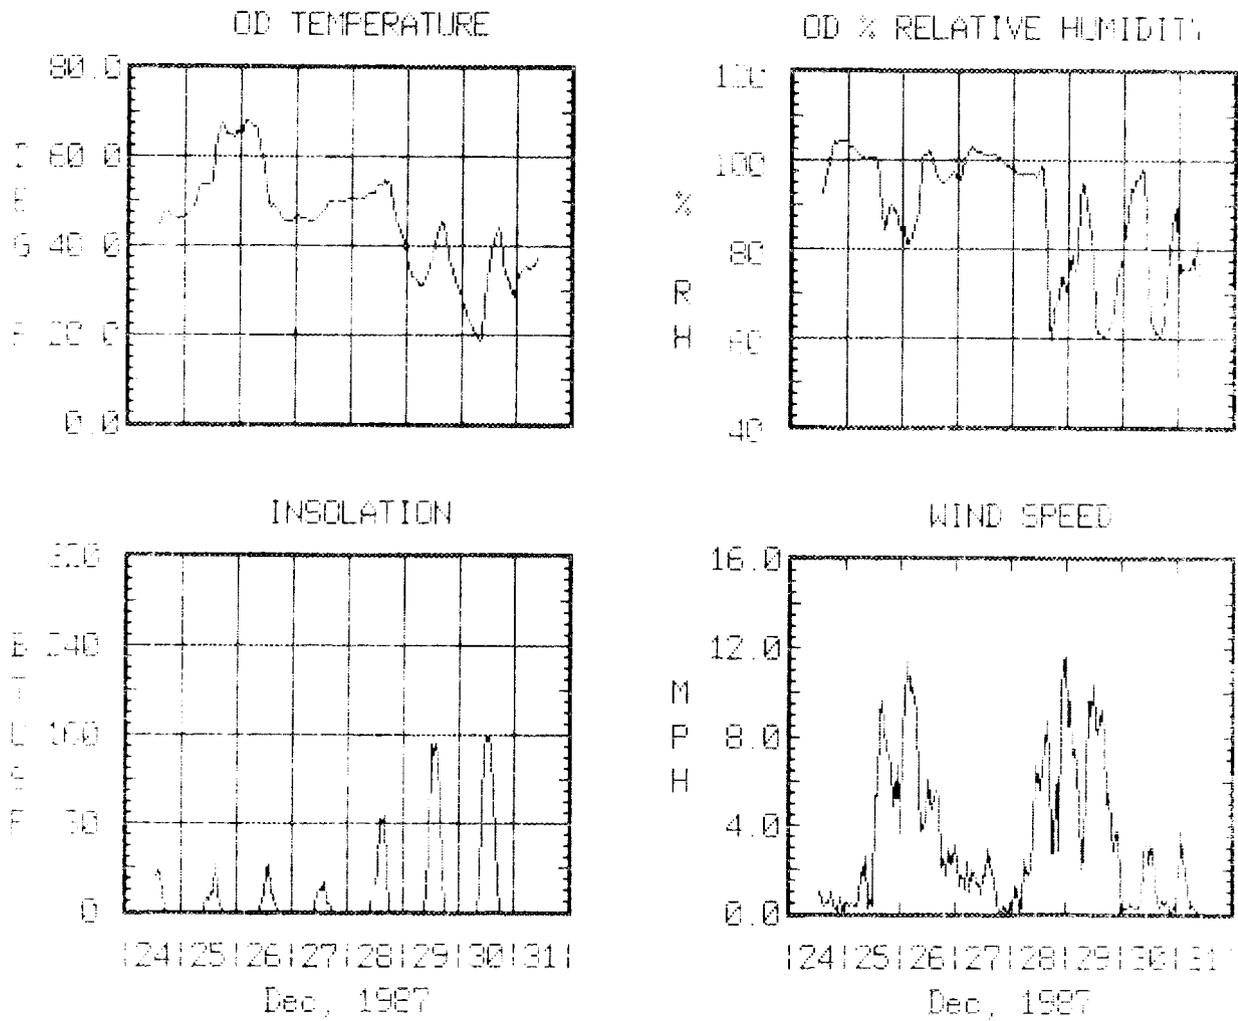
Fig. B.4 Weather data (Dec. 24-31, 1987).

Figure 4.15(a) shows that condensation occurred again in house No. 2 from about 6 p.m. on December 29 until about noon on December 30. The outdoor air temperature dropped sharply on December 29 (Fig. B.4 in Appendix B), causing conditions favorable for condensation.

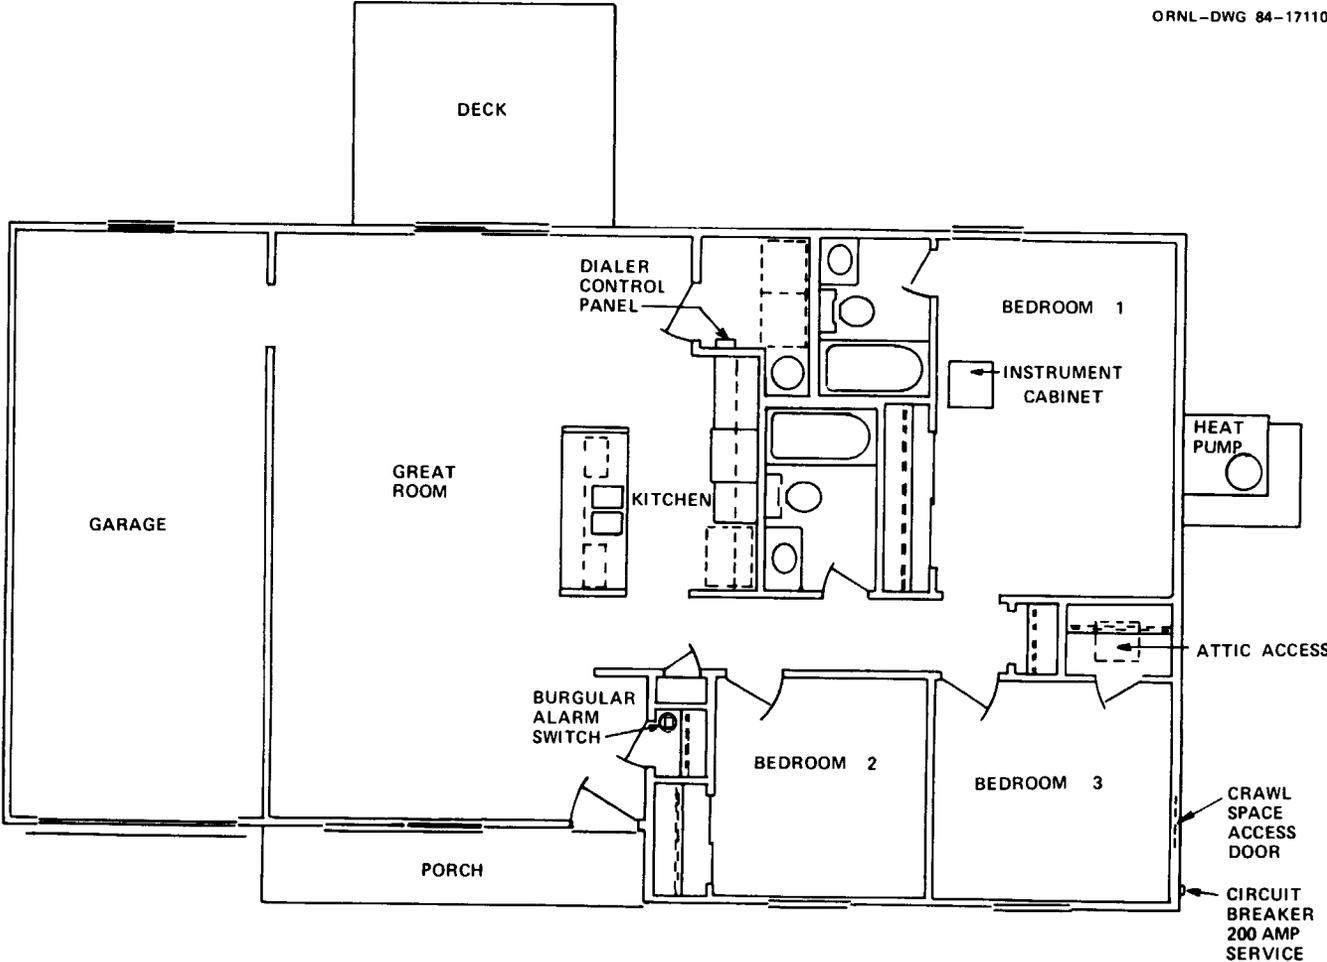
Fig. C.2 Floor plan for a Karns house.

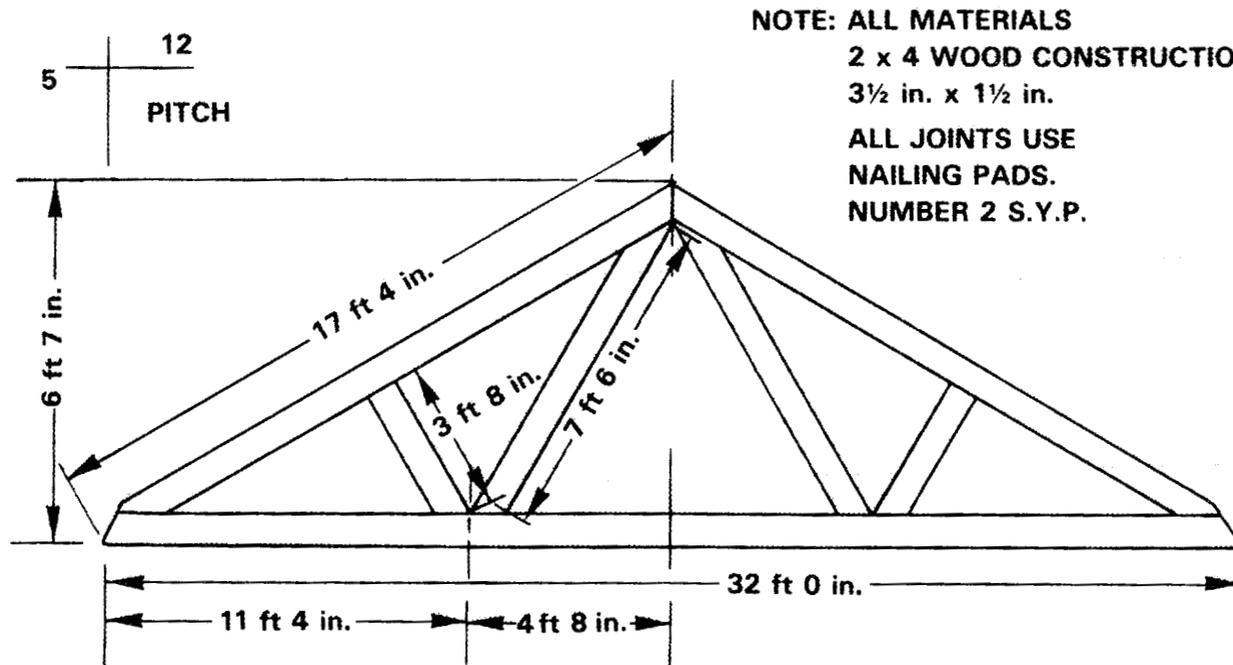
Fig. C.3 Typical Karns house attic truss.

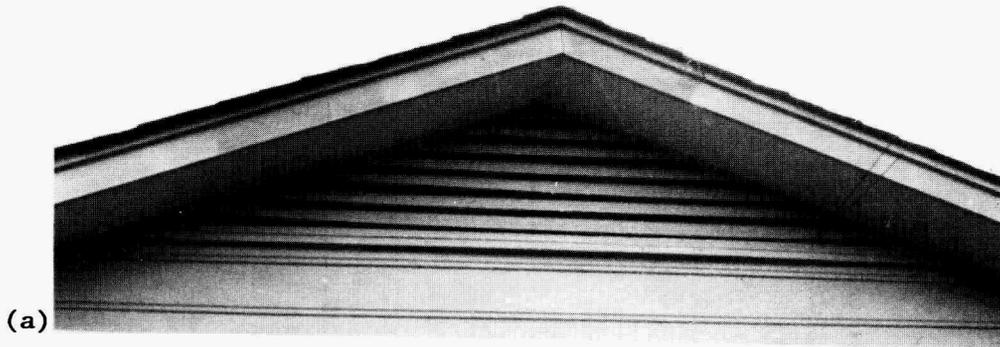
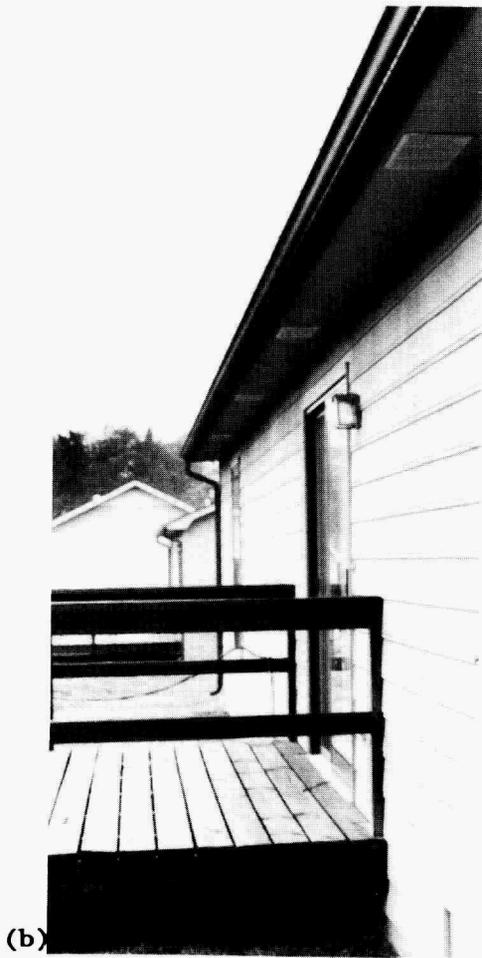
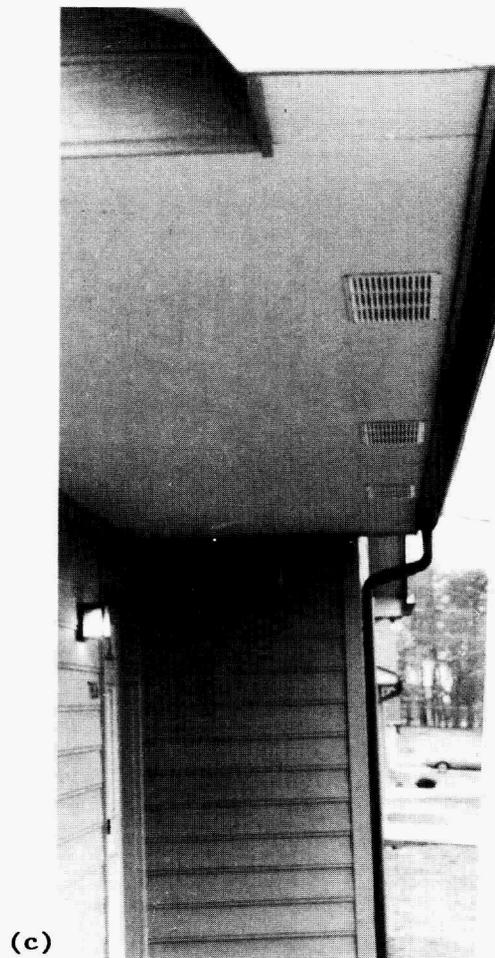
Fig. C.4 Attic ventilation setup at Karns.
