Field Experiences Underscore the Importance of Moisture Control in Energy-Efficient Homes

Abstract

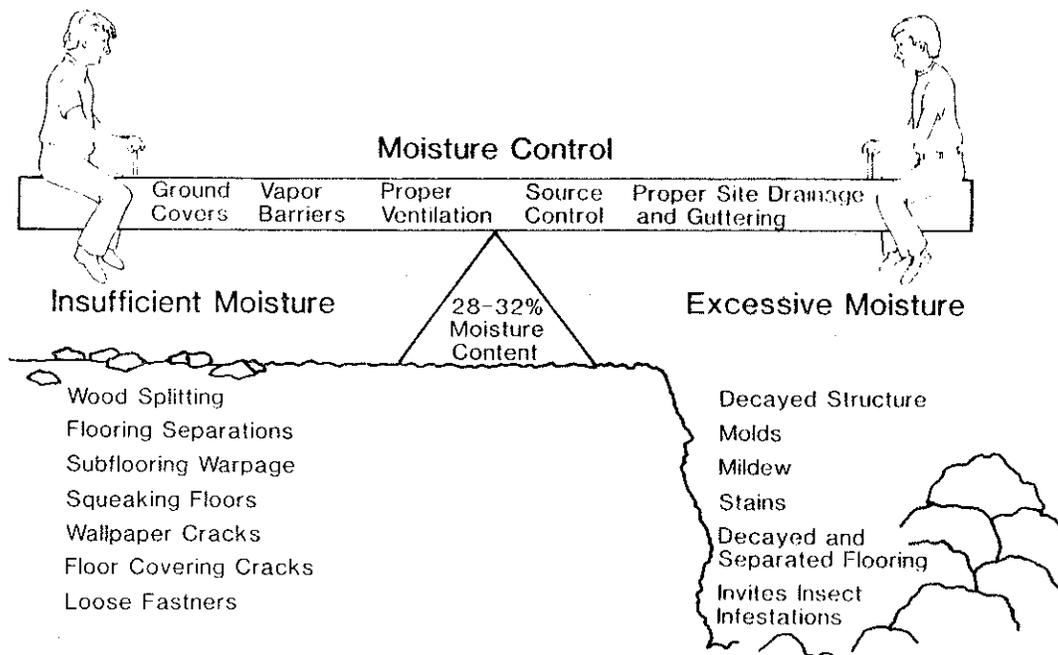
Figure 1

THE MOISTURE BALANCING ACT

In summary, the control of moisture within a house is a more delicate balance than anticipated between excessive and insufficient moisture. The best illustration the authors have developed to depict the overall interaction of moisture control is presented in Fig. 1. The proper use of the elements of moisture control is essential for maintaining a proper balance in the control of house moisture. Wood's dynamic nature and affinity for water and the ever changing environment within which wood is used make this proper balance difficult. The consequence of too little or too much moisture can tip the balance, but the effects of excessive moisture can be much more damaging.
