Retrofit Wall System for Insulation and Lead Encasement in Older Multifamily Housing

ABSTRACT

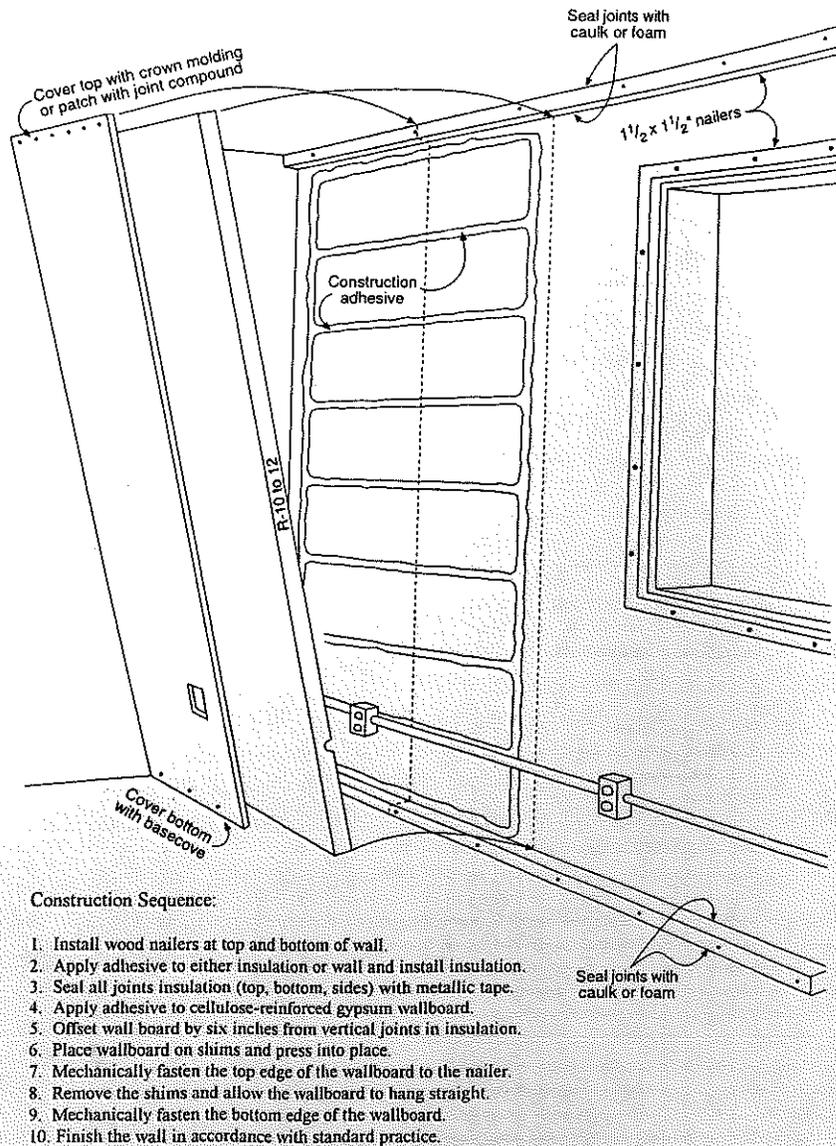
Figure 1 Construction of the composite wall is simple and straightforward.

Description. The wall system includes cellulose-fiber-reinforced gypsum wallboard, foil-faced polyisocyanurate insulation, a one-component polyurethane foam with limited expansion to bond the components together, metallic tape to seal joints in the insulation, and wood nailers and fasteners to mechanically fasten the top and bottom of the system to the existing masonry wall. Figure 1 illustrates the construction of the composite wall. In addition to providing insulation and lead encasement, the foil-faced insulation and sealed joints provide an effective air and moisture barrier in the wall. This barrier will also help to reduce moisture and condensation problems.

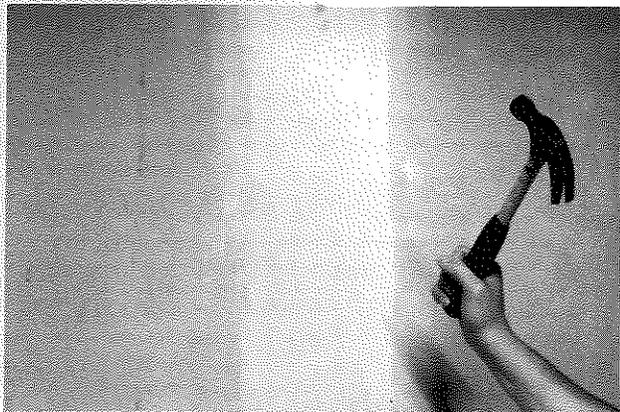
Figure 2 The prototype composite wall was subjected to impact testing to determine how well it would withstand the impact and what would be required to repair the wall. Here a hammer blow has left a dimple in the wallboard joint. Unlike common drywall, there was no "breakthrough" on the back. Repair involved simply filling the dimple with joint compound.

In order to assess the durability of the system, the prototype wall was subjected to impact testing. The wall was subjected to the ASTM standard drywall impact test and performed significantly better than typical wall construction of paper-faced drywall supported on 2x4 wood studs and insulated with fiberglass. "Failure" on the composite wall was a small hairline fracture that was easily repaired with drywall compound. "Failure" of typical wall construction would require removal of the broken drywall, replacement with a new piece, and extensive patching with tape and drywall compound. The prototype wall also was subjected to hammer blows, as shown in Figure 2.

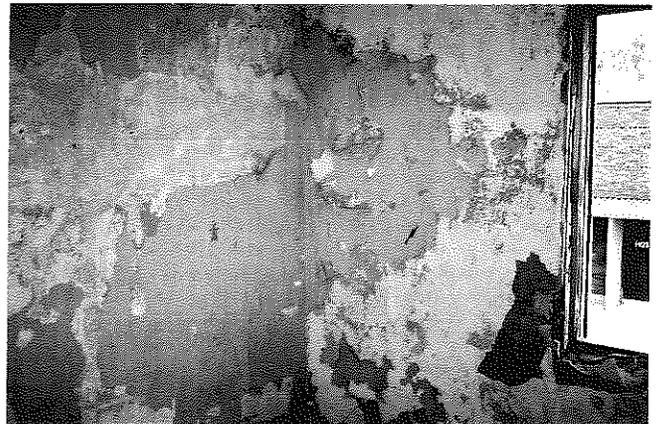
Figure 3 A Public Housing Authority unit was rehabilitated with the installation of an innovative composite wall system. This system undid years of hard use followed by extended vacancy and major moisture damage. High moisture levels from a leaky steam heating system had combined with uninsulated masonry walls to destroy the exterior wall lath and plaster finish.

Field Testing. Subsequently, the system was field tested in an unoccupied unit of the Brooks Homes of the Chicago Housing Authority (CHA); see Figures 3 through 5.

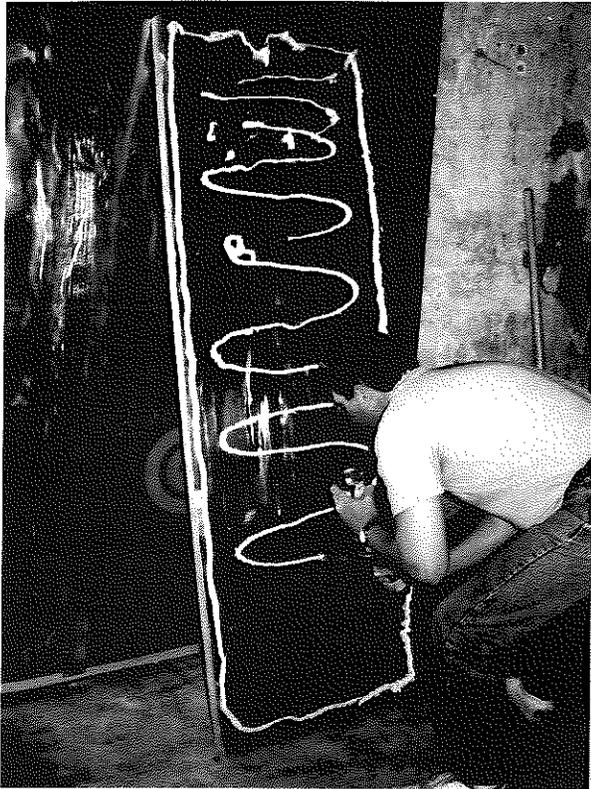
Figure 4 Polyurethane foam adhesive was used to fasten 1½ in. thick rigid foam insulation to the interior surface of the walls. The exterior wall insulation used was a polyisocyanurate insulation with foil facers and an R-12 rating (1½ in. thick). Foam adhesive and drywall screws fasten the ½ in. thick cellulose-reinforced gypsum wallboard to previously installed 2 × 2 wood nailers (top and bottom) and to the rigid foam insulation.

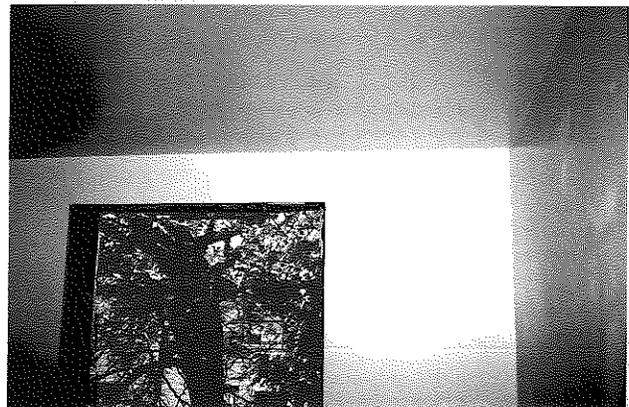
Figure 5 Conventional drywall finishing techniques and painting are used to finish the composite wall system. The completed installation has returned the interior to "like new" condition.
