Developing Innovative Drainage and Drying Solutions for the Building Enclosure

Mark F. Williams, FAIA

ABSTRACT

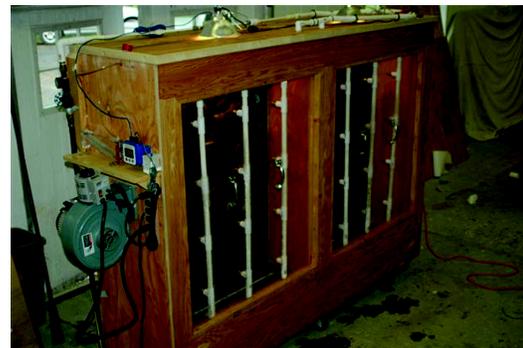
Figure 1 Pressure chamber for two ASTM E-514 cladding mock-ups.

For the present study, ASTM E-514 was conducted as follows. A pressure chamber was built large enough to accommodate two mock-ups placed side by side (see Figure 1). This chamber is constructed of plywood sheathing on wood studs, and is 8 ft (244 cm) wide, 5 ft (183 cm) high, and 2 feet (61 cm) deep. A central partition subdivides the interior chamber space, except for a 3 in. (8 cm) gap at the bottom to allow airflow between the two mock-ups. The front side includes two 40 in. (102 cm) x 45 in. (114 cm) openings which are covered with clear acrylic sheet panels to allow observation during testing. The mock-ups were installed in the chamber and sealed in place with self-adhering membrane and mastic. Water was applied to the front face of each mock-up from a spray rack. Water flow was monitored by a digital flowmeter, and the rack was calibrated to deliver the required quantity of water at the required application rate. The bottom portion of both mock-up areas was provided with drain outlets. Air pressure was applied with a variable speed air blower and monitored by a manometer. The flowmeter, blower, and manometer were all mounted at one end of the chamber.

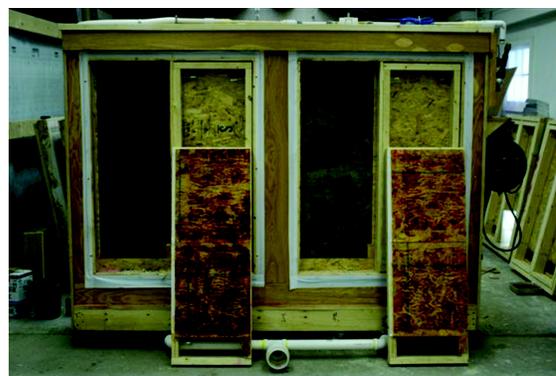
Figure 2 Mock-ups for MSV Evaluation #1 (one layer Grade D WRB). Note increased water staining on sheathing and backside of MSV in mock-up with “crack defect” (left).

Manufactured Stone Veneer (Evaluations #1 - #3). Dye patterns indicating water intrusion occurred on the exterior face of all sheathing panels in MSV mock-ups. The staining originated primarily at fastener punctures, and spread over most of the OSB surfaces. As might be expected, the mock-ups with defects showed larger areas of water intrusion than those without defects.

Overall, one layer of WRB did not prevent water from reaching the sheathing, regardless of whether the mortar included “crack defects” or not. Two layers of WRB offered better protection, but water still reached the sheathing via fastener punctures (see Figure 2). Resistance meter readings taken at puncture sites from either configuration ranged from 30% to 40%. In Evaluation #3, which included a sensor array (but no sheathing; staples installed only into the studs), readings were consistently high (approximately 30% to 40%) in the mock-up with cladding defects, and consistently low (approx-

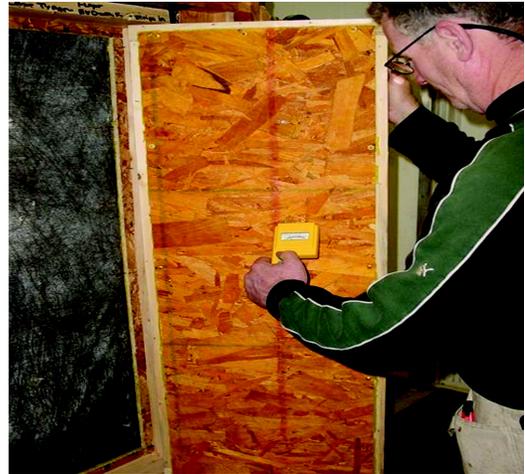
Figure 4 Mock-up for Stucco Evaluation #5 (two layers housewrap, one drainage-enhanced, with furring strips). Left side. Very limited waterstaining on sheathing. Resistance meter registers 8%.

Evaluation #5 tested the same types of WRB materials as used in Evaluation #4, but the two products were separated by closed-cell foam plastic furring strips to create a drainage gap. Lath and WRB materials were fastened to the sheathing panels through these furring strips, which appear to offer some self-sealing properties. In contrast to other evaluations, only one very limited dye pattern was observed, indicating that water was almost totally prevented from penetrating the WRBs and reaching the sheathing. Resistance type meter readings were also very low (typically 5% to 8%). This evaluation demonstrated that the closed-cell foam plastic furring strips were useful in preventing water from reaching the sheathing plane (see Figures 4 and 5). The furred WRB/stucco cladding design approach exemplified in Evaluation #5 is currently being further assessed under real-world conditions, as explained in the Field Evaluations section of this paper.

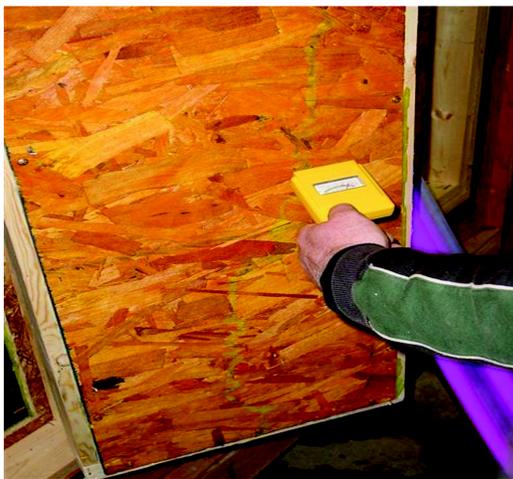
Figure 3 Mock-up for Stucco Evaluation #4 (two layers housewrap, one drainage-enhanced). Several areas of sheathing are waterstained. Resistance meter registers 30%.

Portland Cement Plaster (Stucco) Tests (Evaluations #4 and #5). In Evaluation #4, dye patterns indicating water intrusion occurred between both WRB layers (“traditional” housewrap and “drainage enhanced” housewrap) and on the inside face of the sheathing. The staining originated at staple punctures. There was some evidence of water penetration on the backside of the stucco itself. Resistance type meter readings at the OSB sheathing were 30%-40% (see Figure 3).

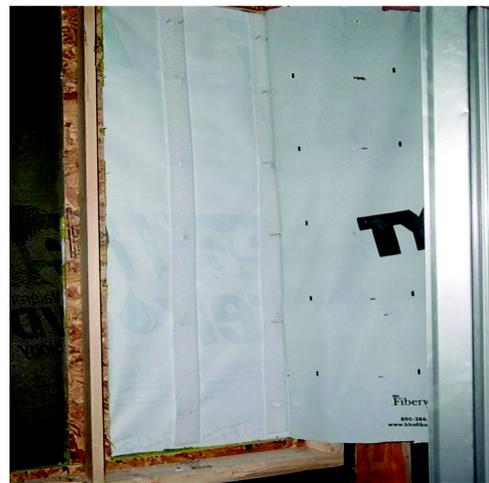
Figure 5 Mock-up for Stucco Evaluation #5 (two layers housewrap, one drainage-enhanced, with furring strips). Right side. No water intrusion evident on WRB layers or sheathing. (Note closed-cell foam plastic furring strips).
